B2. Photographs of footpath Holmfirth 60 and other relevant features Holmfirth 60

NB photographs have been organised to illustrate various features along the route from west to east. Where available, photographs taken at similar locations, but on different dates, have been grouped together. Photos generally progress from west to east.

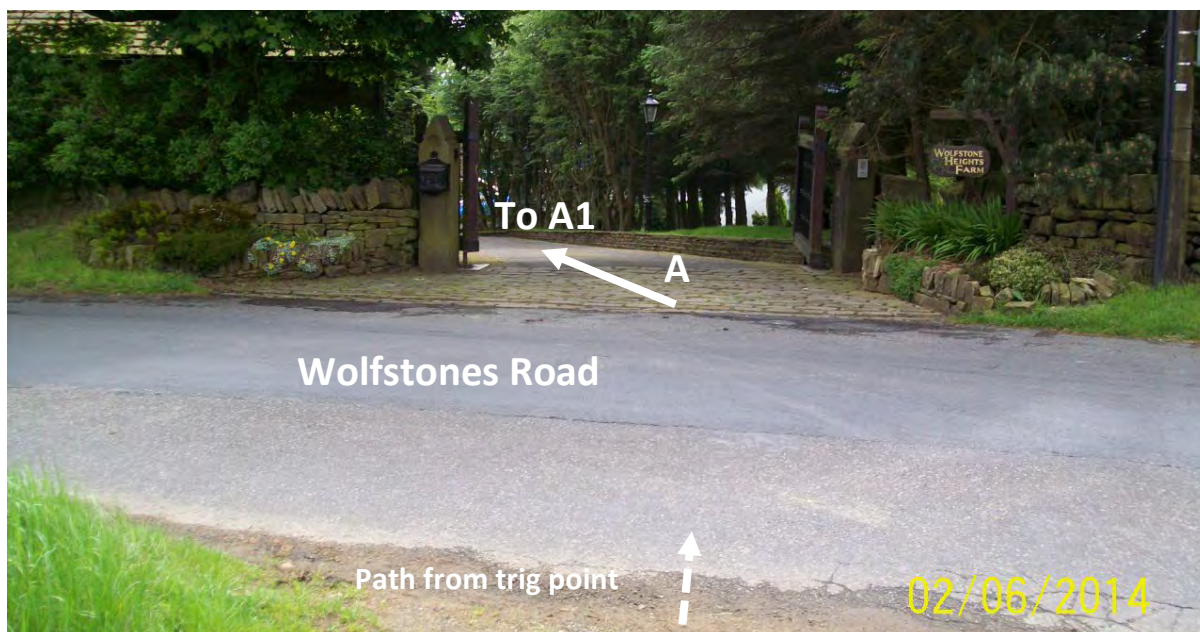
1. Point A at junction with Wolfstones Road. This is the start of the driveway to Wolfstones Heights Farm, followed by footpath Holmfirth 60. Behind the camera position an informal path leads towards the triangulation pillar at Wolfstones Height. The photograph shows automated electric gates, in open position. 2 Jun 2014.

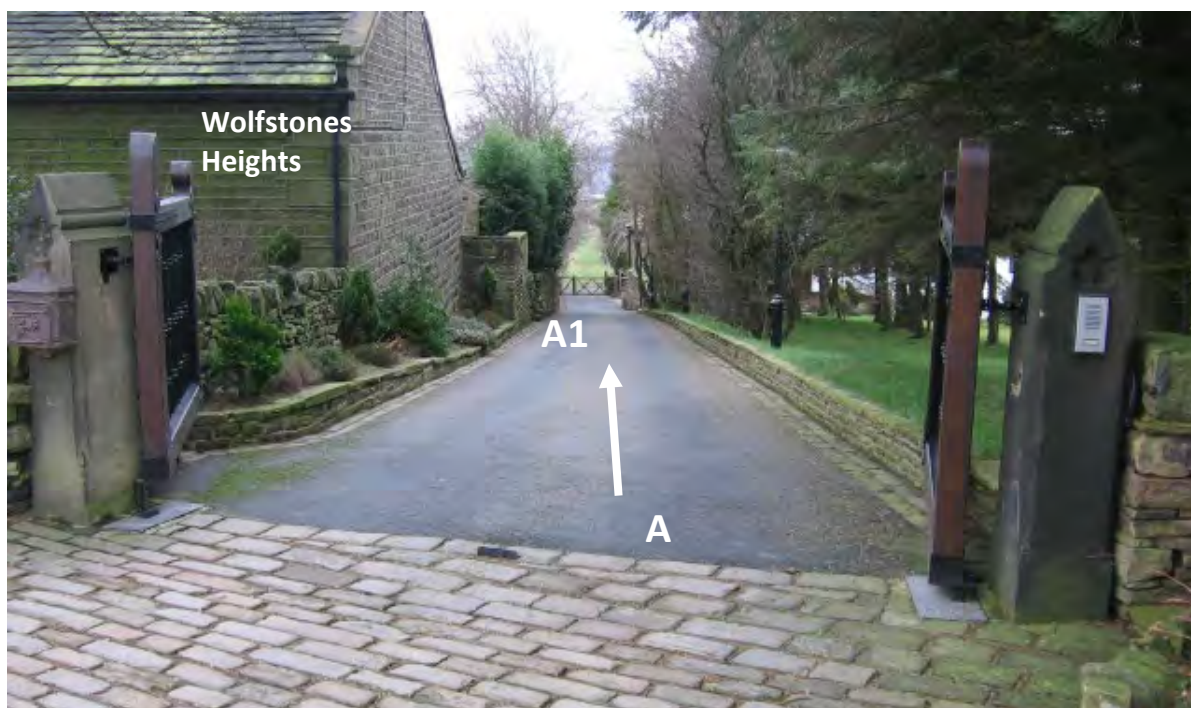
2. Point A at junction with Wolfstones Road, showing electric gates in open position. Photograph taken by Exegesis Spatial Data Management surveyor under contract to Kirklees Council. 13 Feb 2007

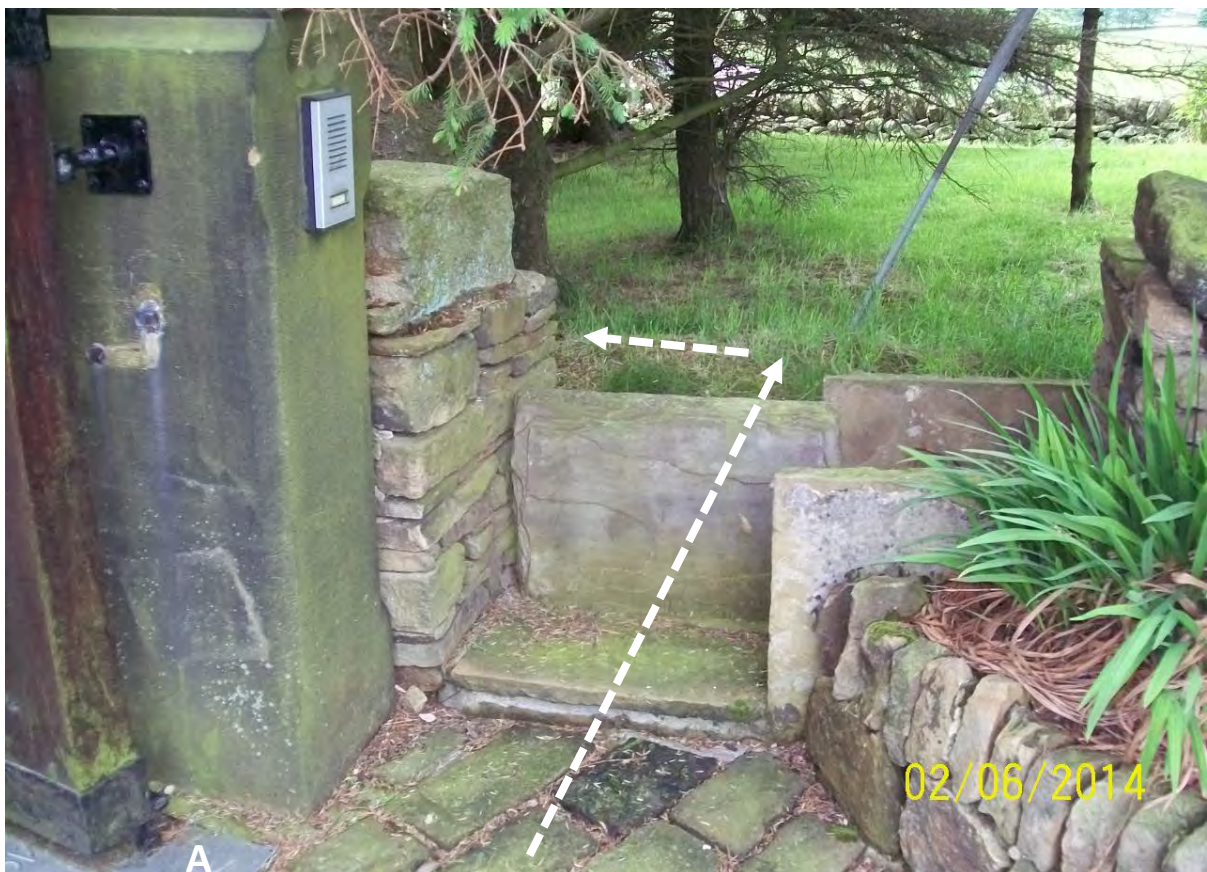
4. Gatepost, electric gate and 'bypass' stile at point A. The 'bypass' around the gatepost on the southern side took users off the driveway. Neither gates nor a stile are recorded as limitations in the Definitive Map and Statement. Use of the bypass would require walking within the part of the driveway fenced off in September 2020. See also Google Street View photos from July 2009 and May 2011. 02 Jun 2014.

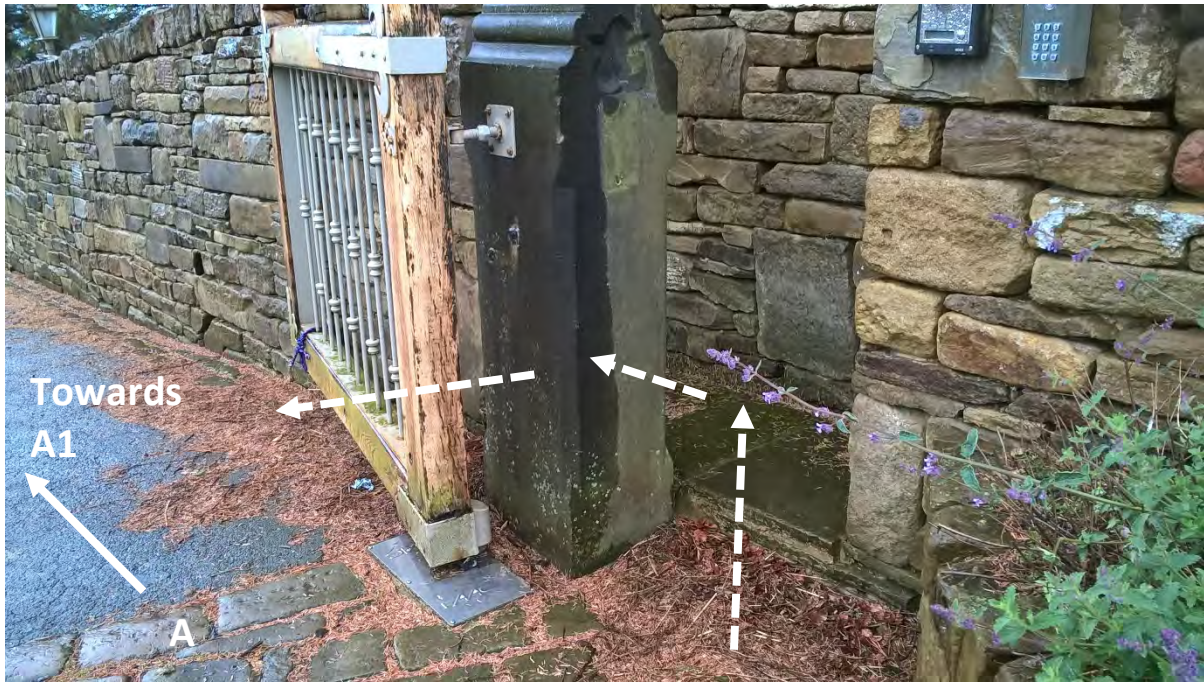
5. Alterations to the bypass gap / stile at point A following construction of a wall along the south side of the driveway. This alteration to the access took place between summer 2014 and summer 2017. The gate was secured in an open position, so access via this gap / stile would not have been possible or necessary at the time this photo was taken. 11 Jun 2019.

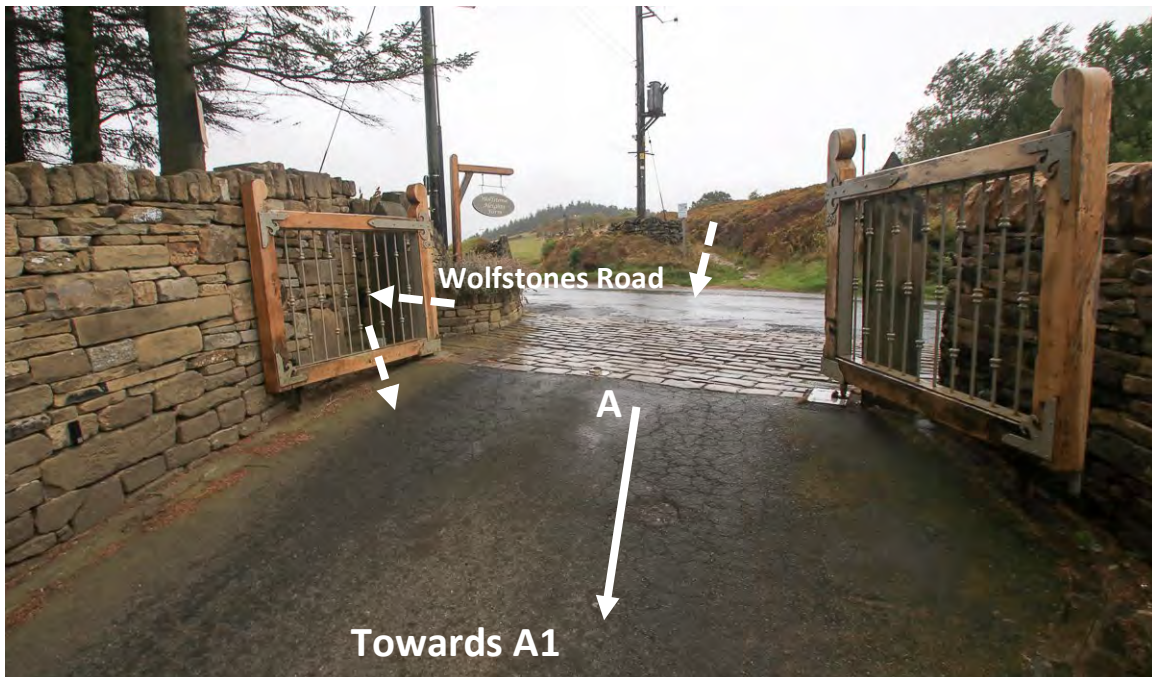
6. Electric gates at Point A and adjacent gap / stile. Looking west to Wolfstones Road. The wall to the south (left) was constructed in the period summer 2014 to summer 2017. Photograph supplied by the applicant. 08 Sep 2018.

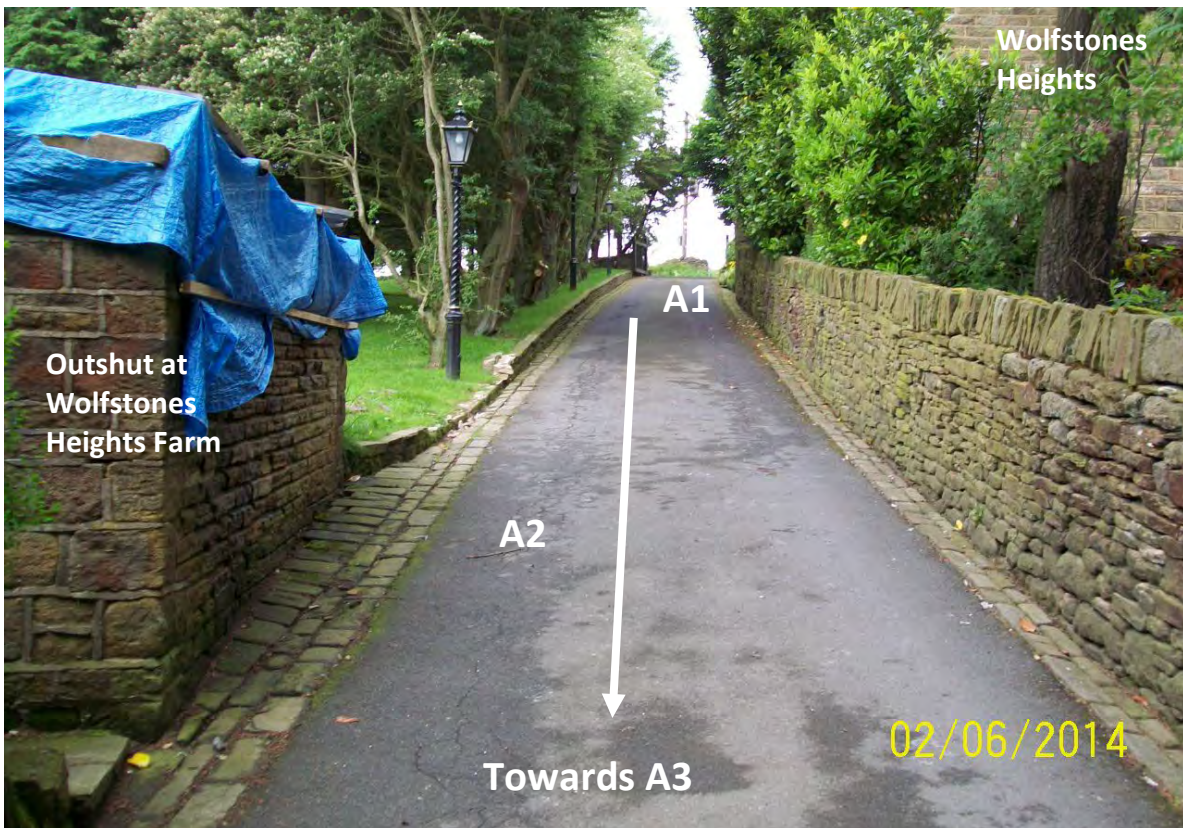
14. View west from near point A2 towards point A at Wolfstones Road. To the left (south) is an outshut forming part of Wolfstones Heights Farm. This part of the building had been damaged by fire in December 2013. 02 Jun 2014.

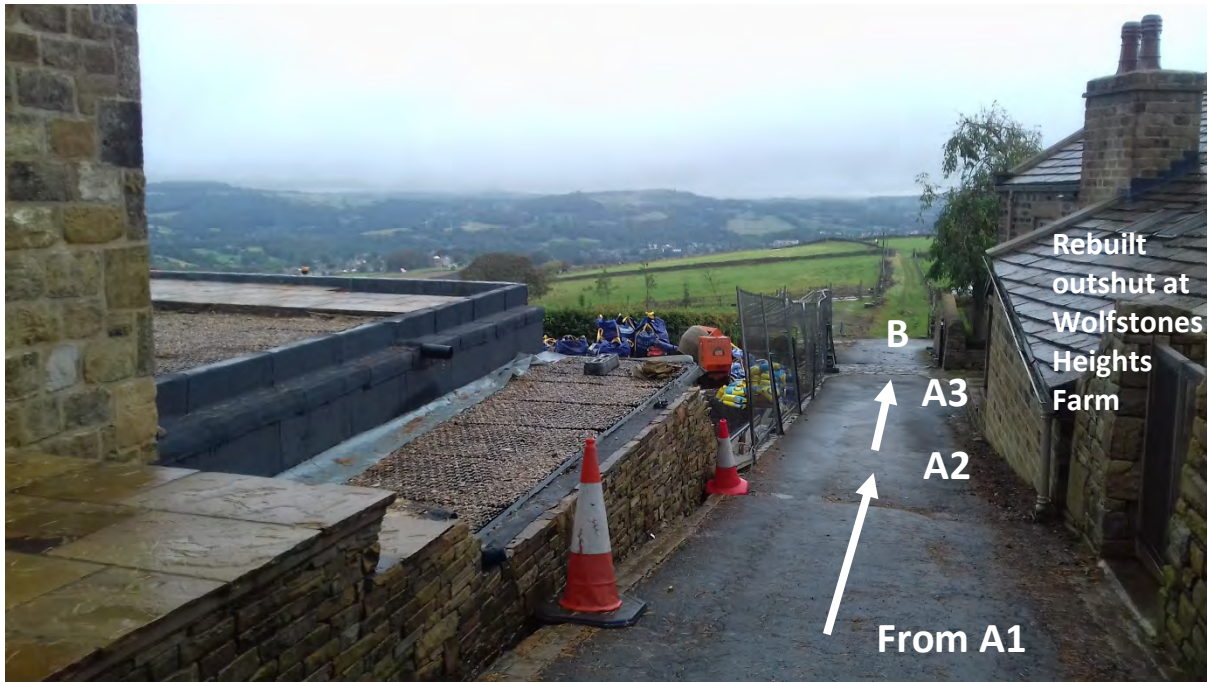
15. View from east to the rebuilt outshut at A2, corner of house at A3 and open gates at B. Work was ongoing to construct garages and related structures to the north of the driveway, however the driveway itself and the continuation to the east were free of building materials or other obstructions etc. 04 Oct 2019.

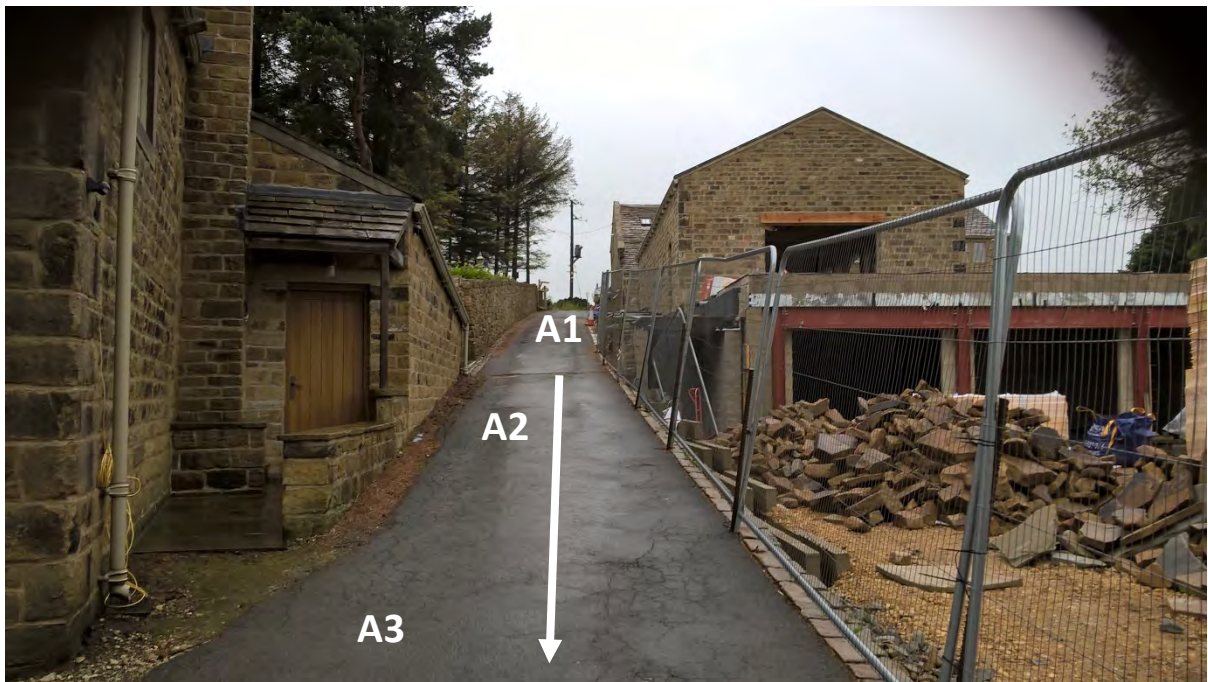
16. View east from the corner of the house at A3, looking west up the driveway toward point A. Similar position to above at A1 looking towards point A. The fire damaged outshut at A2 had been rebuilt. Work was underway to construct a new garage block on the north side of the driveway. 11 Jun 2019.

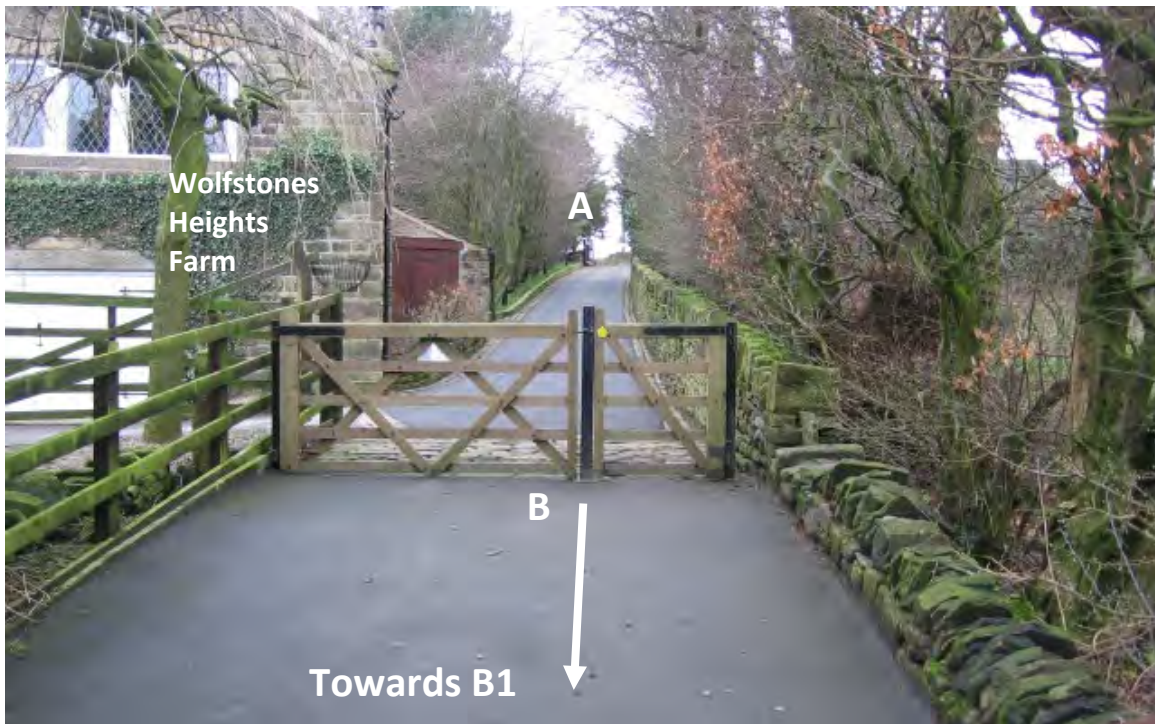
20. Pair of gates and removable post at point B. Looking west past the corner of the house at A3 towards point A. Gates in closed position but not locked. This location was the point at which a field edge footpath through field 1331 (as indicated on 1931 OS map) met the access between the farm and Wolfstones Road. Photograph taken by ESDM surveyor under contract to Kirklees Council. 13 Feb 2007.
