B2. Photographs of footpath Holmfirth 60 and other relevant features Holmfirth 60

NB photographs have been organised to illustrate various features along the route from west to east. Where available, photographs taken at similar locations, but on different dates, have been grouped together. Photos generally progress from west to east.

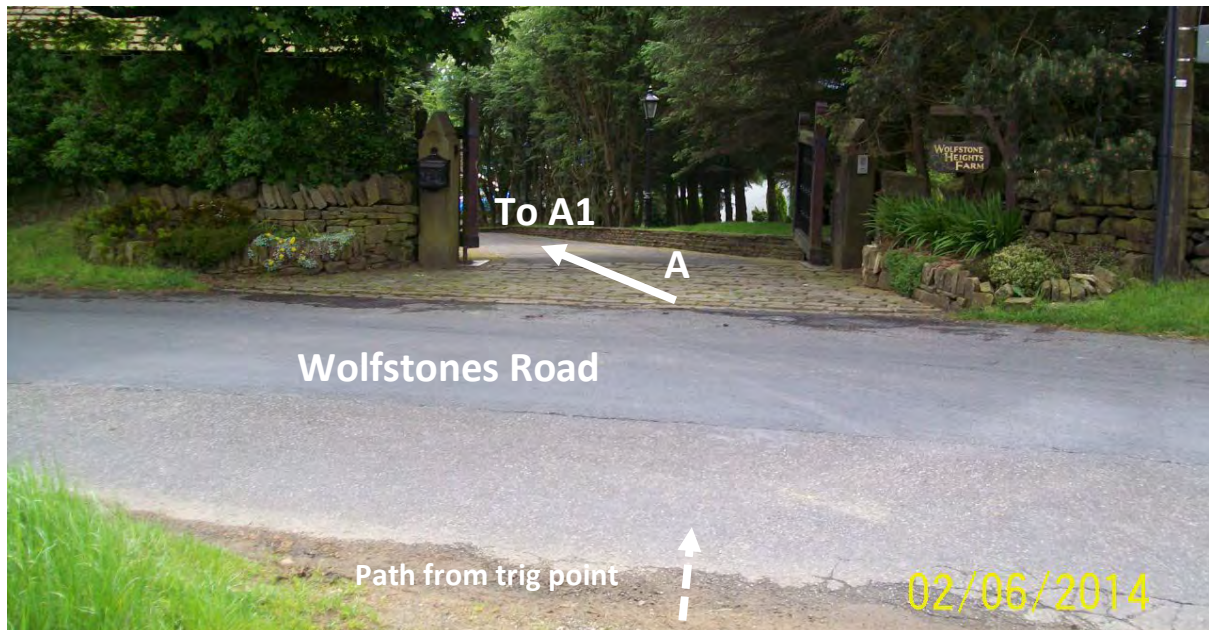
1. Point A at junction with Wolfstones Road. This is the start of the driveway to Wolfstones Heights Farm, followed by footpath Holmfirth 60. Behind the camera position an informal path leads towards the triangulation pillar at Wolfstones Height. The photograph shows automated electric gates, in open position. 2 Jun 2014.

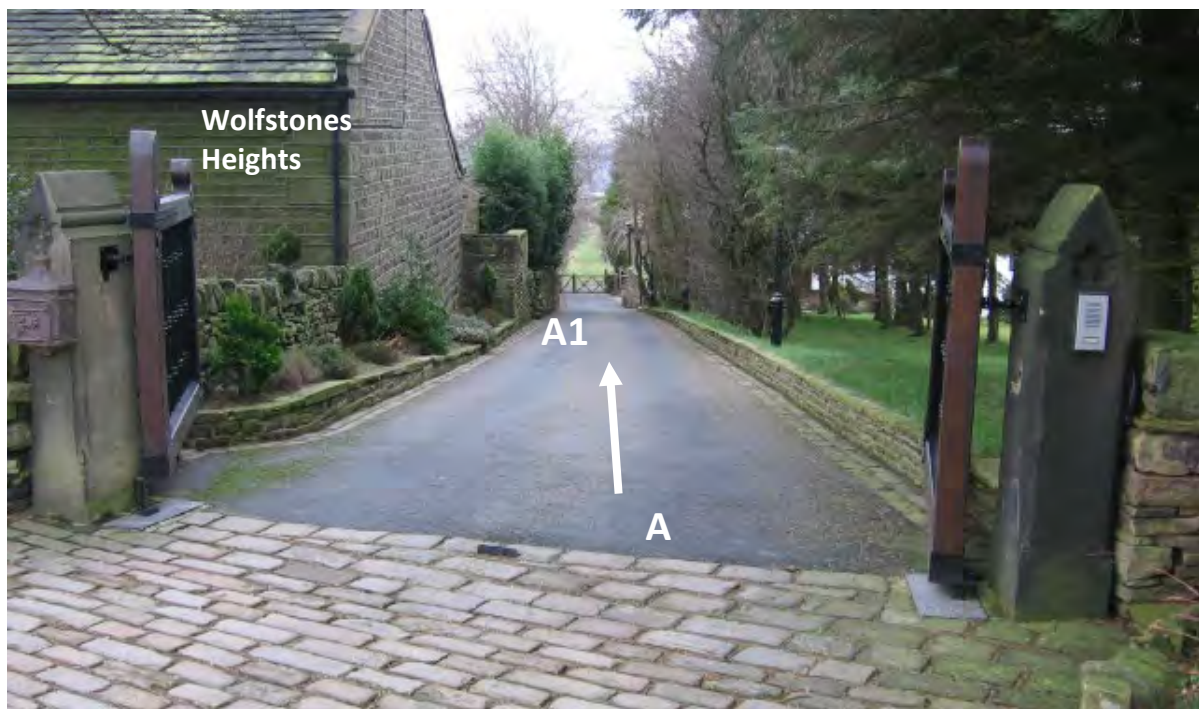
2. Point A at junction with Wolfstones Road, showing electric gates in open position. Photograph taken by Exegesis Spatial Data Management surveyor under contract to Kirklees Council. 13 Feb 2007

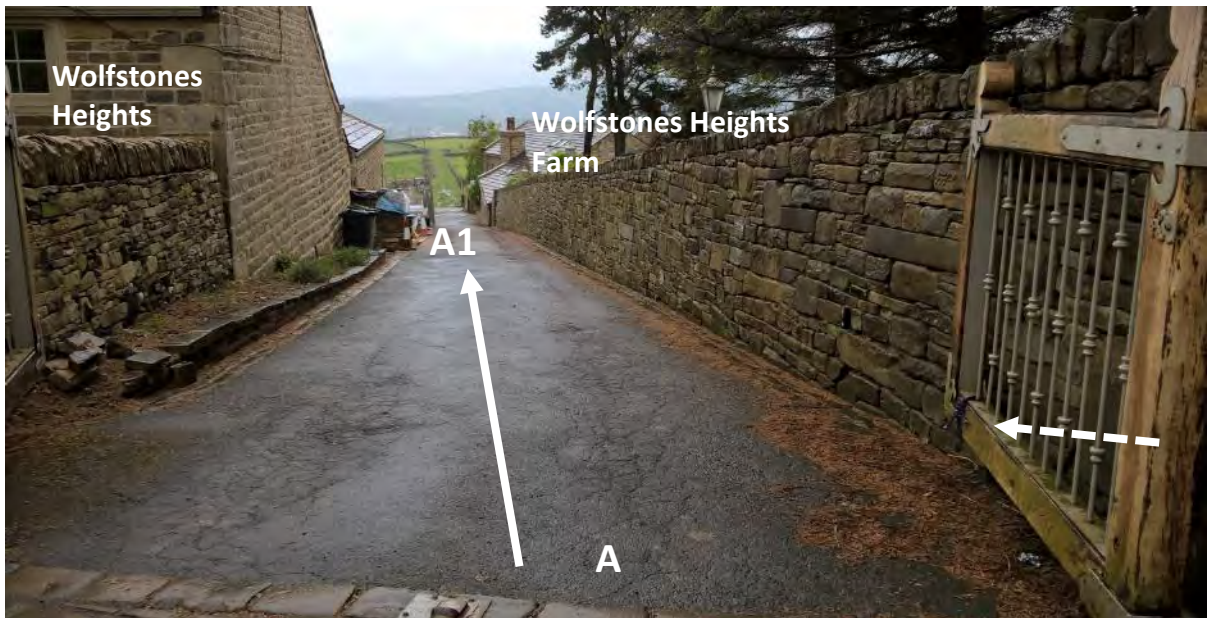
3. View east from point A along the driveway to Wolfstones Heights Farm. In the open position the right-hand gate leaf blocks access to a squeeze stile around the gatepost. The wall on the right (south) was constructed between summer 2014 and summer 2017 in place of a low stone kerb. 11 Jun 2019.

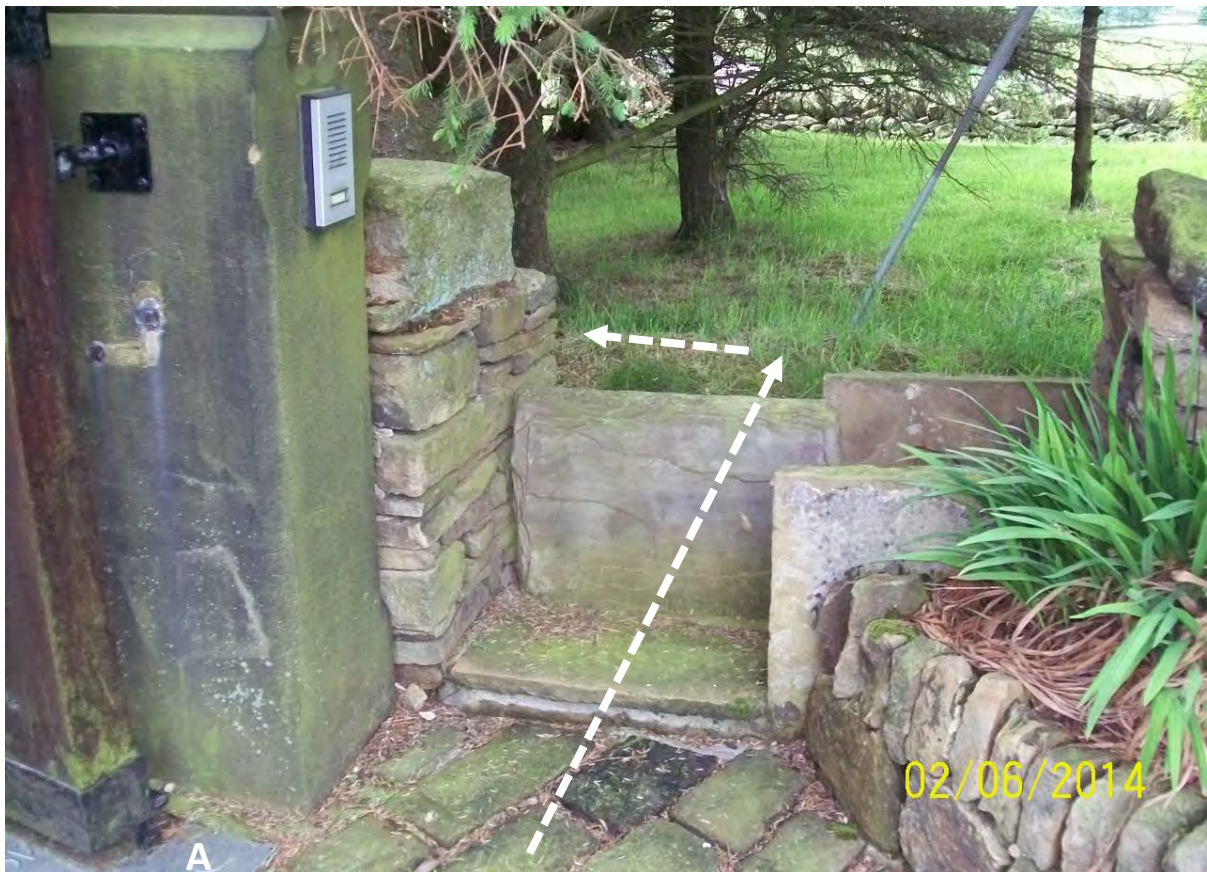
4. Gatepost, electric gate and 'bypass' stile at point A. The 'bypass' around the gatepost on the southern side took users off the driveway. Neither gates nor a stile are recorded as limitations in the Definitive Map and Statement. Use of the bypass would require walking within the part of the driveway fenced off in September 2020. See also Google Street View photos from July 2009 and May 2011. 02 Jun 2014.

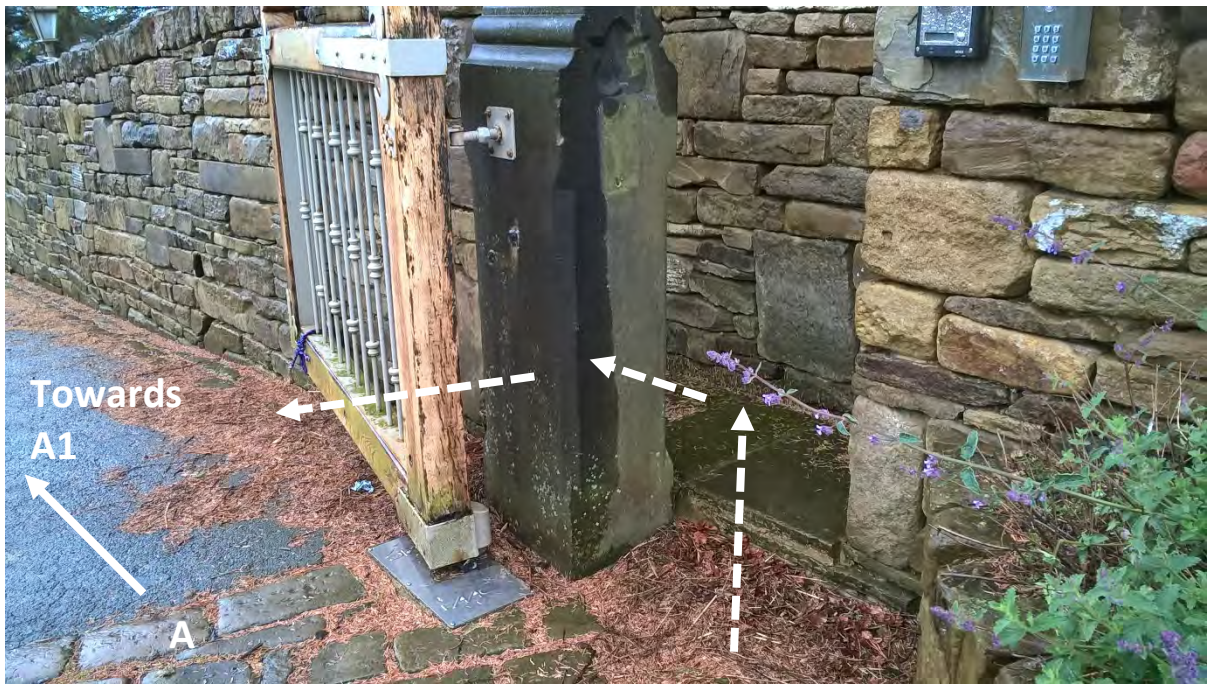
5. Alterations to the bypass gap / stile at point A following construction of a wall along the south side of the driveway. This alteration to the access took place between summer 2014 and summer 2017. The gate was secured in an open position, so access via this gap / stile would not have been possible or necessary at the time this photo was taken. 11 Jun 2019.

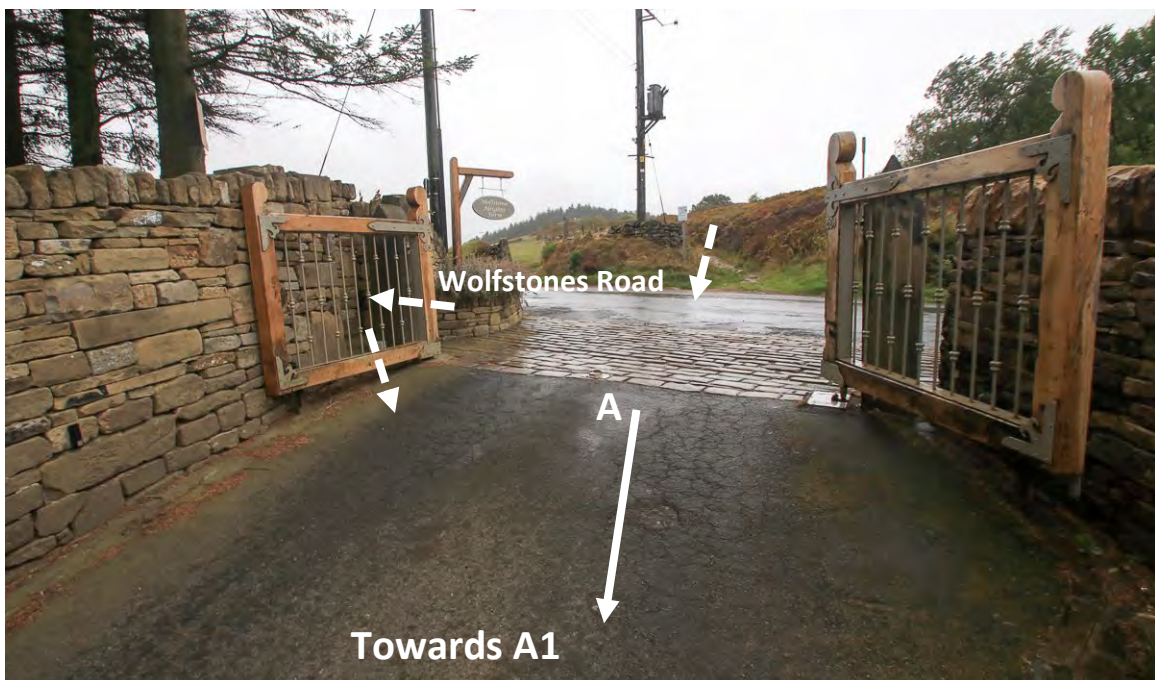
6. Electric gates at Point A and adjacent gap / stile. Looking west to Wolfstones Road. The wall to the south (left) was constructed in the period summer 2014 to summer 2017. Photograph supplied by the applicant. 08 Sep 2018.

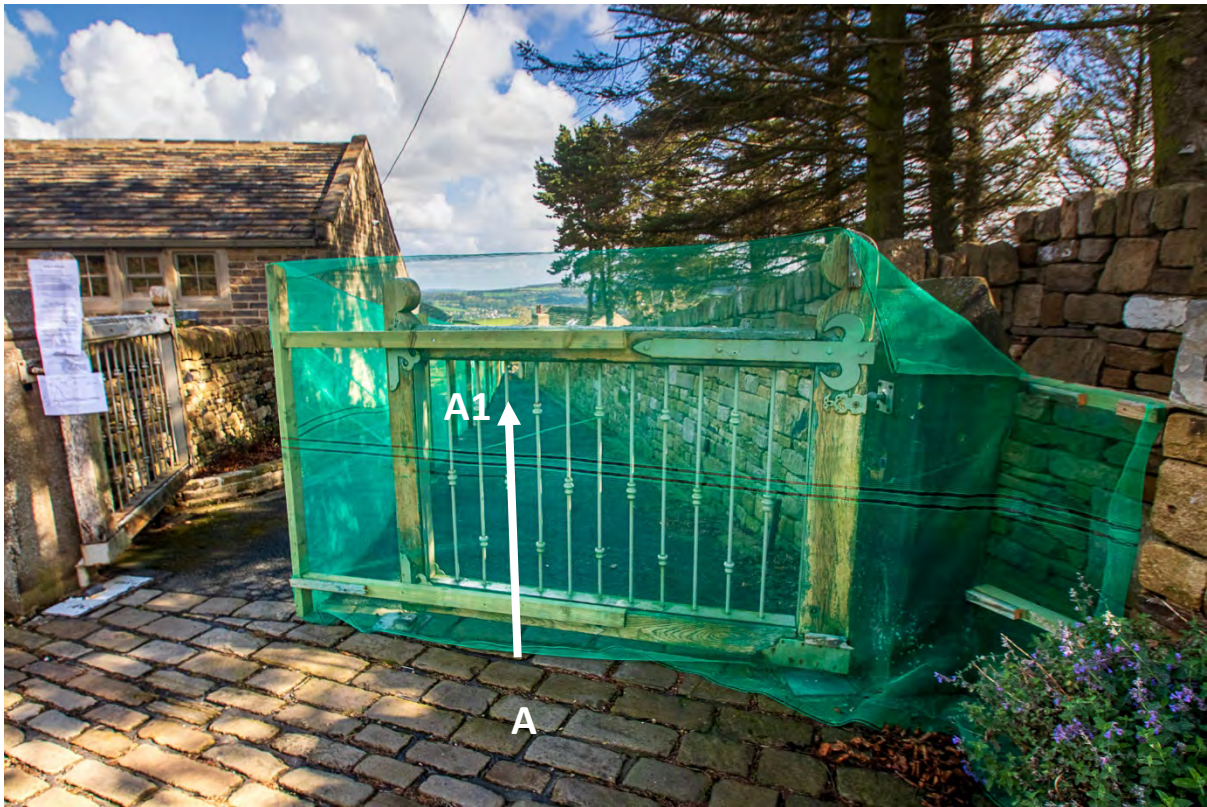
7. Fencing erected within the driveway in early September 2020. Looking east from point A. The available width had been narrowed to approximately 1.2 metres and the squeeze stile bypassing the southern gatepost had also been blocked off. Photograph supplied by the applicant. Sep 2020.

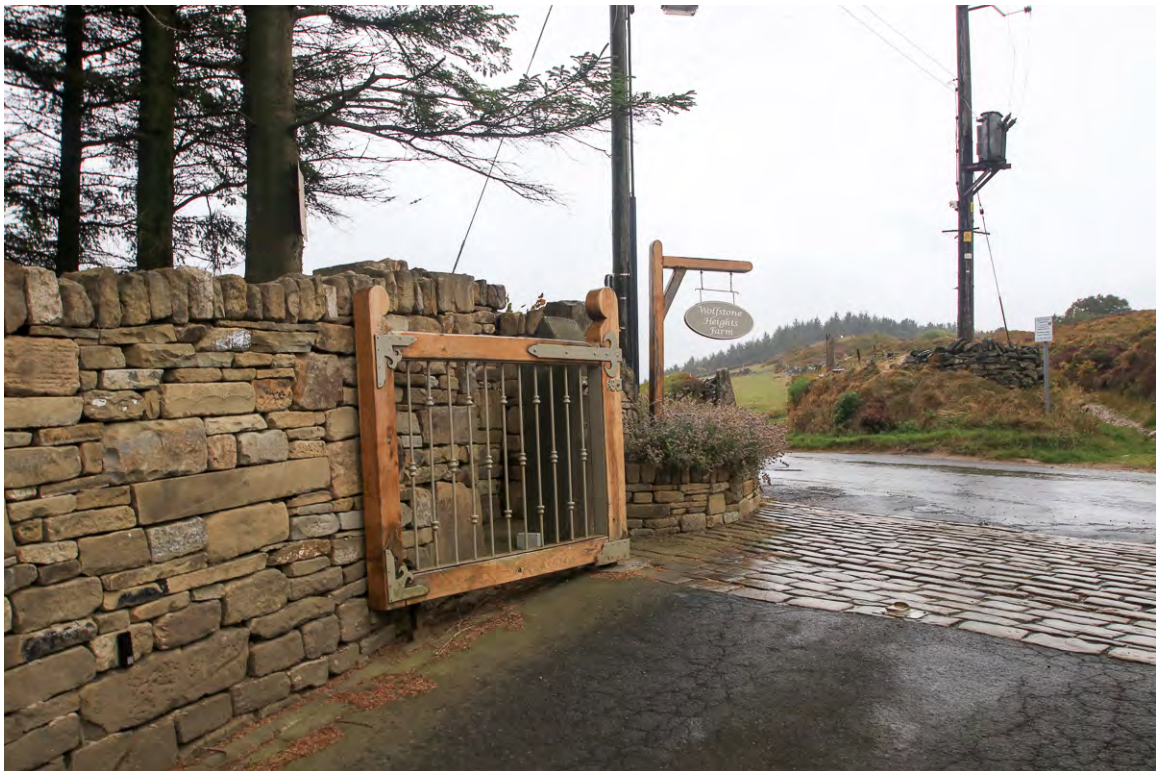
8. Southernmost gate leaf and squeeze stile at point A. Photograph supplied by the applicant. 08 Sep 2018

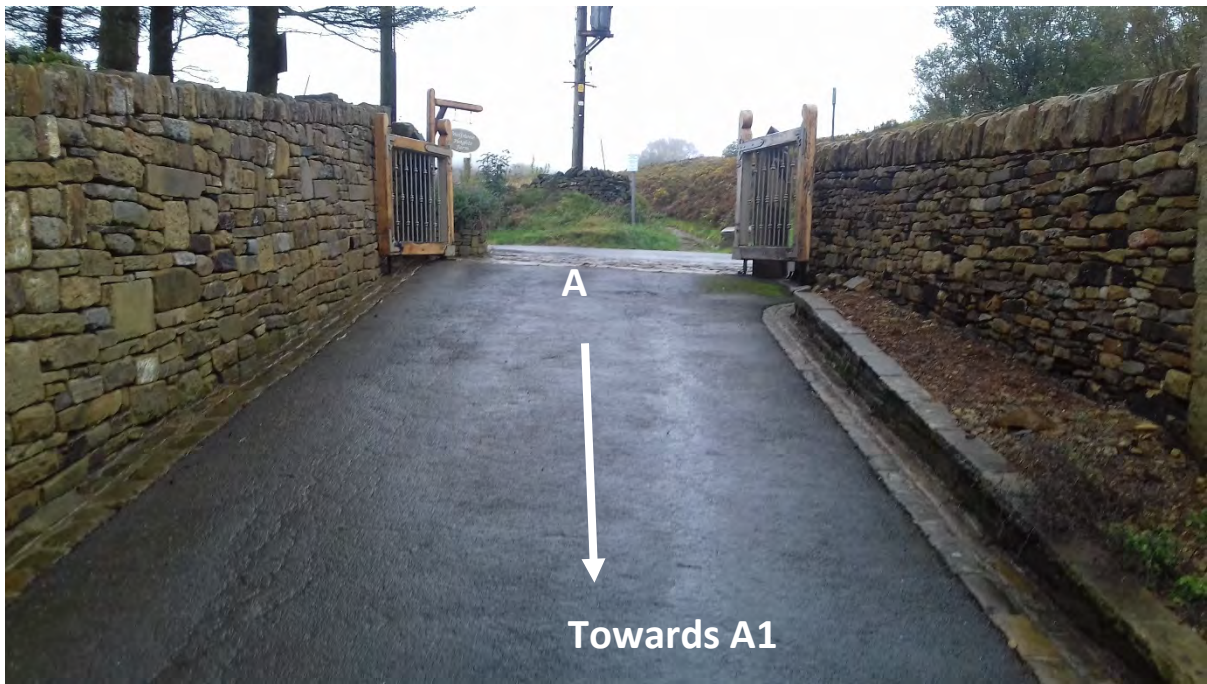
9. View west up driveway to electric gates at point A. Visible in this photo is an area of planting on the north side of the route, bordered by stone edging. This restricts the usable width for a length of about 20 metres. 04 Oct 2019.

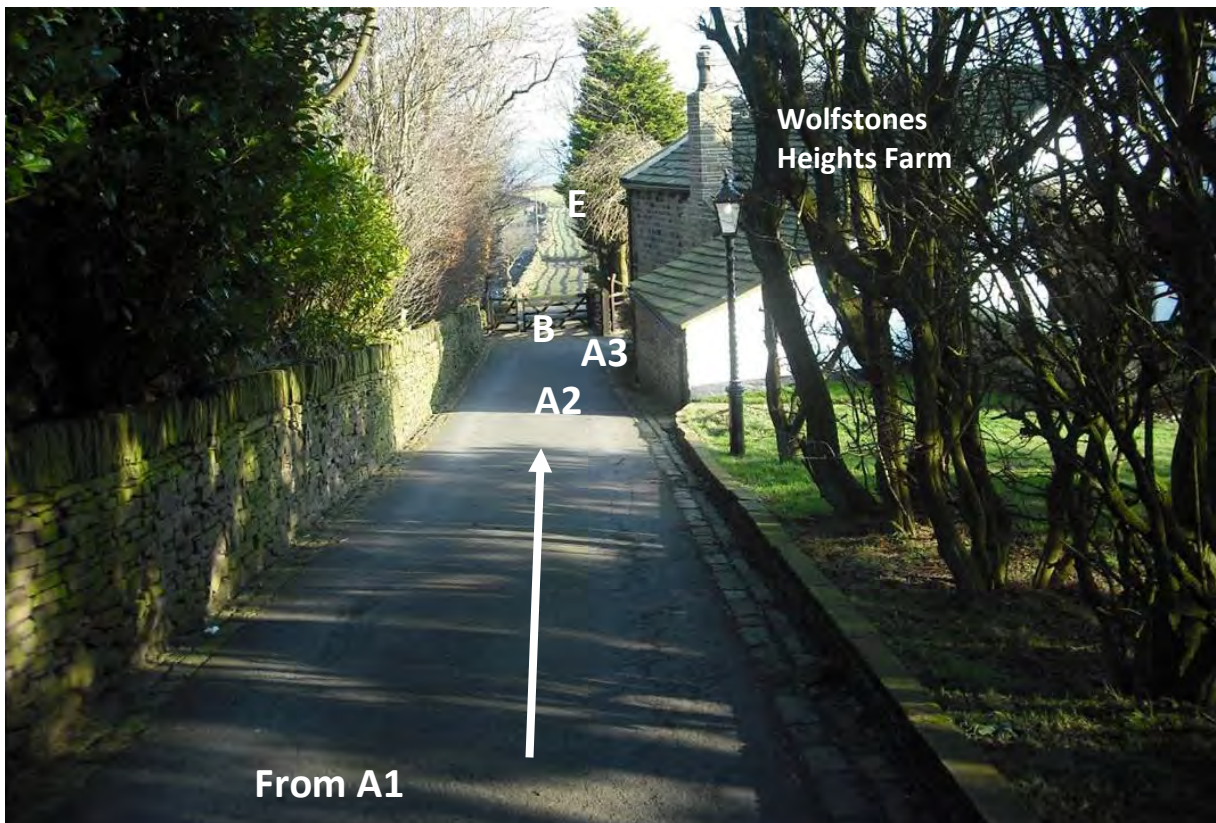
10. View east from near A1 towards A2 and gates at B. This photo clearly shows two gates at point B. The gate to the left (north) is clearly unlocked and open. There are no other obstructions, stored items, vehicles, or materials visible along the length of Holmfirth 60 towards point E. The driveway is bounded on the right (south) by a low kerb and a line of hawthorn trees – possibly a former hedge. Photo taken by a Planning Officer in Feb 2012.

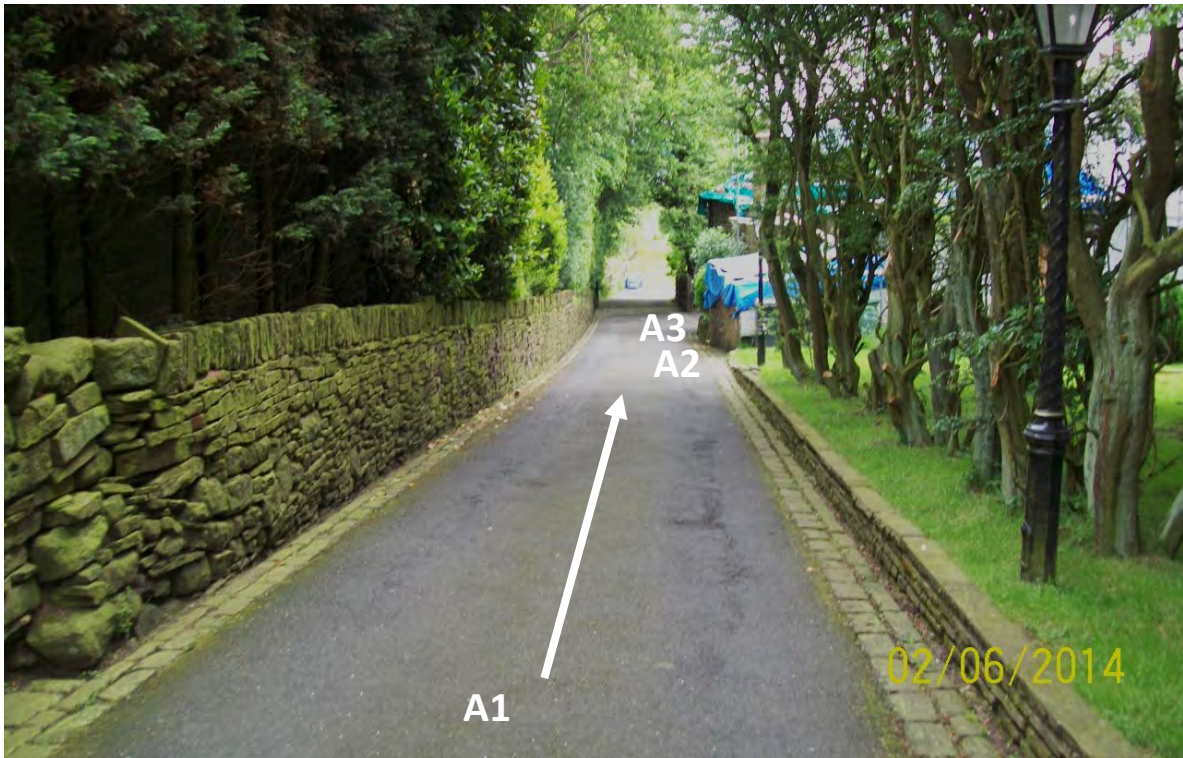
11. View east from near point A1, looking towards point A2. The roofs of Wolfstones Heights Farm are covered with blue tarpaulins following a fire in December 2013. 02 Jun 2014.

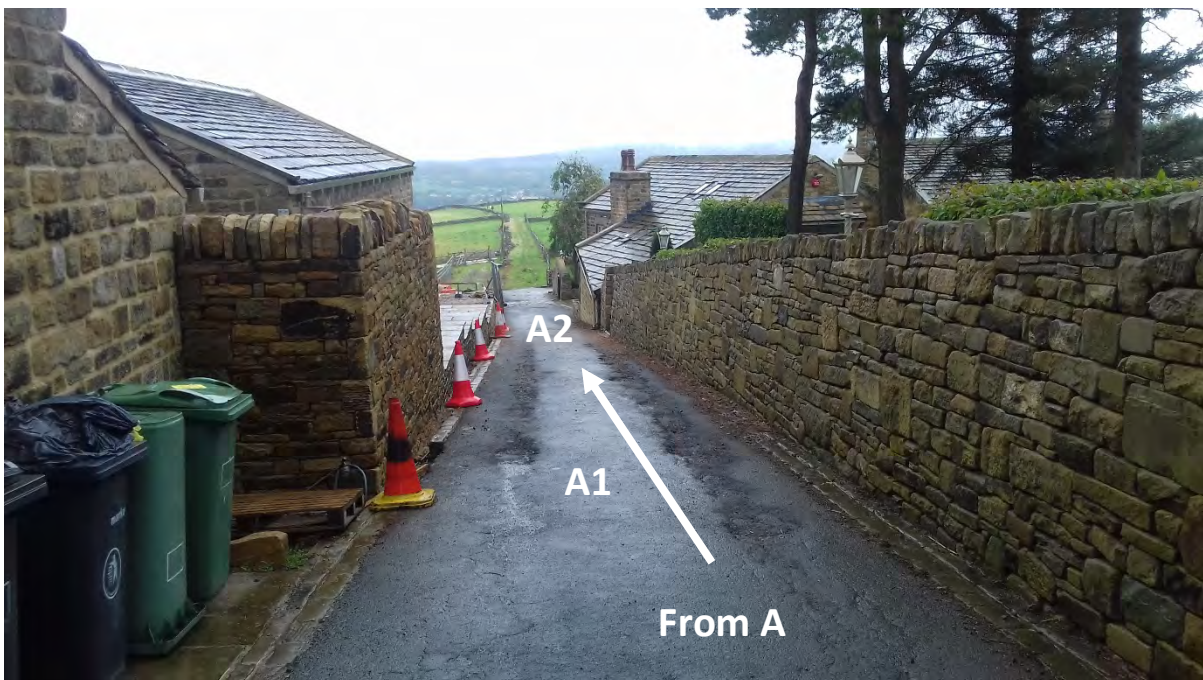
12. View west towards points A1 and A2. The right-angled wall to the left (at A1) is a recent construction but is in the position of an earlier structure shown on various map adjacent to the house know called 'Wolfstones Heights'. 04 Oct 2019.

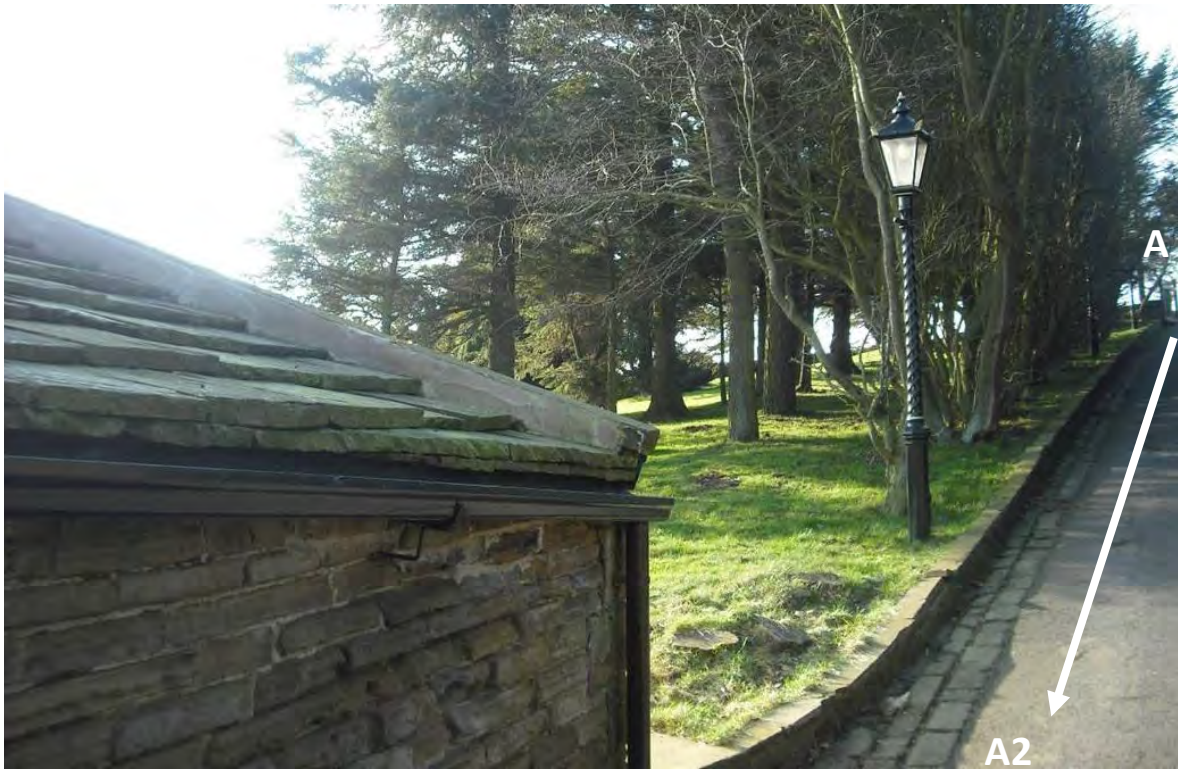
13. South side of the driveway access from near the outshut at Wolfstones Heights Farm at point A2. Showing southmost side of the driveway back towards point A. This end of the building would later be taken down and rebuilt following a fire. Feb 2012.

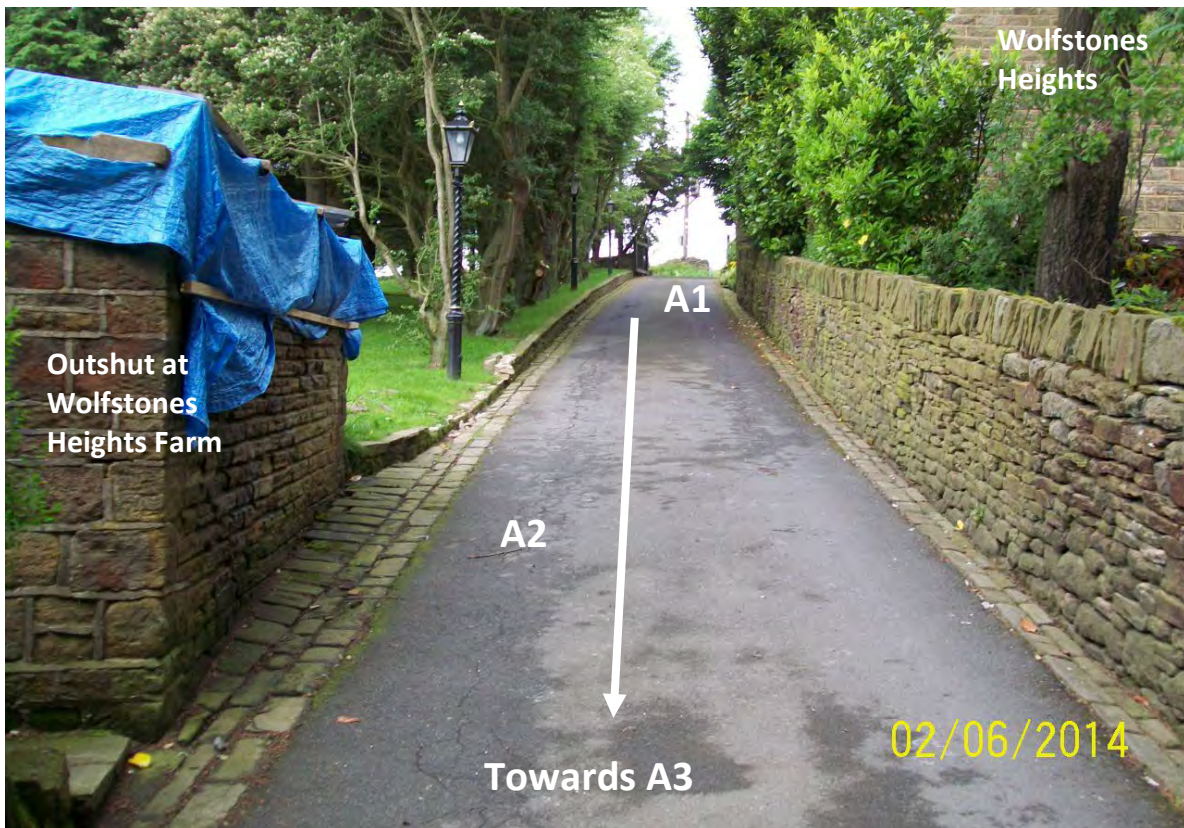
14. View west from near point A2 towards point A at Wolfstones Road. To the left (south) is an outshut forming part of Wolfstones Heights Farm. This part of the building had been damaged by fire in December 2013. 02 Jun 2014.

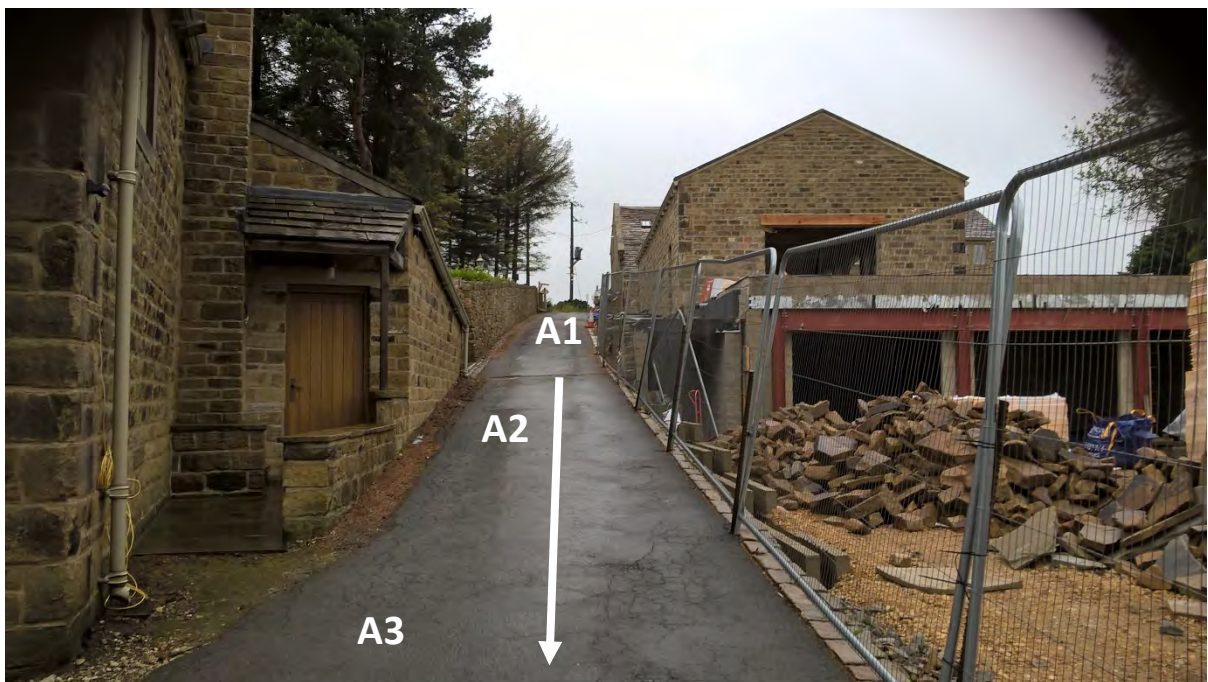
16. View east from the corner of the house at A3, looking west up the driveway toward point A point A. Similar position to above at A1 looking towards point A. The fire damaged outshut at A2 had been rebuilt. Work was underway to construct a new garage block on the north side of the driveway. 11 Jun 2019.

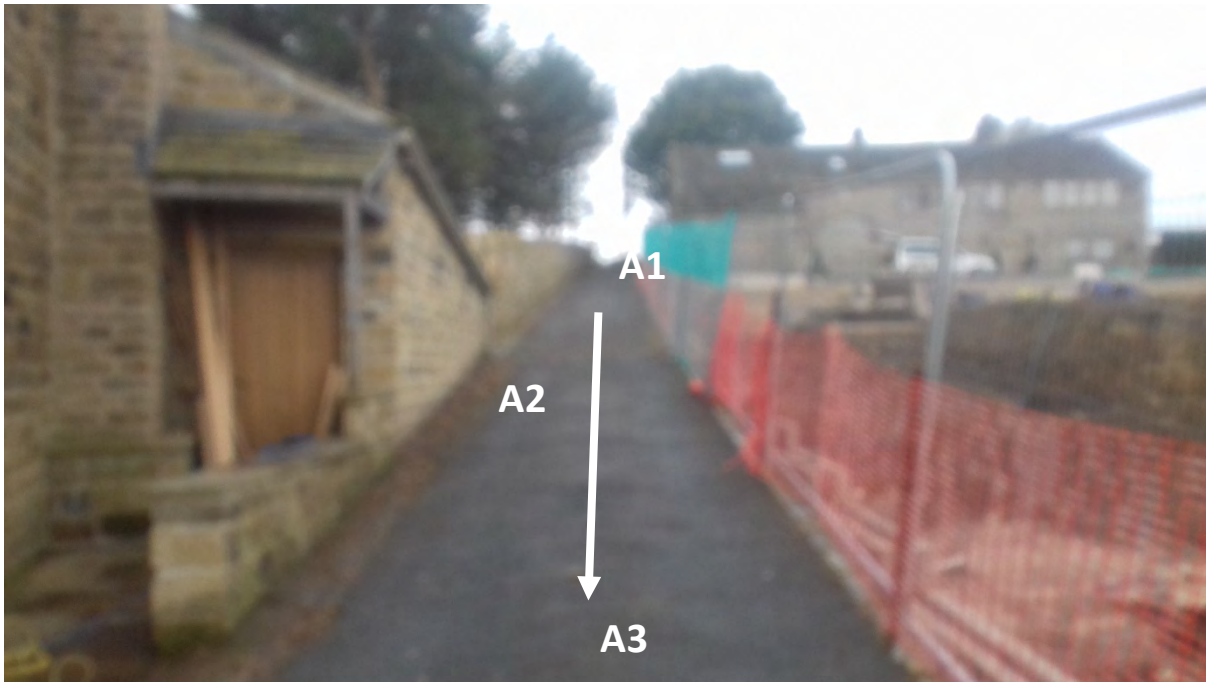
17. Out of focus photo showing driveway adjacent to Wolfstones Heights Farm track adjacent to house and temporary fencing on north side. The photo indicates repairs / rebuilding of the outshut had been completed and the wall constructed on the south side leading to point A. Oct 2017.

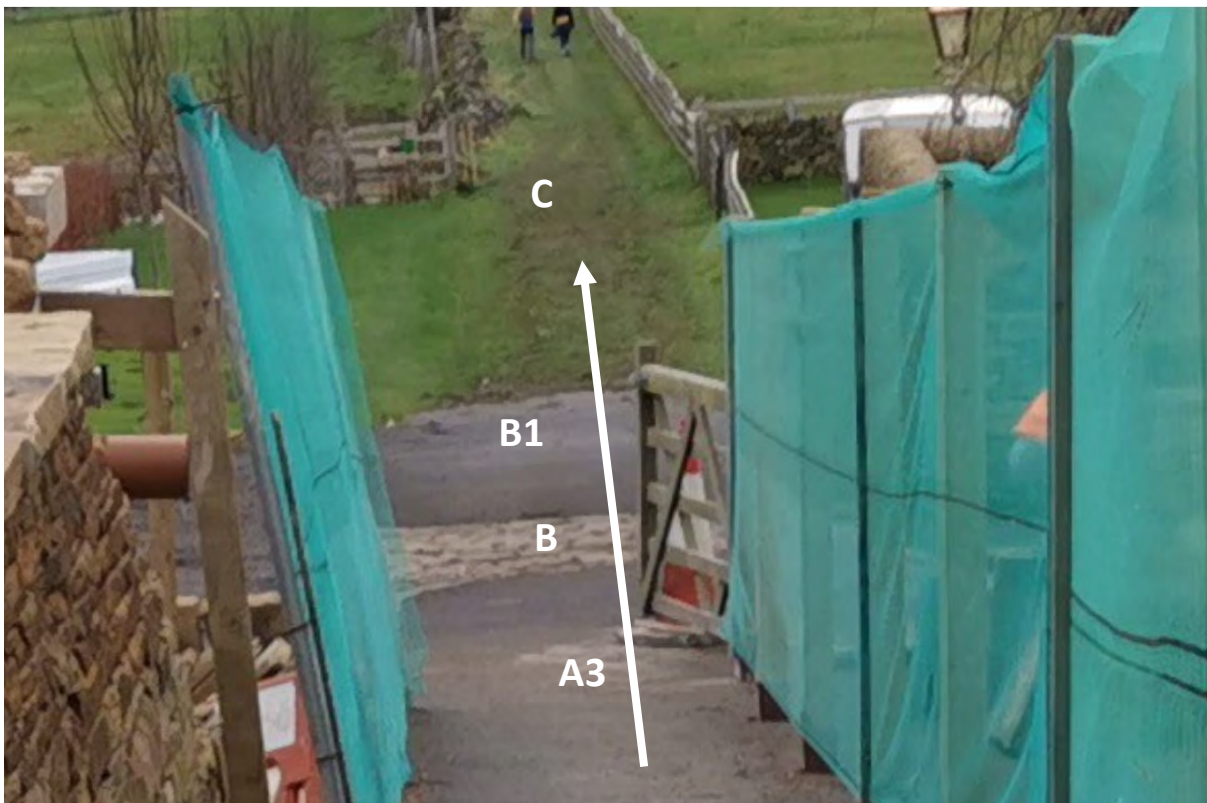
18. Foreshortened telephoto shot indicating narrowing of driveway approaching point A3 near Wolfstones Heights Farm and gate relocated from point B to point A3. 24 Nov 2020

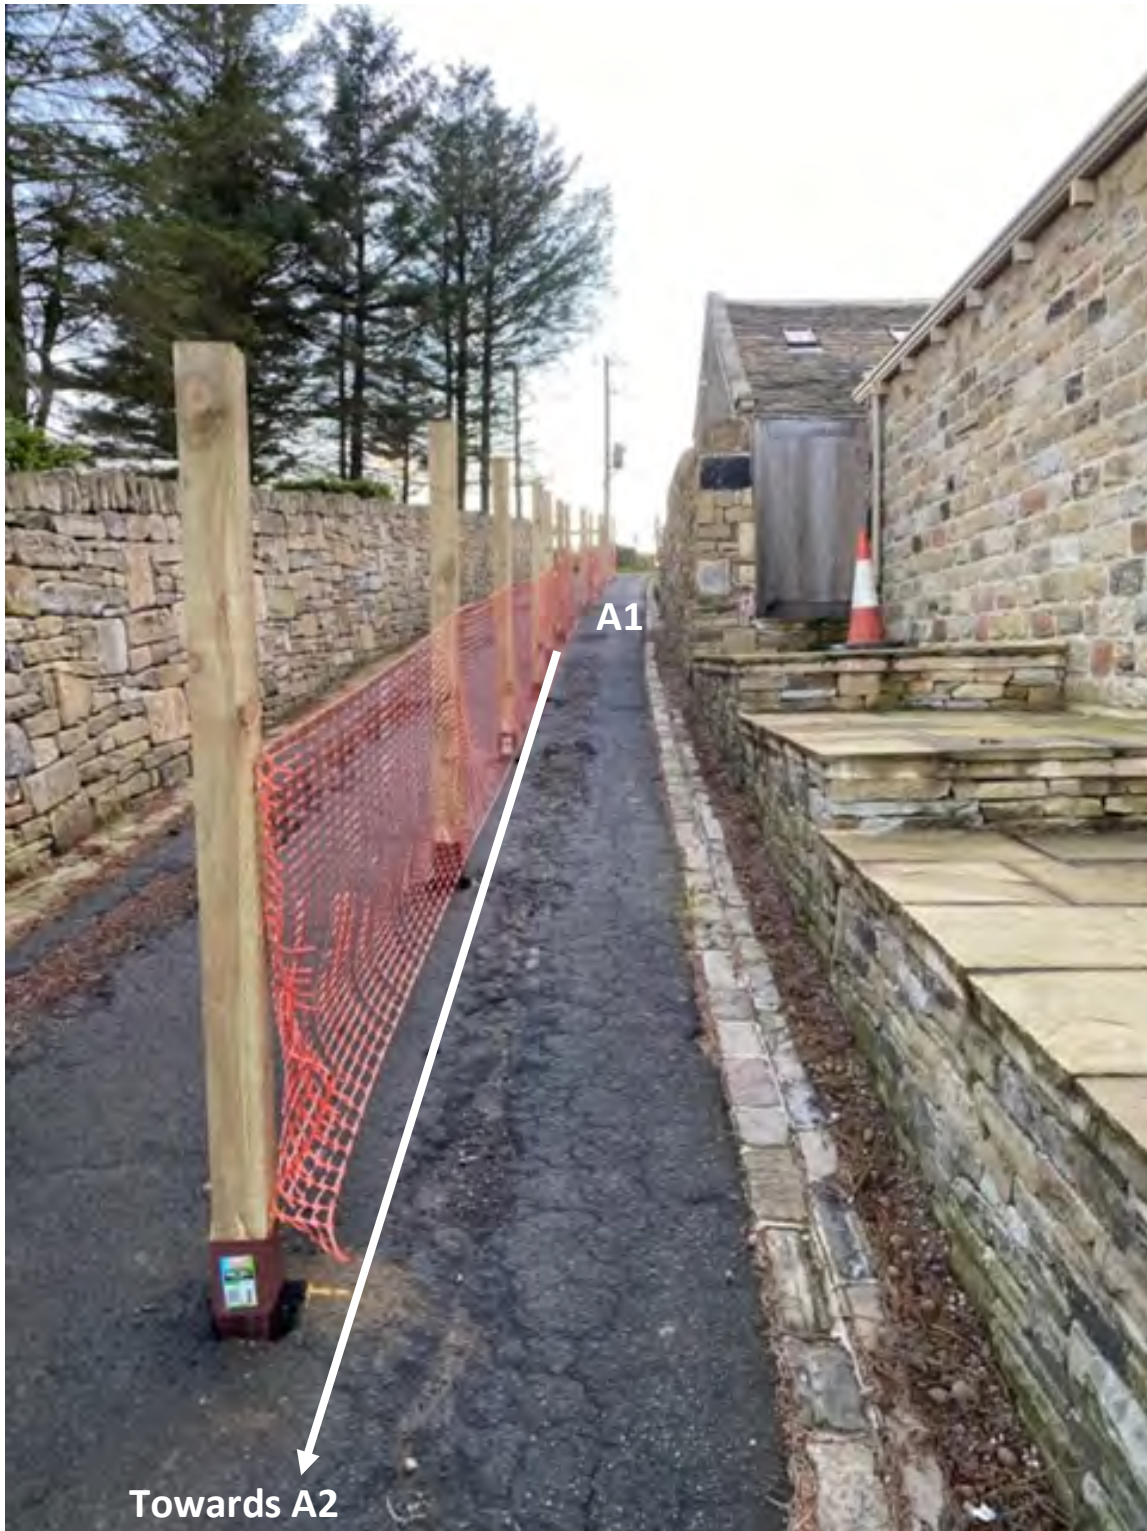
19. View west towards point A1 from near A2 showing line of fence posts erected in early September narrowing the usable width of the driveway (path Holmfirth 60) to approx. 1.2m. 21 Oct 2020.

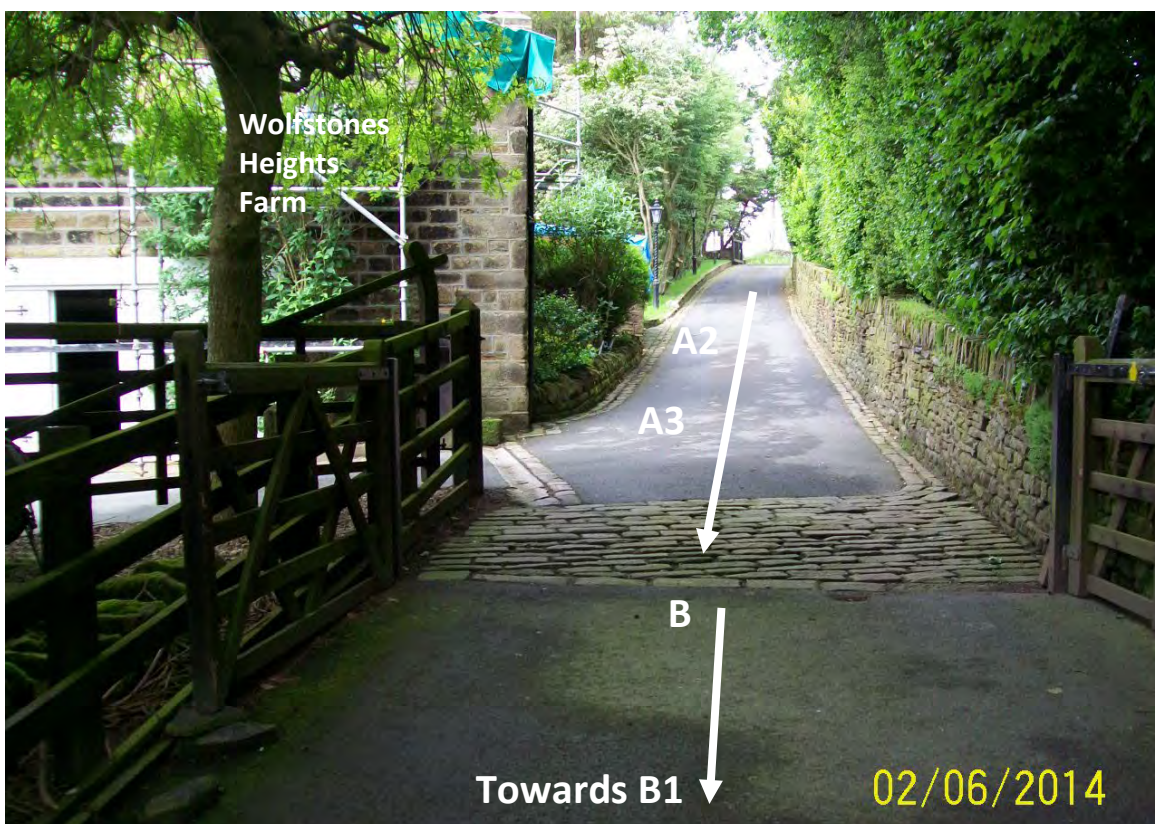
21. Pair of wooden gates at point B. Looking west past the corner of the house at A3 towards point A. Both gates were open. Scaffolding is visible adjacent to the main part of the house but there were no obstructions on the driveway itself. The 1985 Definitive Map and Statement records a stile at this location. 02 Jun 2014.

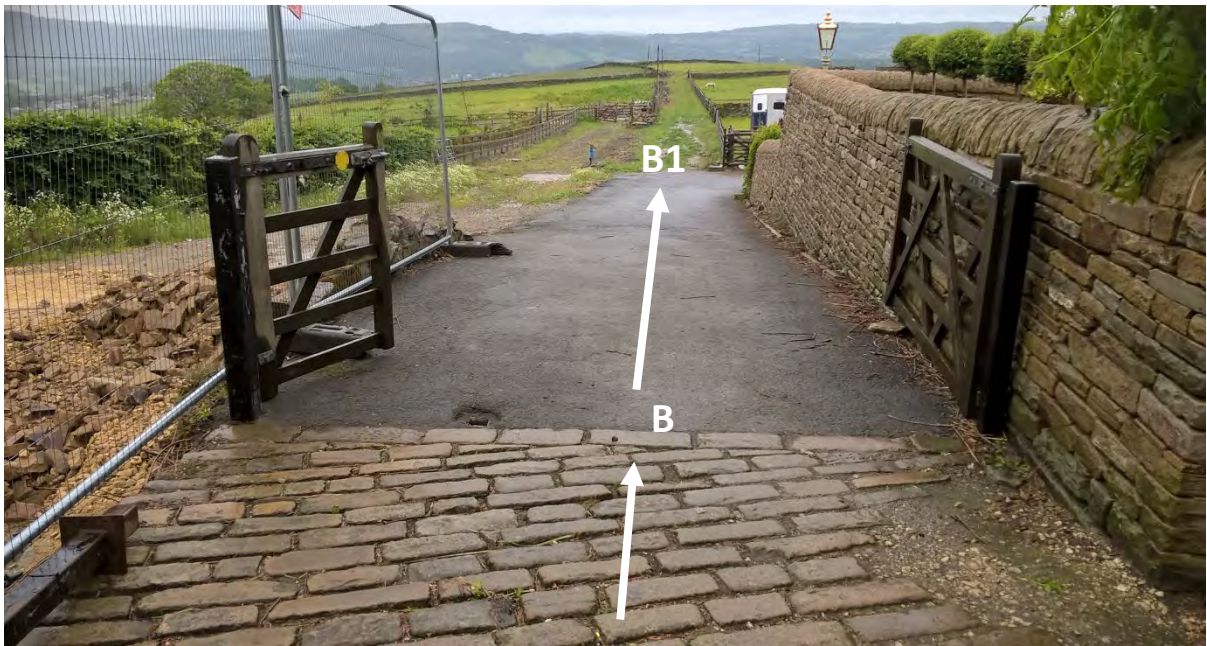
22. Wooden gates at point B. Looking east towards point B1. Both gates were open with no sign of a lock Looking east towards point B1. Dry stone walling to the north side of Holmfirth 60 had been removed. The post and rail fencing to the south side (right) seen in photos 20 and 21 above had been replaced by a dry stone wall in the same position. 11 Jun 2019.

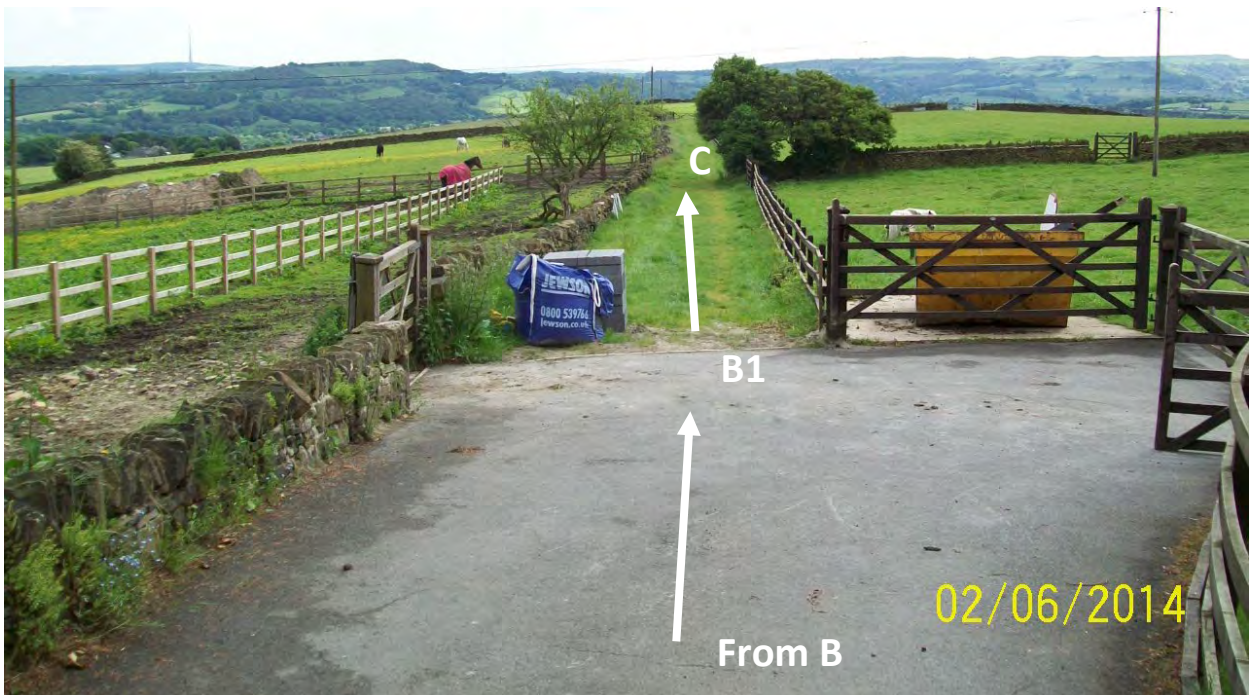
23. View west from west of point B, looking towards B1 and C. At B1 the surface changes from asphalt to grass. The photo shows building materials being stored on the north side of the route, but no deposits, obstructions or structures of any kind obstructions of any k no obstructions on the south side. 02 Jun 2014.

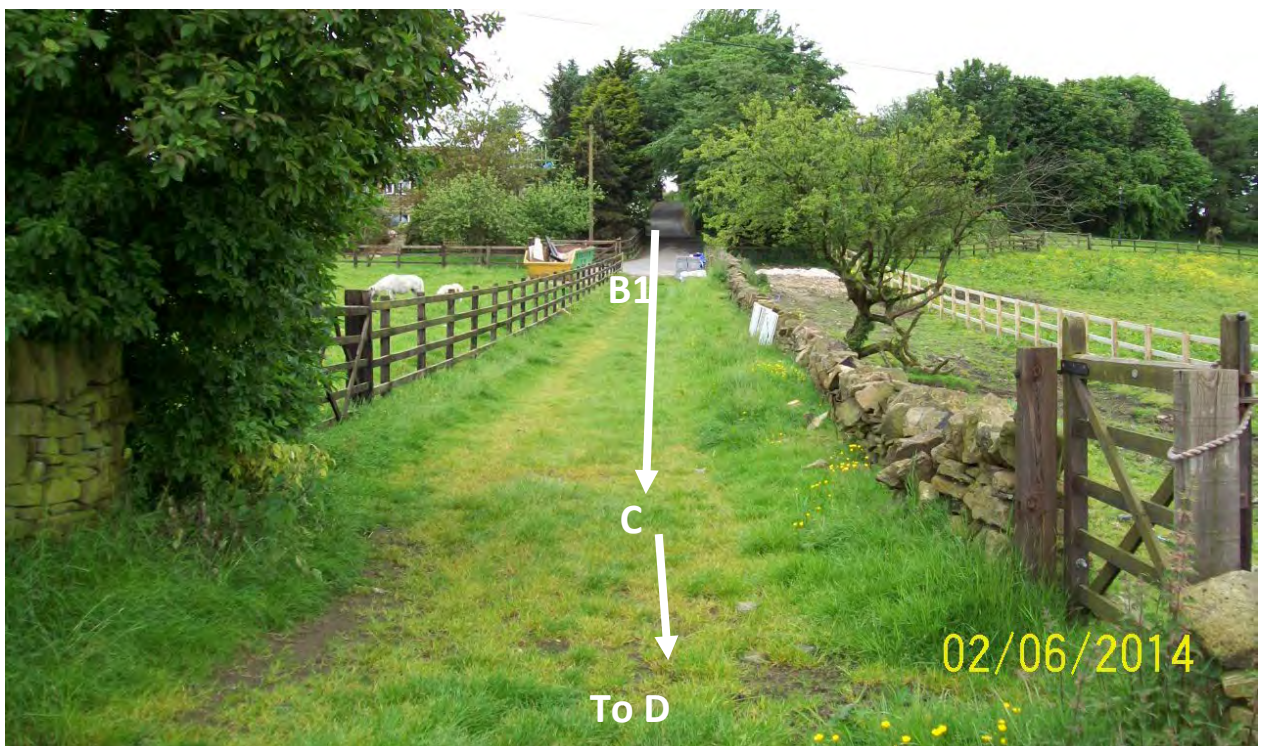
25. Point C looking west towards point B1. The north side of the track is bounded by a field boundary wall, with a post and rail fence to the south. This was the boundary between fields 1332 and 1333 (as per the 1930s OS map). The Definitive Map and Statement records a stile at this location, no longer extant. 02 Jun 2014.

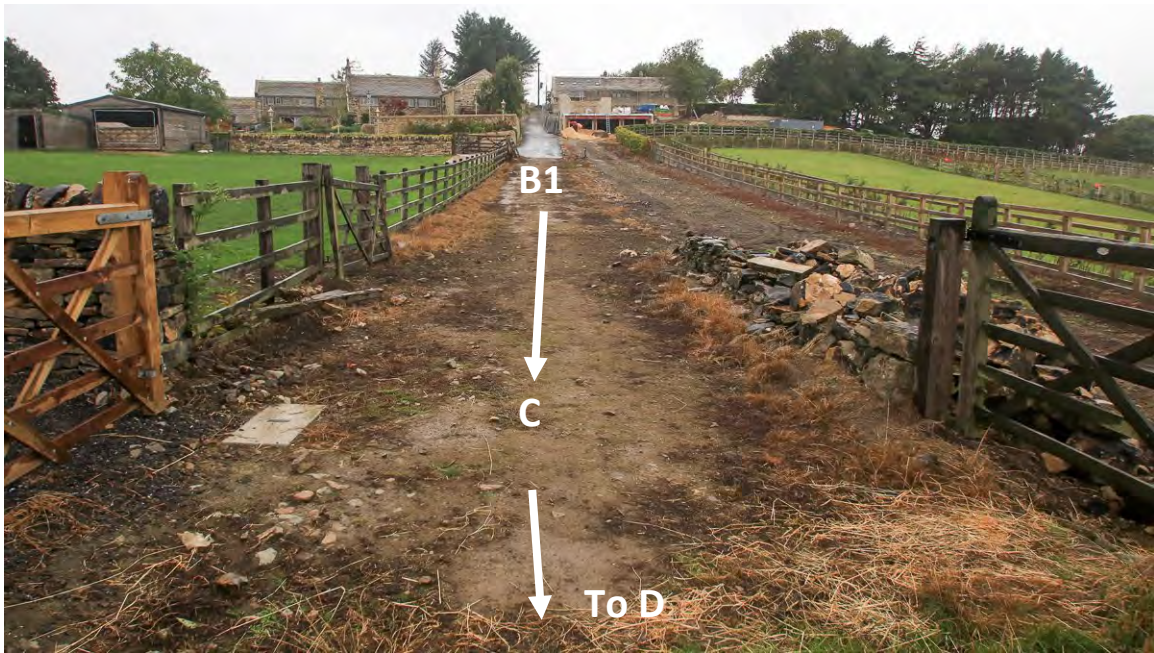
26. View west from point C. The dry-stone wall to the north side of the path had been removed. Photograph supplied by the applicant. 08 Sep 2018
