B2. Photographs of footpath Holmfirth 60 and other relevant features Holmfirth 60

NB photographs have been organised to illustrate various features along the route from west to east. Where available, photographs taken at similar locations, but on different dates, have been grouped together. Photos generally progress from west to east.

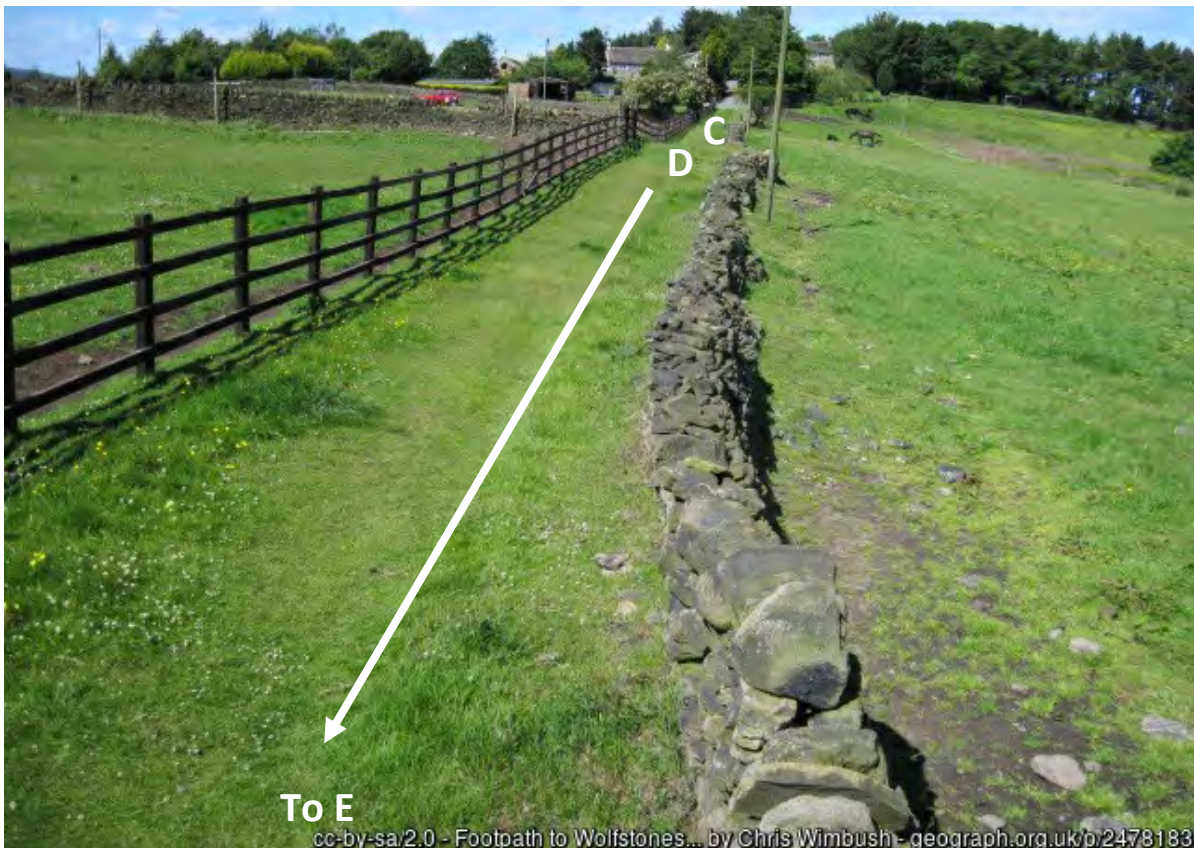
27. View west towards point D from point E at Brown Hill. The route is shown is bounded on the north side by a dry-stone wall and on the south side by post and rail fencing. Point D is at the boundary between fields 1315 and 1332 (as shown on the 1930s OS map). The first Definitive Map indicated a wicket gate at point D. This is no longer extant. Photo by a member of the public, taken 26 Jun 2011 and published at geograph.org.uk/p/2478183 . A copy was also supplied by the applicant.

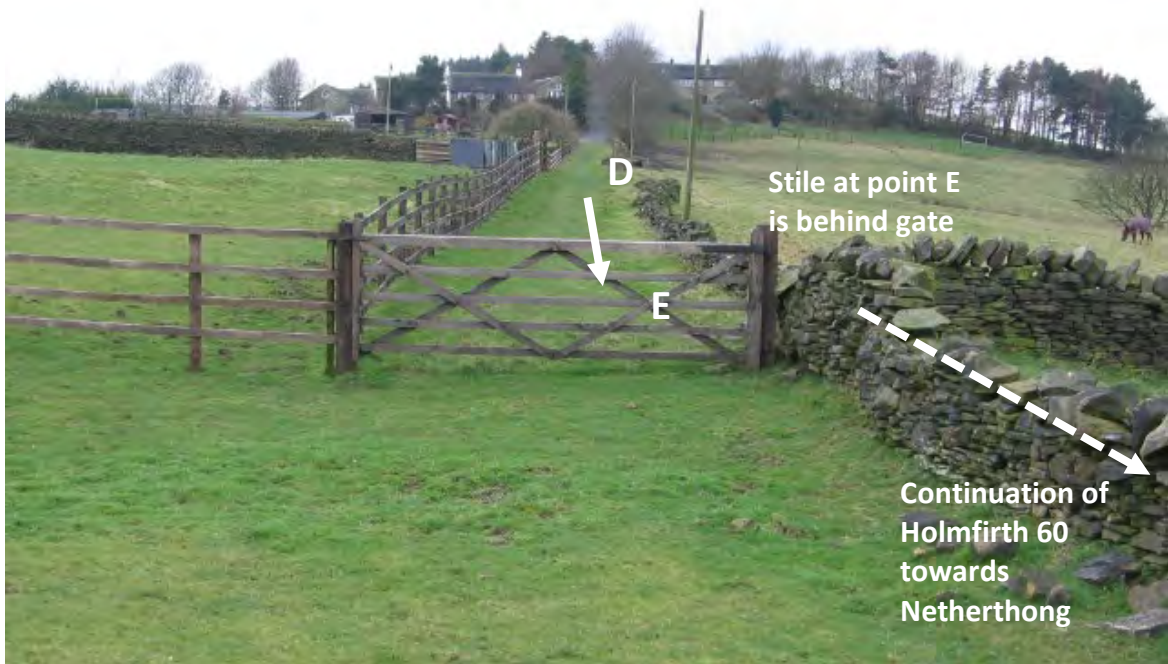
30. View west from near Point E. The position of the path as marked on the Definitive Map is quite generalised at this point to due to deficiencies in the OS base mapping used. However, evidence shows that the footpath continues via a stile and on the north side of the wall, not via the gate. Photograph taken by ESDM surveyor under contract to Kirklees Council. 13 Feb 2007.

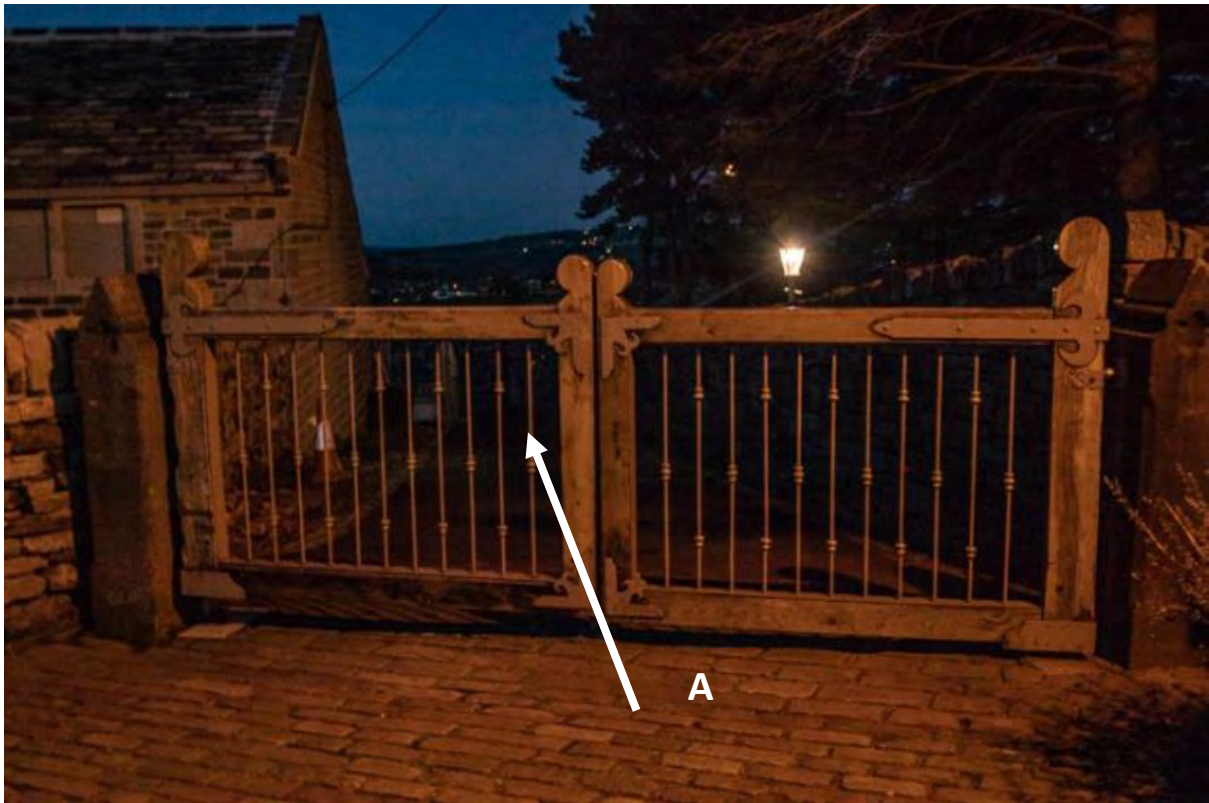
32. Electric gates at Point A. Photograph taken by a Peak and Northern Footpaths Society Inspector on finding the gates to have been closed at dusk. 24 Sep 2018.
