Dewsbury Sports Centre – Condition Assessment – December 2023

Dewsbury Sports Centre – Wet Side

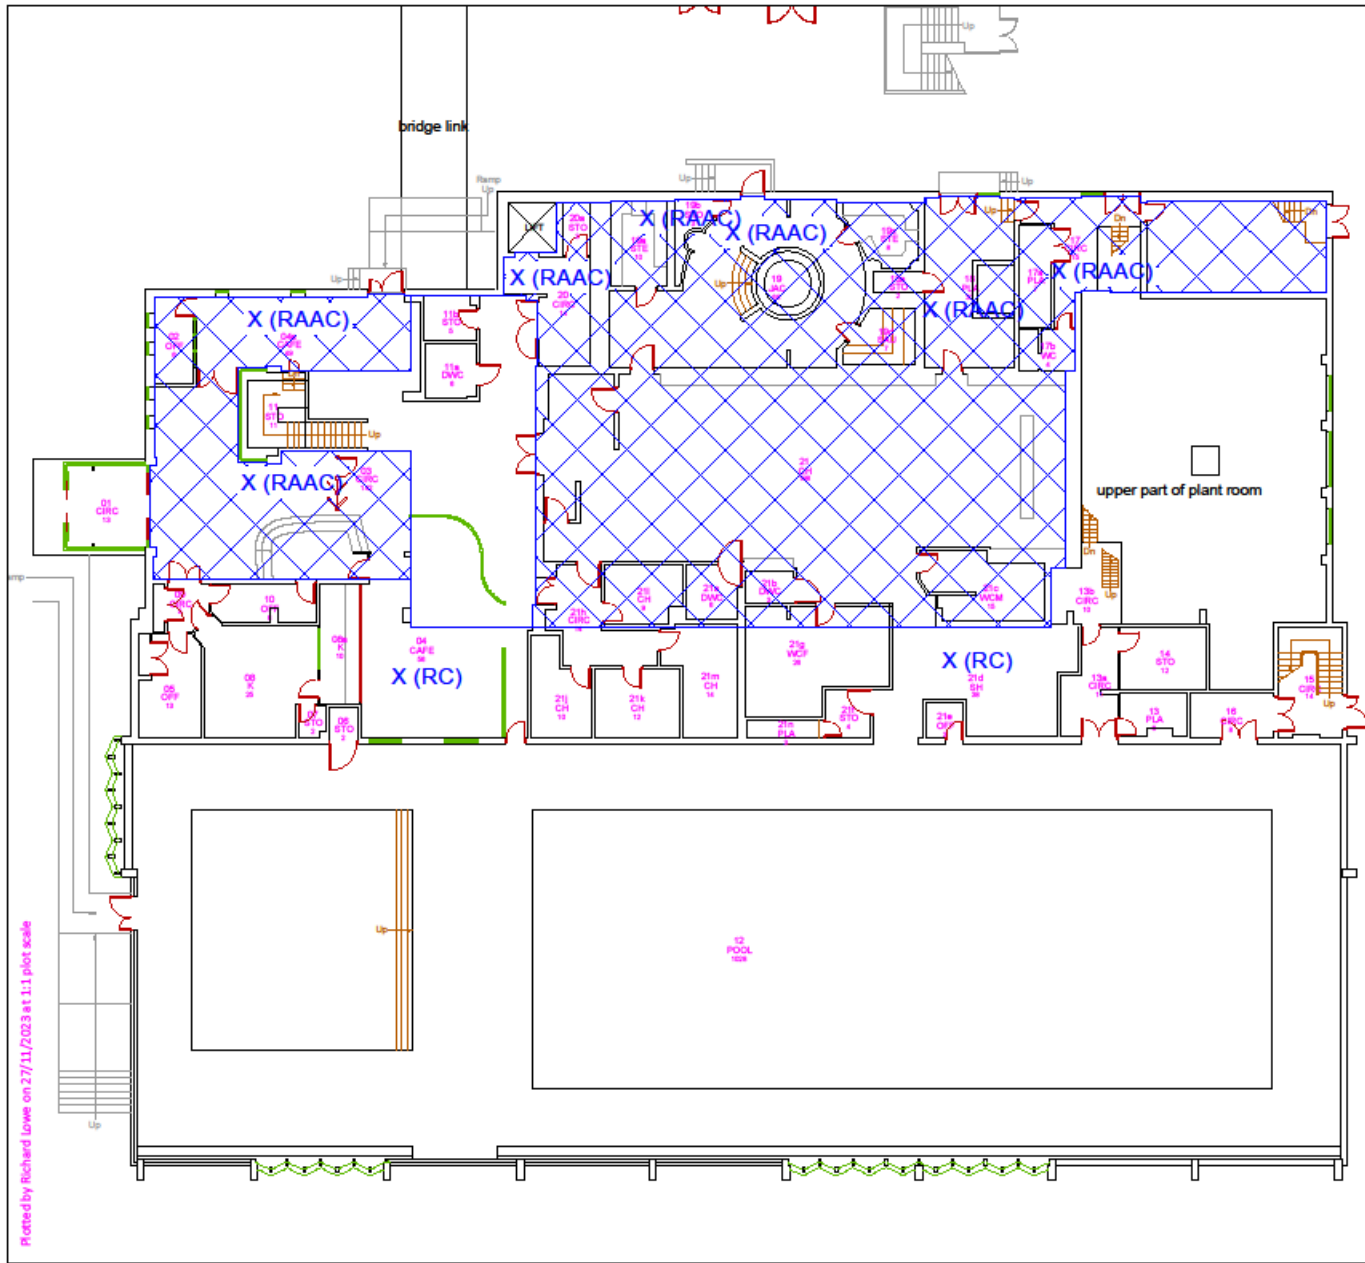
Dewsbury Leisure Centre - Ground Floor

In early September 2023, a site inspection of Dewsbury Sports Centre was undertaken by the Council’s Structures team based on a review of photographic and historic drawing evidence. This inspection identified the presence of RAAC roof planks within the entire roof area of the Wet Side building, as illustrated on the attached plans. As a consequence, Structural Surveys Limited (SSL) were commissioned to inspect the building to confirm the extent of the RAAC, which they did.

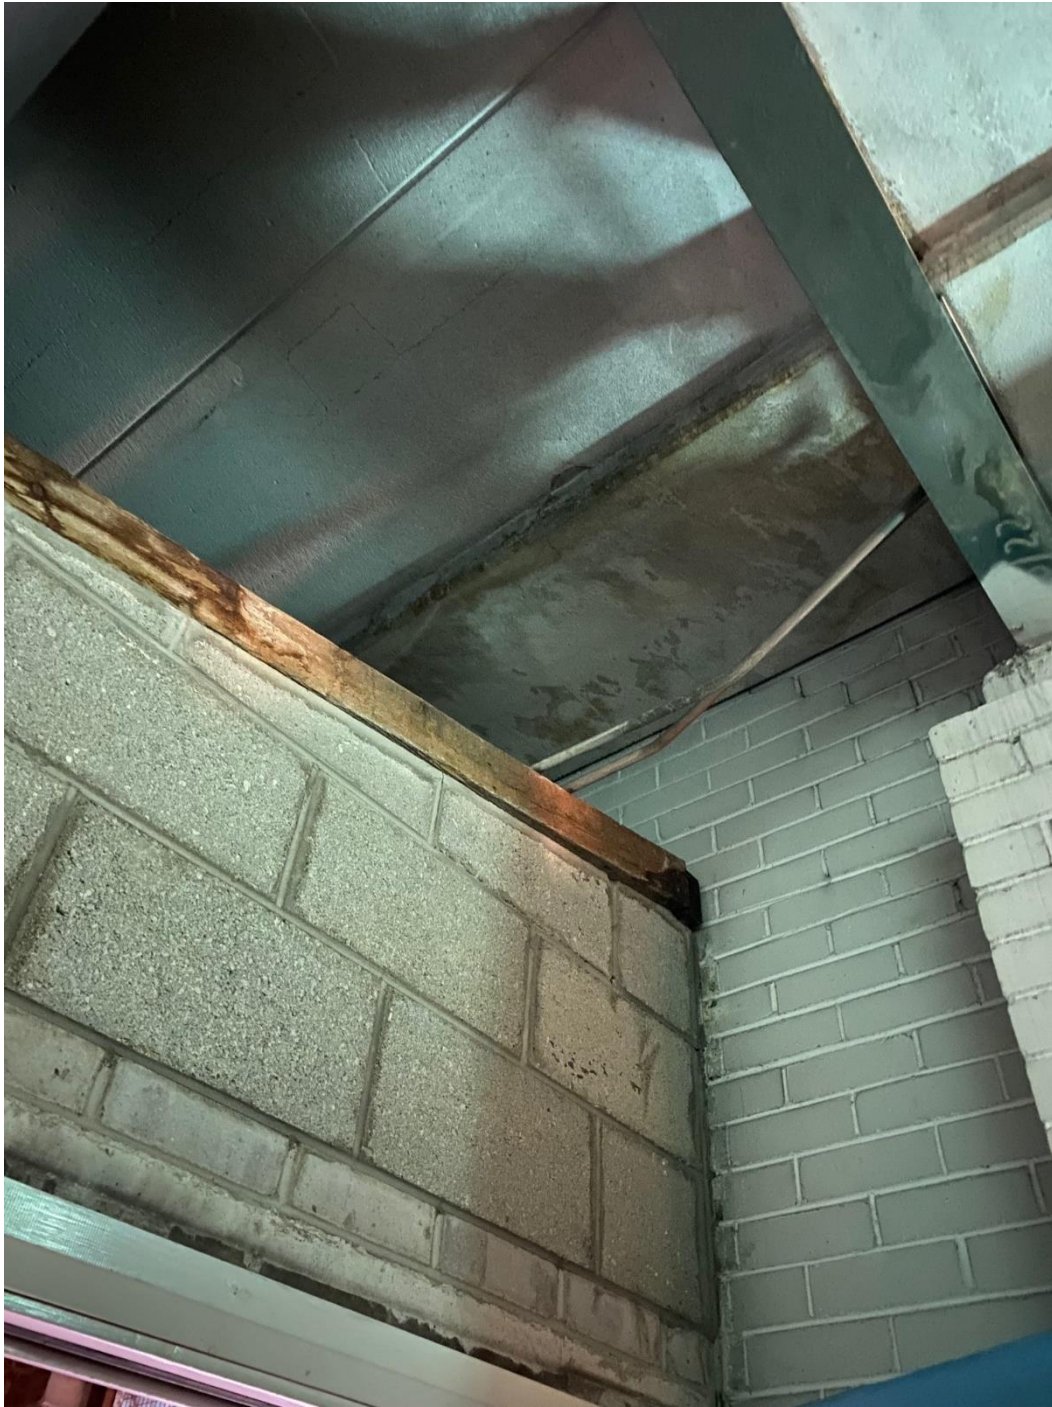
Photo 001 – Water staining and spalling concrete.

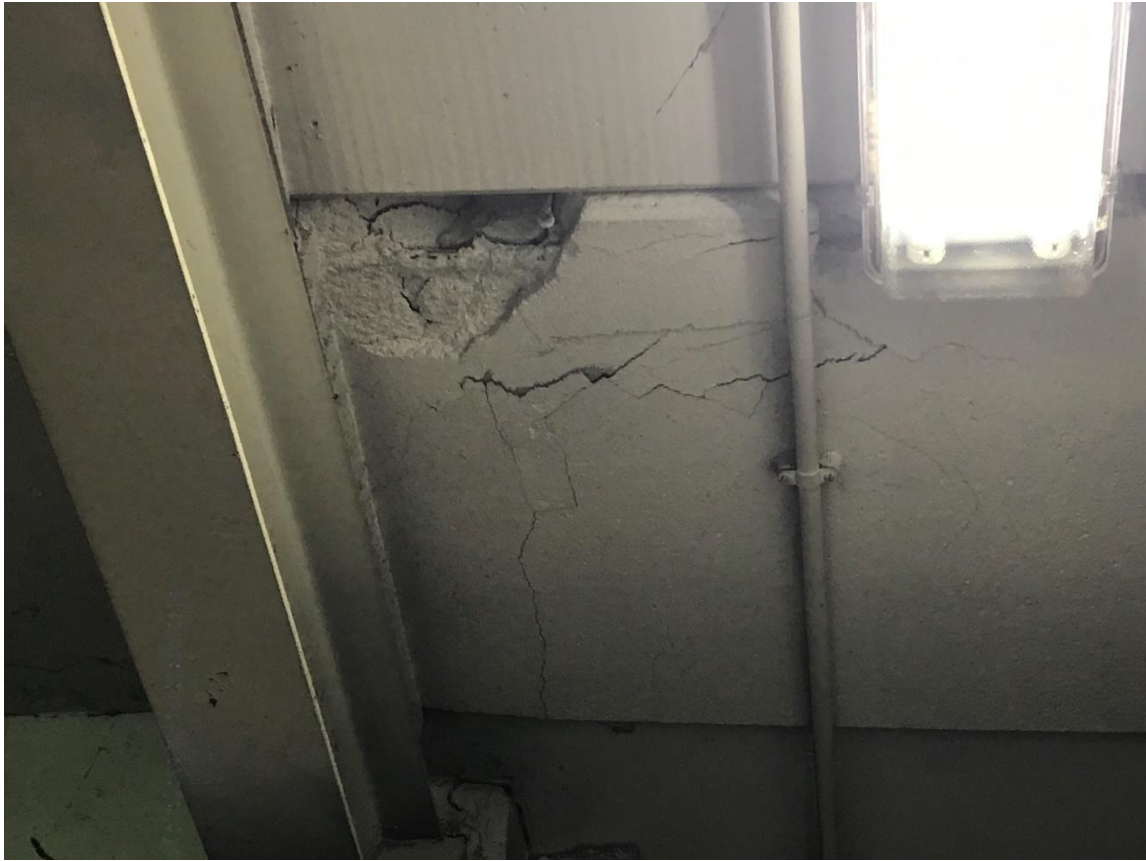
Photo 002 – Damage to RAAC panel.

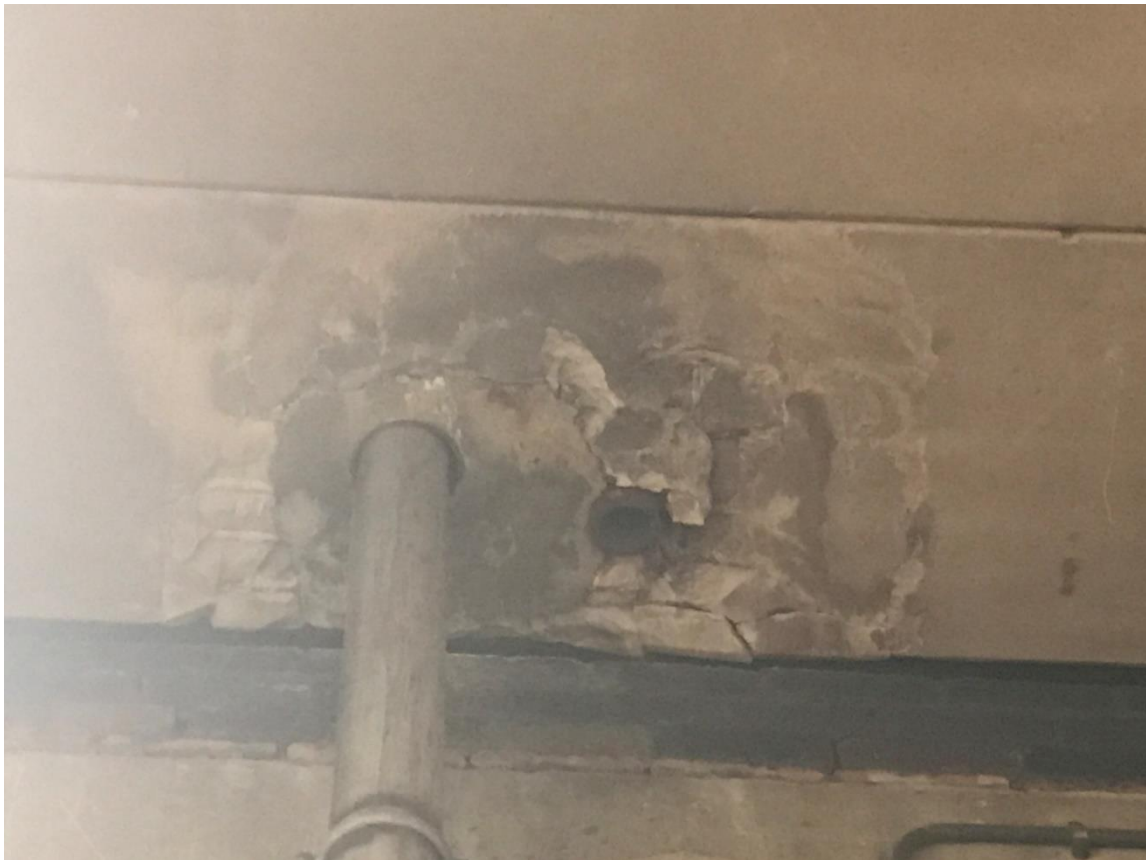
Photo 003 – Damage to RAAC panel, service installation.

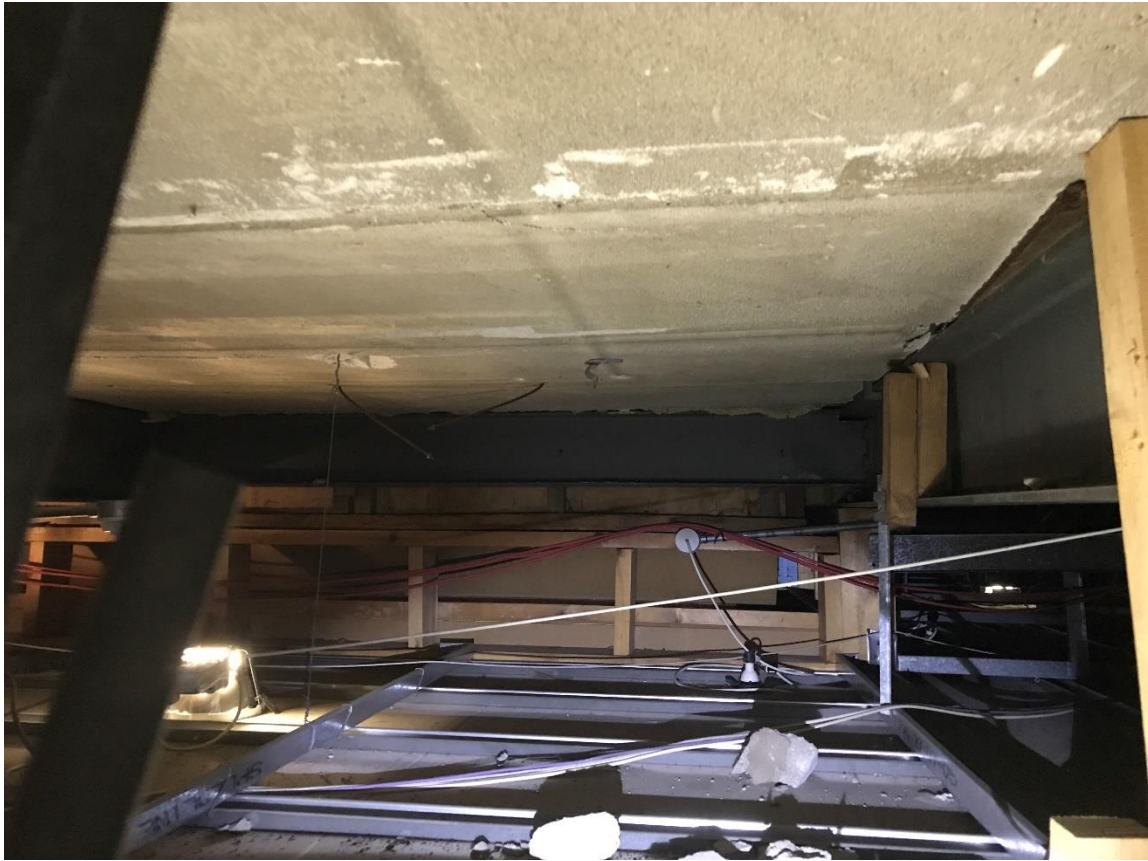
Photo 004 – RAAC resting on suspended ceiling.

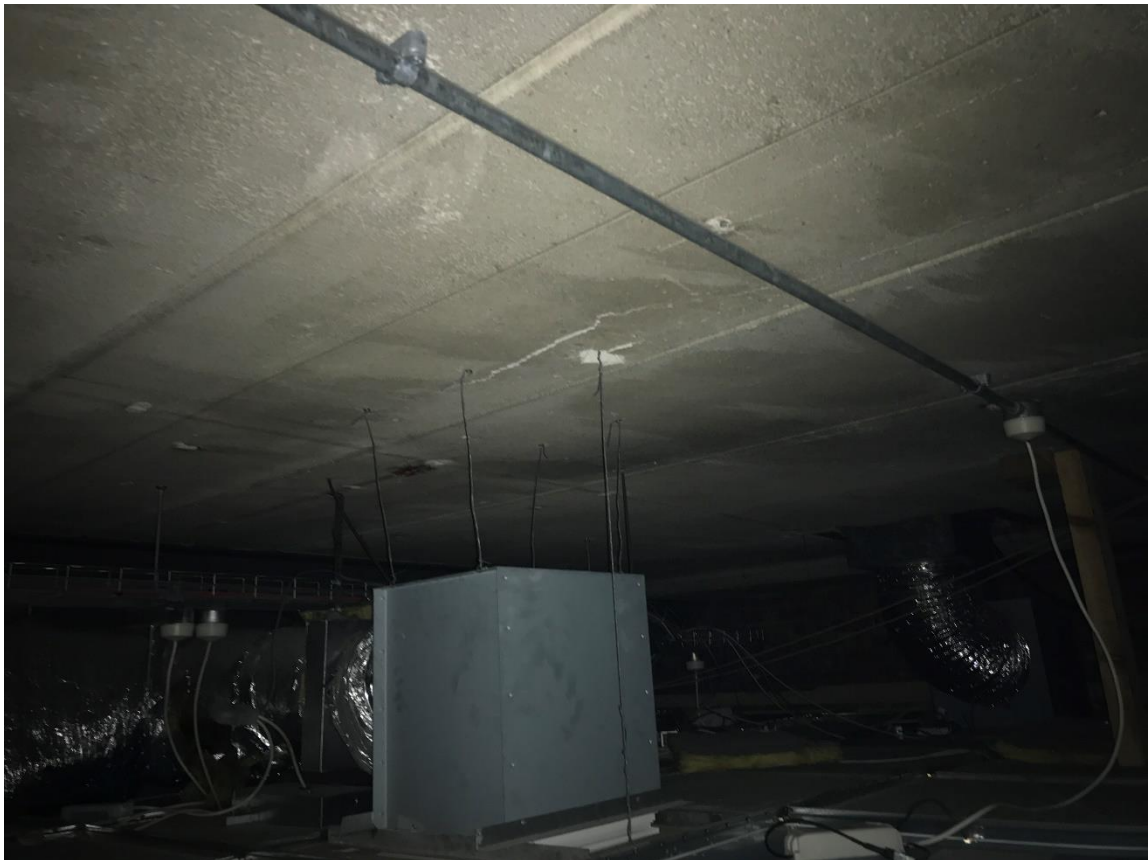
Photo 005 – Distressed RAAC panel.

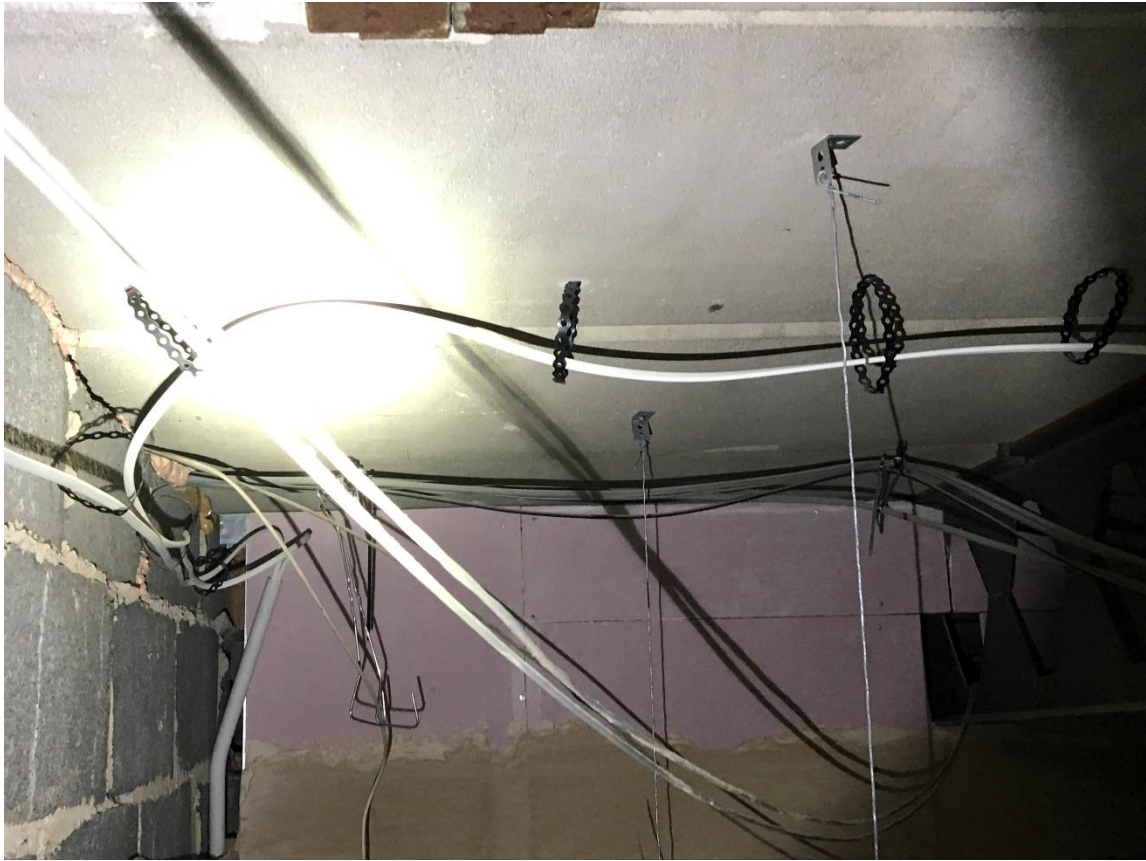
Photo 006 – Sagging RAAC panel.

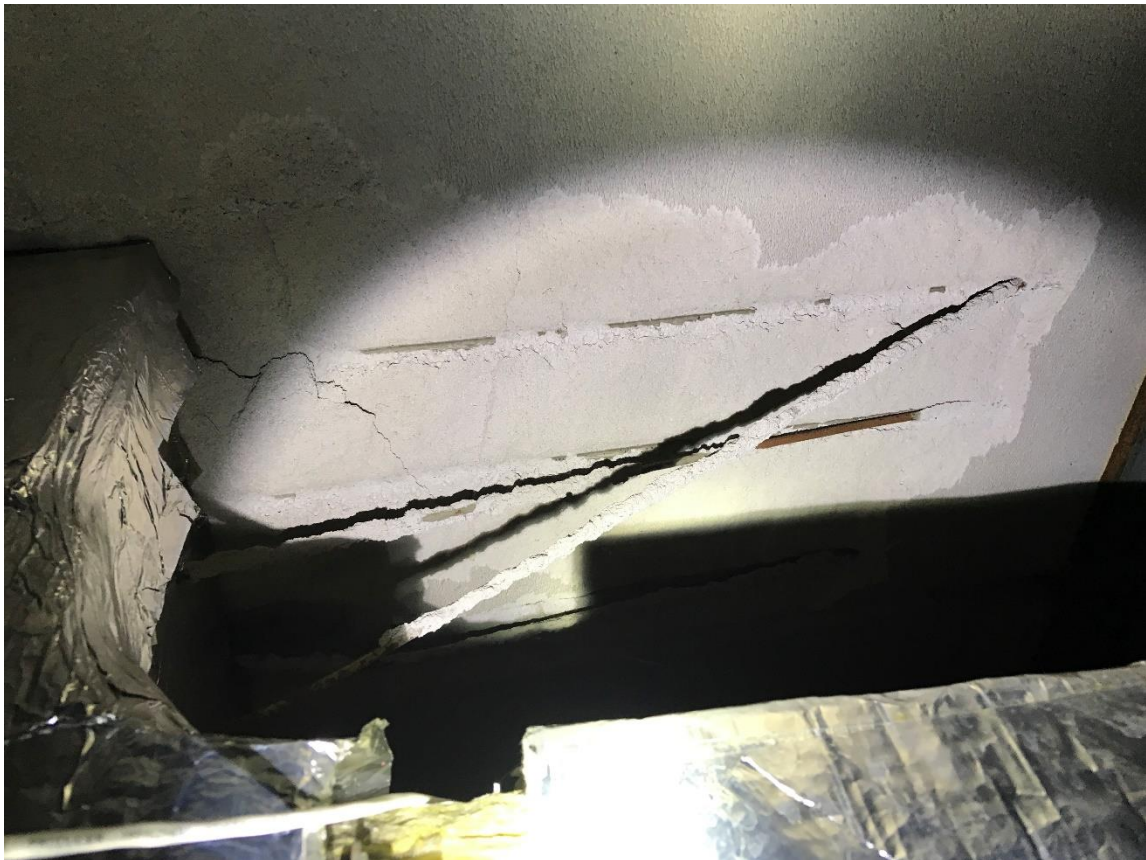
Photo 007 - Damage to RAAC panel, service installation.

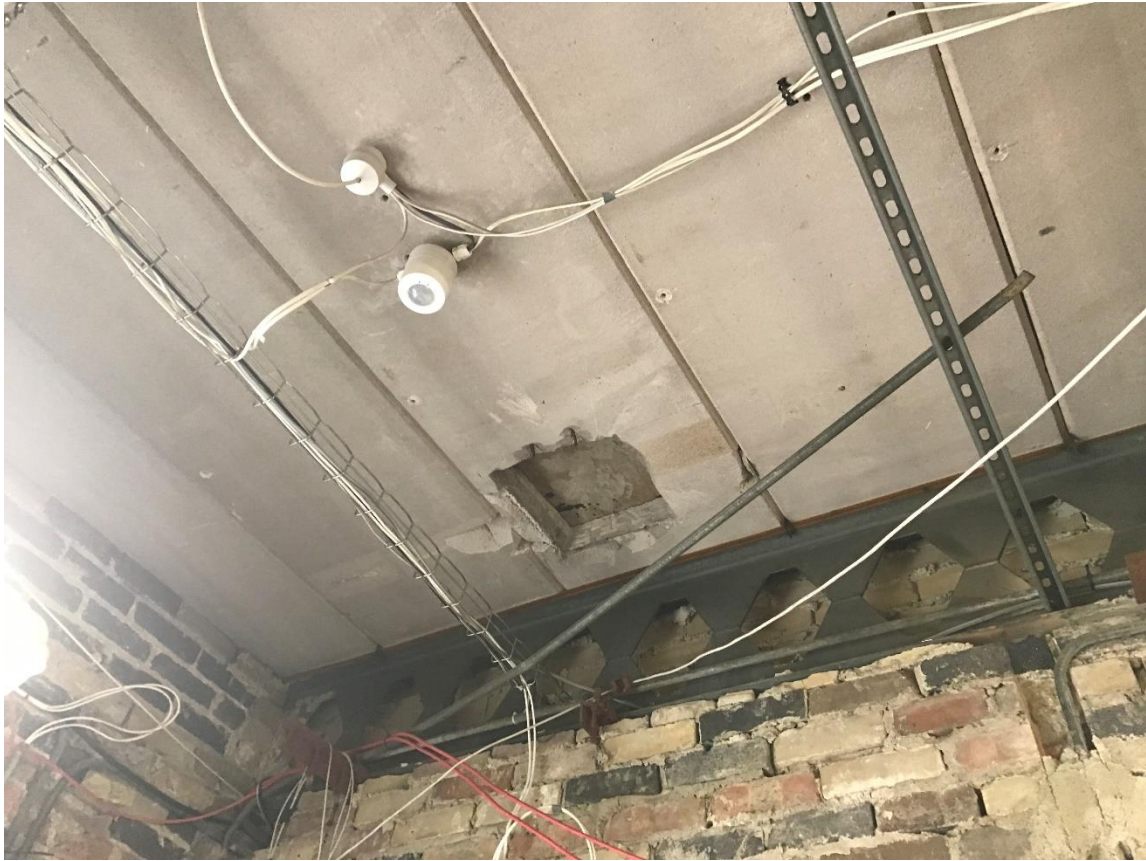
Photo 008 - Damage to RAAC panel.

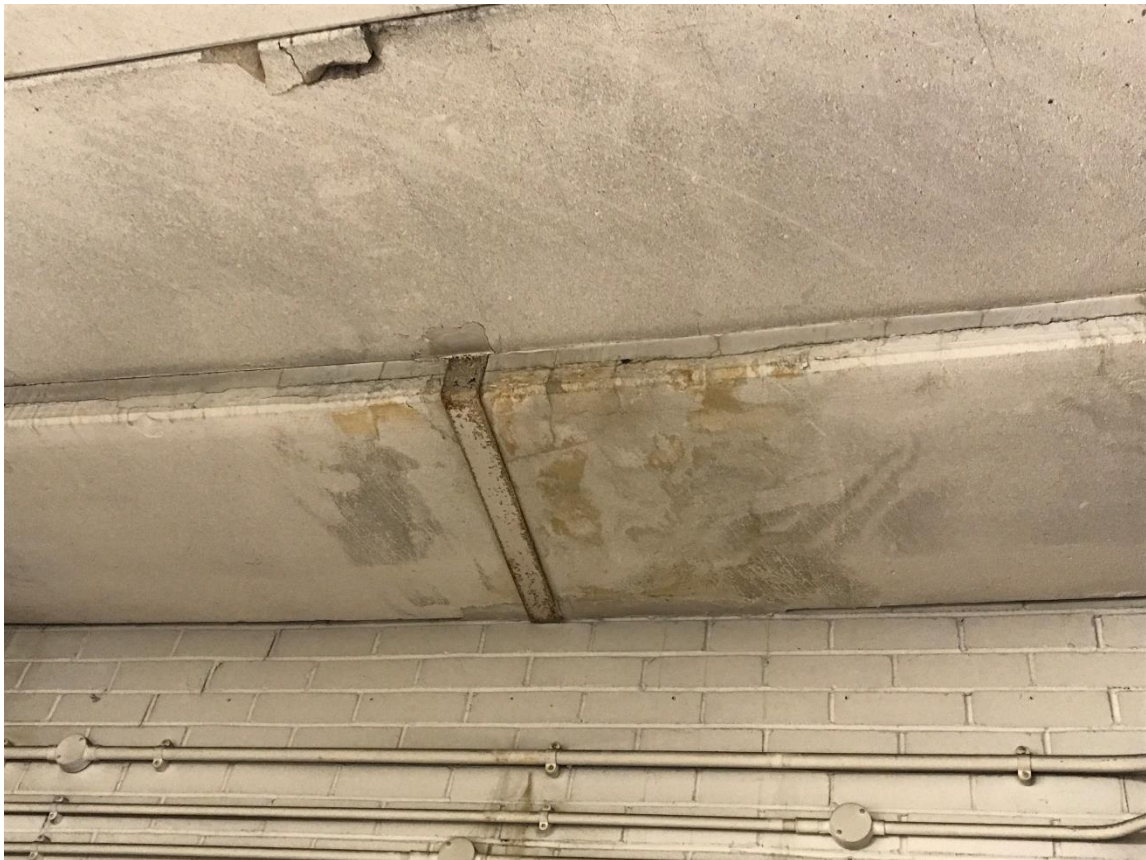
Photo 009 - Sagging RAAC panel and water ingress.

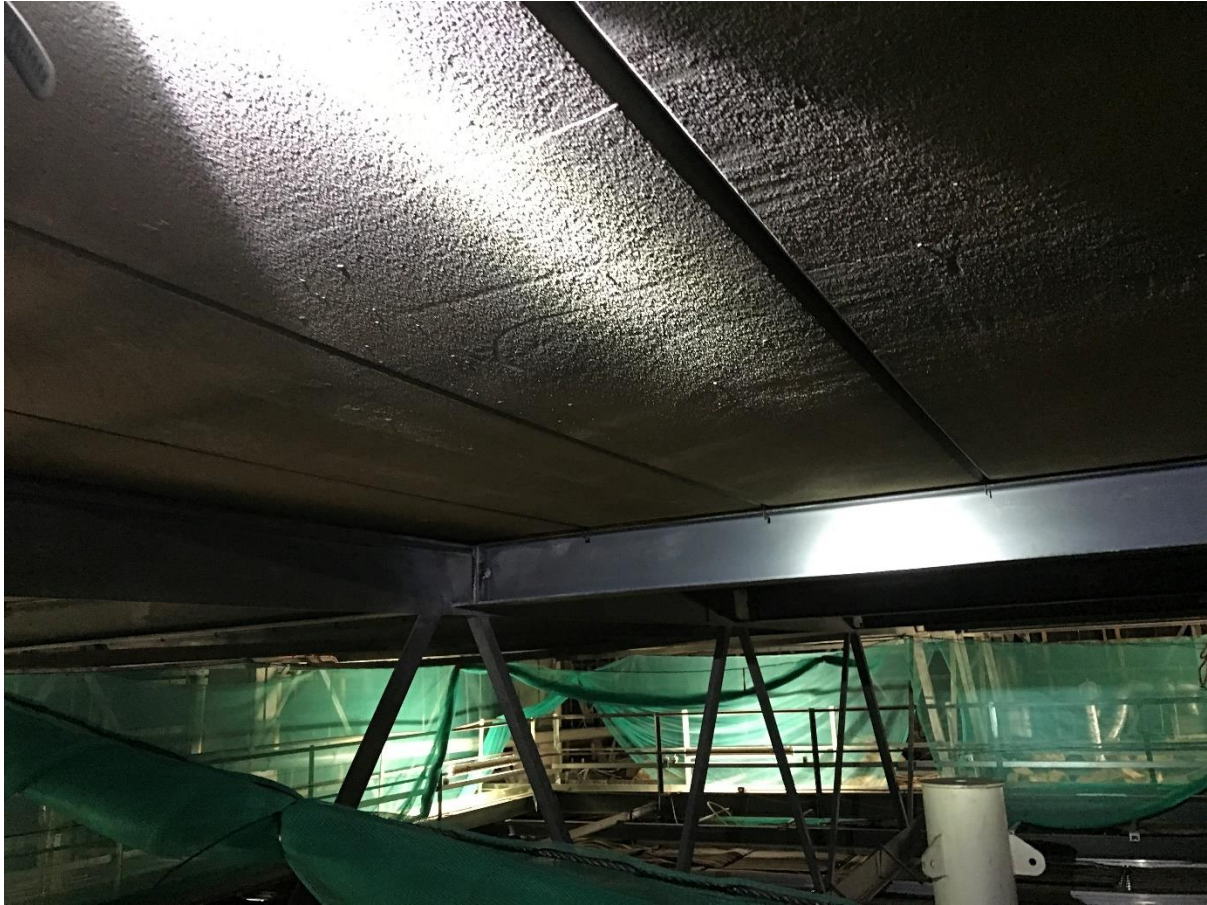
Photo 010 – Sagging RAAC panel.
