Cleckheaton Town Hall Building Assessment

Kirklees Council Technical Services

CLA420228

29/07/2024

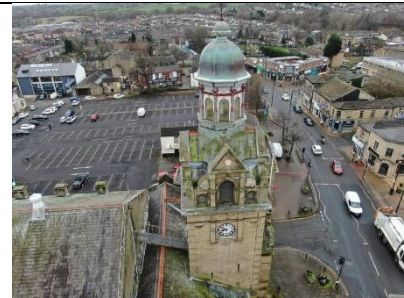
Figure 1 - Clocktower roof

The main roofs are not original and appear to have been re-roofed circa 50 years ago. A small number of slipped slates were found in our inspection. The roof under slating membrane present has an expected lifespan of 30 years. The under slating whilst protected by the slate covering from solar degradation is beginning to show failure evidenced by localised water ingress found internally to some circulation spaces in the main hall and the former caretaker’s house.

Localised repairs are required in the immediate term and take the form of refixing slipped slates, flashing renewal, re-bedding coping stones and re-bedding the ornate crested ridges. Other minor works include clearing gutters of vegetation matter.

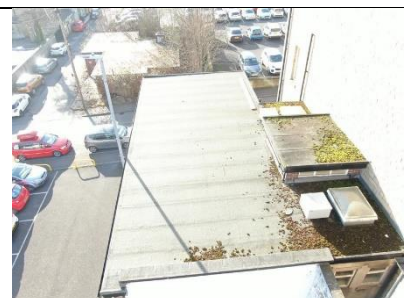
The flat roof felt is over 15 years old and in reasonable condition considering its age. Flat roof coverings of this type have an expected lifespan of 20-25 years.

Figure 5 Rear felted flat roof

<p>have allowed for replacement of the roof covering and increasing insulation to current building regulations standards in our cost plan.</p> <p>As far as general maintenance immediate flat roof works include removal of the moss which has built up.</p>	
<p>Fascias and Soffits to Rear Roof</p>	
<p>To the right and rear sides of the flat roof timber fascia and soffits are fitted. The fascia and soffits have a painted finish.</p> <p>The fascias are in a poor condition largely due to a lack of cyclical decoration. Timbers have degraded and are suffering from splitting and early signs of rot in places. Renewal of timber fascia and soffits are recommended.</p>

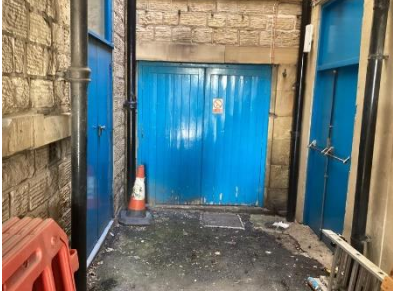
<p>Figure 7 Typical rainwater goods in alcove</p>

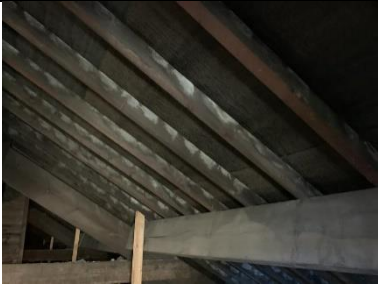
<p>Internal Fabric Items</p> <p>Roof Void (Main Hall) Roof structure comprises timber truss, purlin, and rafter construction. Most of the timbers are original. White coloured marks were noted to rafters suggesting some sort of mould but on closer inspection we are of the opinion that they are the remnants of the back pointing from the original roof covering.</p> <p>There is a partial roof access walkway formed in timber in the ceiling void of the main hall. This is a later addition. We refer you to the Autumnal Services Limited document “Review of Safe Work at Height Access Roof Space Above Main Hall Cleckheaton Town Hall” dated July 2020. The report raises concern that the high-level walkway is not safe and should not be used.</p> <p>Other high-level considerations include:</p> <ol style="list-style-type: none"> 1. Improvements to the clock tower access ladders and platform 2. The walkway bridge from the clock tower to the main hall roof is poor and should be replaced with an engineered bridge. <p>To facilitate safe access to the ceiling voids in the main hall a scaffold crash deck has been installed throughout until a safe form of roof access is installed.</p>

<p>Figure 20 Roof void area over main hall</p>

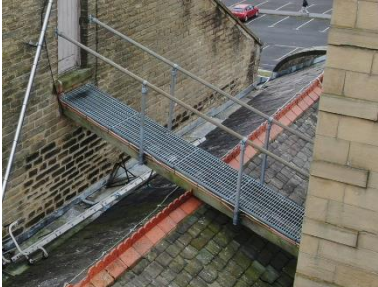
<p>Figure 21 Link from clock tower to main hall roof void</p>

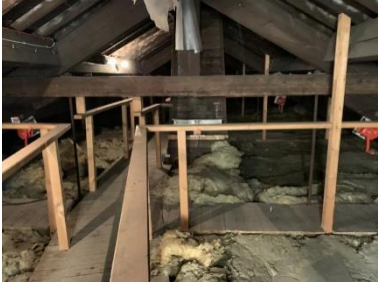
<p>Figure 22 Walkway within main hall roof void is unsafe</p>

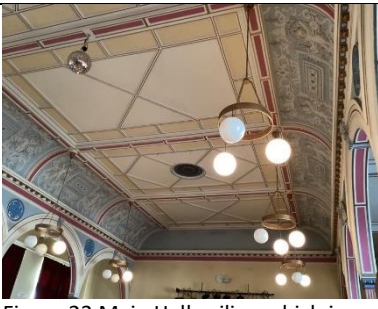
<p>Ceilings</p> <p>Main hall ceilings are formed in ornate plaster with cornice and rose details throughout. The plaster is finished with an ornate decorative paint finish. We refer you to the 2023 and 2024 Ornate Interiors plaster survey reports. In summary, the plaster is cracked and damaged to the underside and lath and plaster nibs are missing and broken in the roof void.</p> <p>The damage is so significant there is a high risk of plaster breakages and falls from the ceiling to the floor below. Specialist ornate plaster repairs are required and details of them are outlined in the report.</p> <p>Office and circulation spaces are a mix of lath and plaster, gypsum plaster board and mineral fibre tiles. There are localised issues that include water staining to plaster ceilings from roof level and internal water leaks along with mechanical damage from occupational use. Suspended</p>

<p>Figure 23 Main Hall ceiling which is unsafe</p>

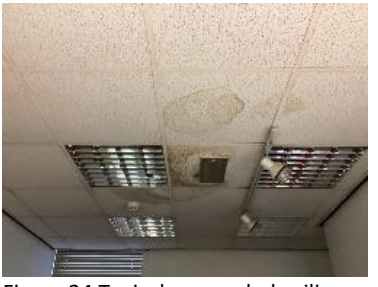
<p>Figure 24 Typical suspended ceiling defects</p>

<p>ceilings have stained, missing and broken tiles in places these should be renewed.</p>	
<p>Walls</p> <p>Main hall walls are formed in plaster with ornate detailing in places. The plaster is finished with wallpaper to some flat sections of wall. Both plaster and paper are painted. Walls are marked and damaged in various places throughout the town hall.</p> <p>Offices and circulation areas are plastered with a decorative paint finish and wallpaper. Office walls are marked and damaged in various places throughout the building. Damage is caused by occupational use.</p> <p>Wholesale decoration of the town hall appears not to have been carried out for several years. As part of the wider property refurbishment further fabric damage is expected.</p> <p>We recommend the Town Hall fabric is repaired and fully decorated as part of the final works phases of a wider refurbishment programme.</p>

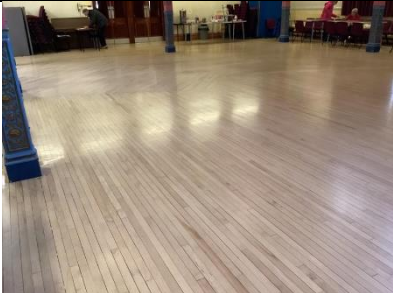
<p>Floors</p> <p>Main hall floors are timber strip flooring with a waxed finish. The floor is in fair condition, though showing signs of wear in places. Re-finishing the floors is recommended and this should see an improvement in their appearance.</p> <p>Offices and Circulation Areas Floors are a mix of timber, concrete and stone flag. Floor coverings are predominantly carpet (tiles and broadloom) and vinyl flooring to kitchen and WC facilities. Floor coverings are of various ages and conditions with some very dated.</p> <p>As part of any property refurbishment the risk of soiling and damage to floor coverings is high and consideration to replacing floor coverings throughout at the later stages of a refurbishment programme is recommended.</p>

<p>Figure 27 Main Hall timber strip flooring</p>
<p>Doors</p> <p>Main Hall Internal doors are formed in timber panelled units with a varnished finish. Some of the doors will pre-date the listing and are of historic interest. Fittings are worn in places and there is occupational damage through use. Sympathetic repairs commensurate with the listed status are required here.</p>

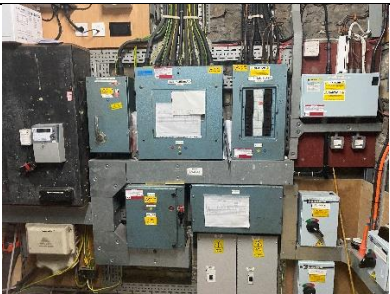
<p>Main Electrical Distribution</p> <p>Age of Installation: 50 years (approx.) Economic Design Life: 35 years</p> <p>The main electrical distribution equipment is located under the staircase on the upper ground floor level. The electrical network is fed from a 200A TP&N busbar chamber which serves numerous MCCB and MCB distribution located throughout the building with a network of both MICC (Mineral Insulated Copper Covered) and PVC/SWA/PVC sub distribution cables.</p> <p>The electrical distribution, switch gear and associated electrical protection devices are generally obsolete and no longer meets current wiring and safety standards.</p> <p>The majority of the electrical switchgear and cabling dates from the original installation and has significantly exceeded the expected economic design life is overdue replacement.</p>

<p>Figure 34 Main electrical switchgear</p>
<p>Final Circuit Wiring</p> <p>Age of Installation: 50 years (approx.) Economic Design Life: 35 years</p> <p>Final electrical circuits are fed from numerous electrical distribution boards situated throughout the building. In some locations the distribution boards have been upgraded due to reactive repairs or to support isolated areas of refurbishment. Many of the distribution boards are original (see adjacent photos) with obsolete circuit breakers/fuse gear which no longer meet current wiring and safety standards.</p>

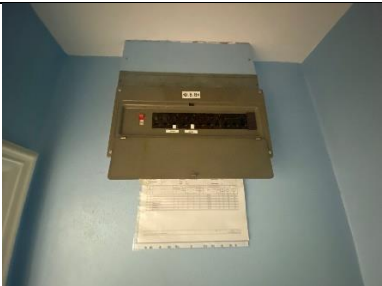
<p>Figure 35 Obsolete fuseboard</p>

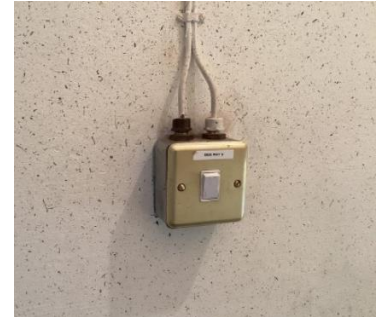
The MICC cable is generally considered robust, however there are indications that it is starting to fail. The copper outer sheath of the cable can be susceptible to ‘pitting’ or ‘pin holing’ when it is buried in or in direct contact with plasterwork without protection. Deterioration of this type has been noted on the Electrical Inspection and Condition report. Also, the compound used in the cable termination can fail due to ingress of contaminants and moisture causing short circuit. This is evidenced in a several locations throughout the building (see adjacent photo of failed socket position).

Figure 37 Light switch with MICC feed

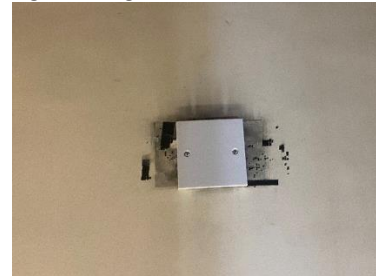
Figure 38 Failed socket outlet

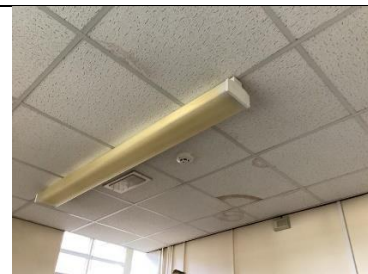
In general, the lighting in the Town Hall has exceeded its economic design life and should be considered for replacement throughout.

Except for recent reactive repairs, the light fittings generally use fluorescent lighting technology which is now obsolete. Sale of replacement fluorescent lamps was

Figure 39 Example of fluorescent lighting

<p>banned in August 2023, so as lamps fail light fittings will need to be replaced or heavily modified to accept LED alternatives.</p> <p>Replacement of the lighting installation would offer, significant energy saving opportunities through the introduction high efficiency LED lighting technology and lighting controls to optimise energy performance.</p>

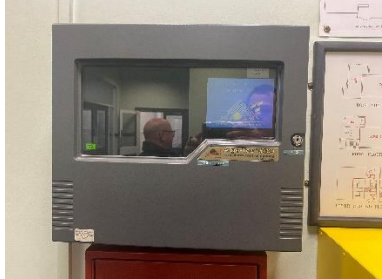
<p>Age of Installation: 23 years Economic Service Life: 15 years</p> <p>The building is protected by an analogue addressable fire alarm system. The system employs a Protec 6400 control system serving numerous detection and alarm devices throughout the building.</p> <p>The Protec system has exceeded it's expected service life, is obsolete and is no longer supported by the manufacturer.</p> <p>Failure of the alarm control system could leave the building vulnerable without option to repair, only replace.</p> <p>The fire alarm system should be prioritised for replacement.</p>

<p>Figure 43 Fire alarm control panel</p>
<p>Intruder Alarm System</p>	
<p>Age of Installation:16 years Economic Service Life: 15 years</p> <p>The building is protected by a Honeywell Galaxy intruder alarm system which is serviceable and still supported by the manufacturer.</p> <p>The alarm system is serviced and maintained by Homes and Neighbourhoods Direct Labour team and maintenance records show it has been reliable in operation.</p> <p>However, although serviceable, it is at the end of its design life and therefore the intruder alarm system should be considered for replacement as part of any wider refurbishment programme.</p>

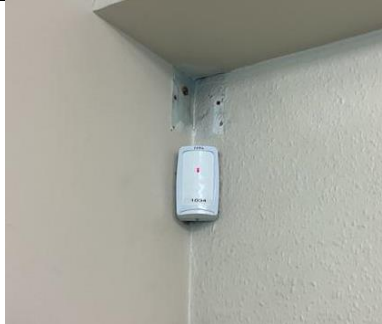
<p>Figure 44 Retrospect replacement of intruder alarm device</p>

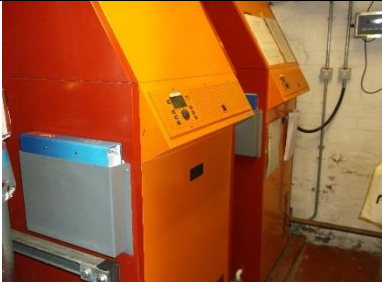
<p>General Existing Heating System</p>	
<p>The existing boiler plant consists of a dual fuel type arrangement with a biomass system and a gas fired installation feeding into a single low loss header configuration which distributes out to a number of pumped heating zones. The existing plant operates as a pressurised heating system to serve a mixture of emitters throughout the building and is operated by a Trend Building Management System.</p>	
<p>Biomass Boiler Plant</p>	
<p>The biomass boiler plant was installed in 2009, consisting of two Hoval Biolyt 70 boilers with a combined rated output of approximately 138kW. However, due to operational and cost issues they were decommissioned several years later. The biomass plant has not been in use since the end of 2015, with no requirements or plans to resume the use of the plant.</p>

<p>Figure 50 Two biomass boilers</p>
<p>Based on this, the recommendation would be to completely remove the biomass plant, including the boilers, flues, pipework, and auger feed systems. This would ultimately assist in freeing some additional space within an already reasonably tight plant room.</p>

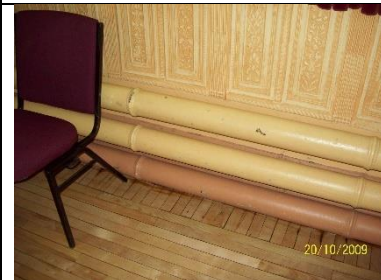
Figure 55 Heating pipework

The distribution system could be completely drained, flushed through, refilled, vented, and treated to ensure that the system is as clean as possible. However, there is a high risk with older radiators and pipework that such a process can give rise to leaks or further blockages and air locks causing operational issues and possible full system replacement.

<p>Given the above, the recommendation here would be to replace the heating distribution pipework and radiators right back to the boiler room with new alternatives to match or improve those that exist. This would establish increased efficiency for the premise, having the benefit of a completely new heating installation offering many years of reliable service.</p>	
<p>Heating Distribution Pipework and Radiators to Other Areas</p>	
<p>With the exception of the Main Hall area, the Distribution pipework and heat emitters throughout the rest of the building appear to be a mixture of cast iron and steel, of various ages from around 35-60 years. A small number of radiators are slightly newer and are likely to be replacements of previously failed emitters and layout modifications. There are a few column style radiators in open public areas, but the majority of emitters that serve the offices, toilets and general circulation spaces are of the pressed steel panel type.</p> <p>Although a reasonable number of the radiators and associated pipework appears to be in a fair condition, some are showing signs of age. A number of Thermostatic Radiator Valves (TRV's) appear broken or have heads missing. There have also been historical reports of some underheating in certain areas which could be due to a natural accumulation of scale, dirt and debris build up reducing heating outputs and causing blockages within the pipework.</p> <p>The distribution system could be completely drained, flushed through, refilled, vented, and treated to ensure that the system is as clean as possible. However, there is a high risk with older radiators and pipework that such a process can give rise to leaks or further blockages and air locks causing operational issues and possible full system replacement.</p> <p>Given the above, the recommendation here would be to replace the heating distribution pipework and radiators right back to the boiler room with new alternatives to match or improve those that exist. This would establish increased efficiency for the premise, having the benefit of a completely new heating installation offering many years of reliable service.</p>

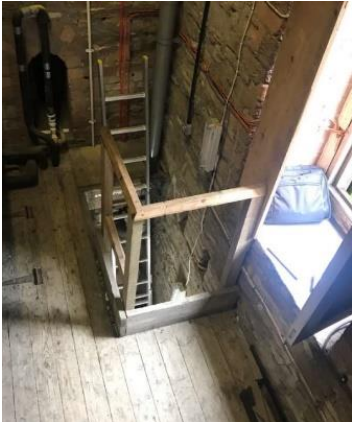
Means of Safe Access	
<p>Kirklees Council commissioned a report in July 2020 by external consultants Mason Clark to look at the safety of access into the clock tower, and external access across an external walkway into the roof void above the main concert hall and main stage.</p> <p>The report summaries access as ‘non-compliant’ with very significantly poor condition of access walkway externally. The report concluded that this should not be used.</p> <p>Access to the clock tower is non-compliant and has significant health and safety concerns. Access is provided via a secured temporary ladder, inadequate safety railings, possible fall from height</p>

and highlights a concern with the strength of the historic existing wooden structures.

Figure 66 Unsafe access to clock tower

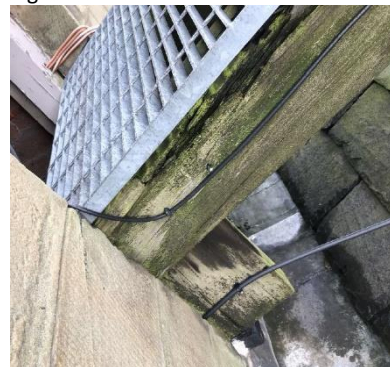
Figure 67 Rotten external roof access.

<ul style="list-style-type: none"> • provide a full access walkway across the entire roof void through to the stage area, ensuring complaint handrailing and suitable lighting for activities undertaken. 	
<p>Concert Hall Floor</p>	
<p>The existing concert hall is used for various events, meetings and concerts which are vastly varied and some of the newer events could be considered above the original use of the premises facilities. The structure of the floor is not known and cannot be easily accessed without intrusive investigations which would impact on the significance of the premises listing.</p> <p>An alternative proposal used at Dewsbury Town Hall would be mirrored at Cleckheaton Town Hall using a low frequency vibration to determine the existing structural capacity for static and dynamic loading.</p> <p>No signs of structural stress have been identified or seen within recent inspections but to ensure that the facilities can continue to offer the wide range of events a detailed analysis is recommended to determine the existing structure capacity under static and dynamic loadings.</p> <p>Image is from Dewsbury Town Hall testing.</p>

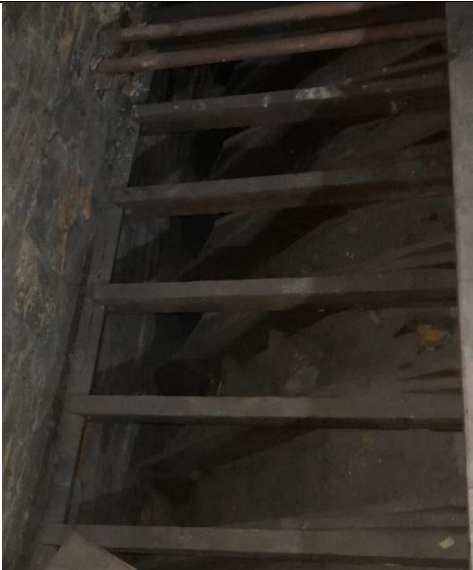
<p>Main Stage</p>	
<p>Recently the stage has been investigated following a minor collapse of the existing latte and plaster, this resulted in closure of the main stage for safety reasons.</p> <p>Subsequently further investigations have been undertaken to confirm the existing condition of the main roof structure following the recent collapse and concerns highlighted.</p> <p>Upon further investigation it has been found that the existing structure has deteriorated and can no longer be considered as adequate in areas. This is due to general deterioration over the life of the materials used, age of the premises and modifications undertaken which are not adequately</p>

<p>Figure 69 Stage ceiling support structure</p>

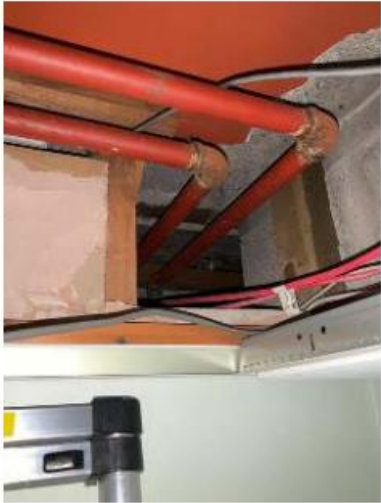
Firestopping	
<p>It was identified in all areas that there were multiple penetrations through the compartment walls with no firestopping works previously installed, requiring a mix of batt and mastic work.</p> <p>The ground floor above the suspended ceiling hosted a variety of seals which had been installed to allow cables from the corridor to the office areas. The cables above the grid will require attention due to the nature of the installation and how it has been left - it is deemed a fire hazard. Removing the grid, multiple cables just hung from the suspended ceiling. This is an obvious cause for concern, especially given a previous fire in this area in 2019.</p> <p>The ground floor corridor has three door heads in the area, all door heads are to be remediated with fire line board and then fire stopped accordingly, afterwards.</p> <p>Sections of the door heads are missing and is to a sub-standard quality. All works through the MF ceiling is to be batt and mastic due to what appears to be a single skin board wall make up.</p>

<p>Figure 72 Fire compartment none installed.</p>

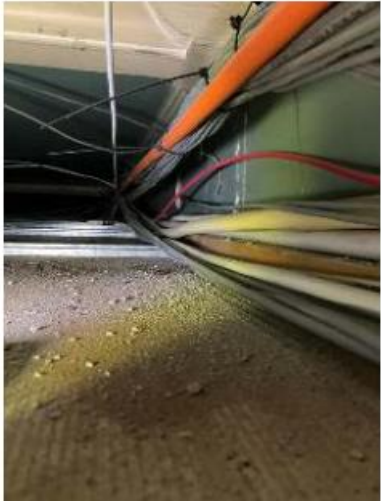
<p>Figure 73 Fire compartment none installed.</p>
