## **Appendix B – Photos of Order Route**

**Wildlife & Countryside Act 1981 – Section 53  
West Yorkshire County Council Definitive Map and  
Statement for the Kirklees Area**

**Kirklees Council (Kirkburton 256 – Moor Lane) Definitive Map  
Modification Order 2024**

## Photos (1-25) dated 22.07.23

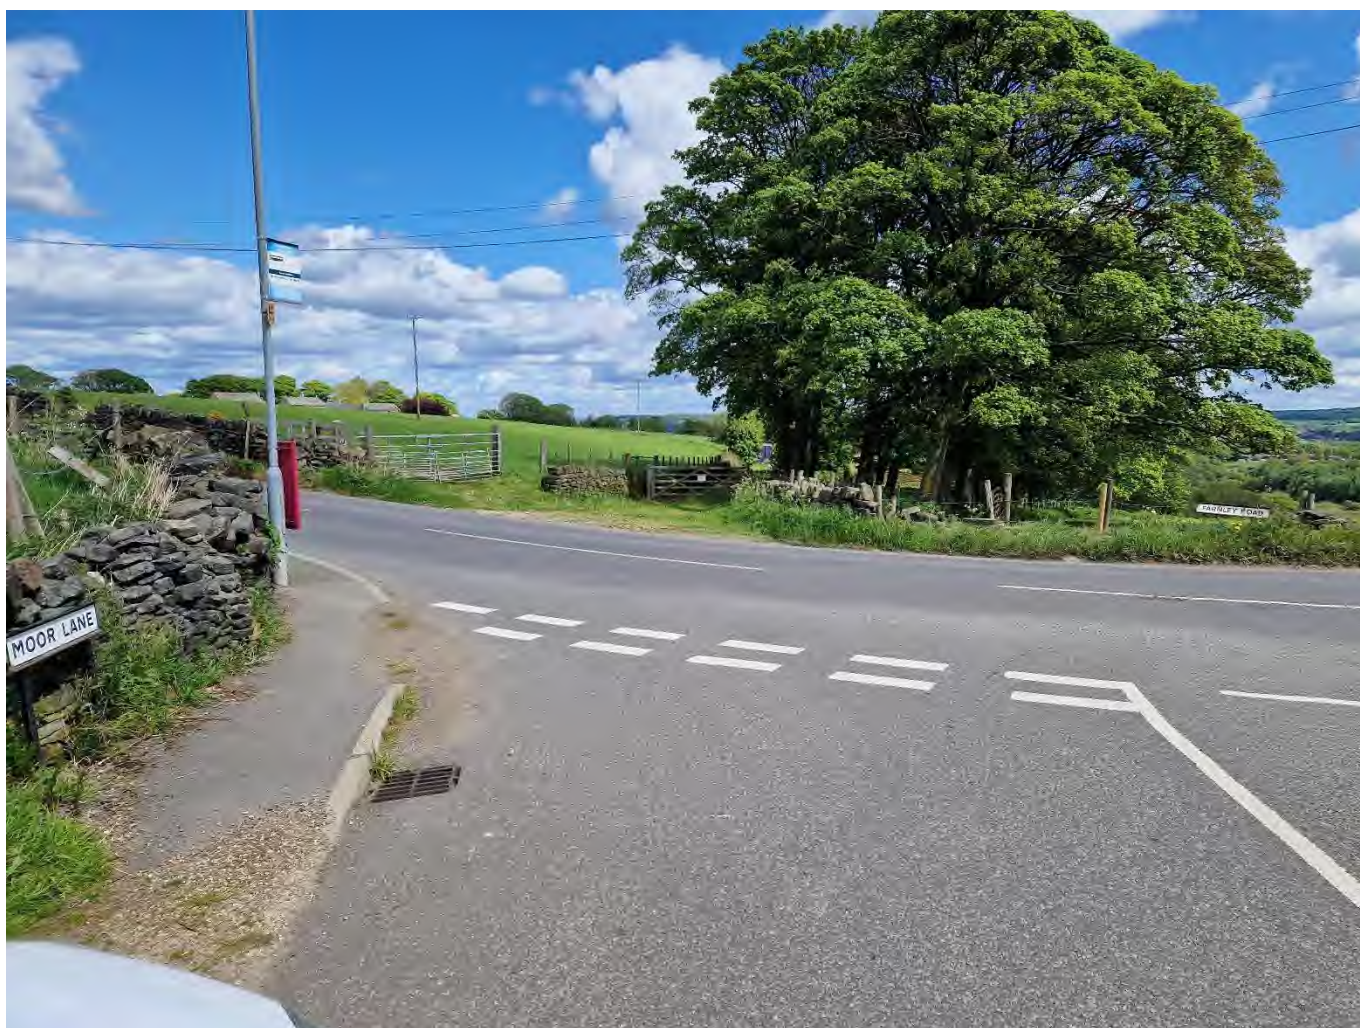
*Photo 1: Point B on the Order Map. Start of Order route at its junction with Farnley Bank Road and Moor Lane*

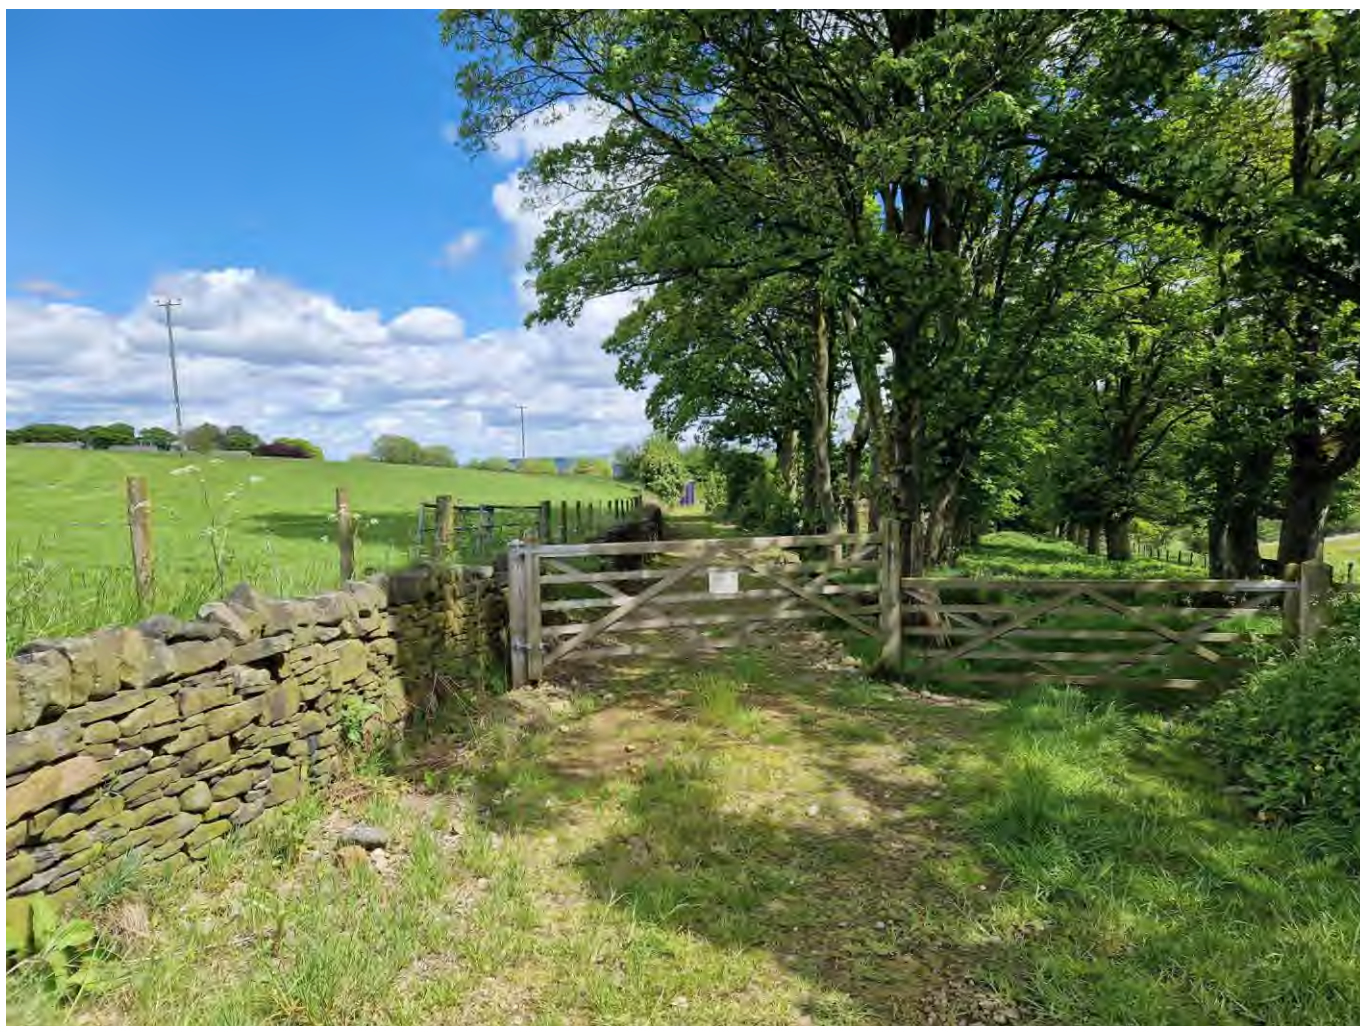
*Photo 2: Point B on the Order Map. Start of the Order route leading through recently erected field gate (Grid Reference: SE 1667 1245).*

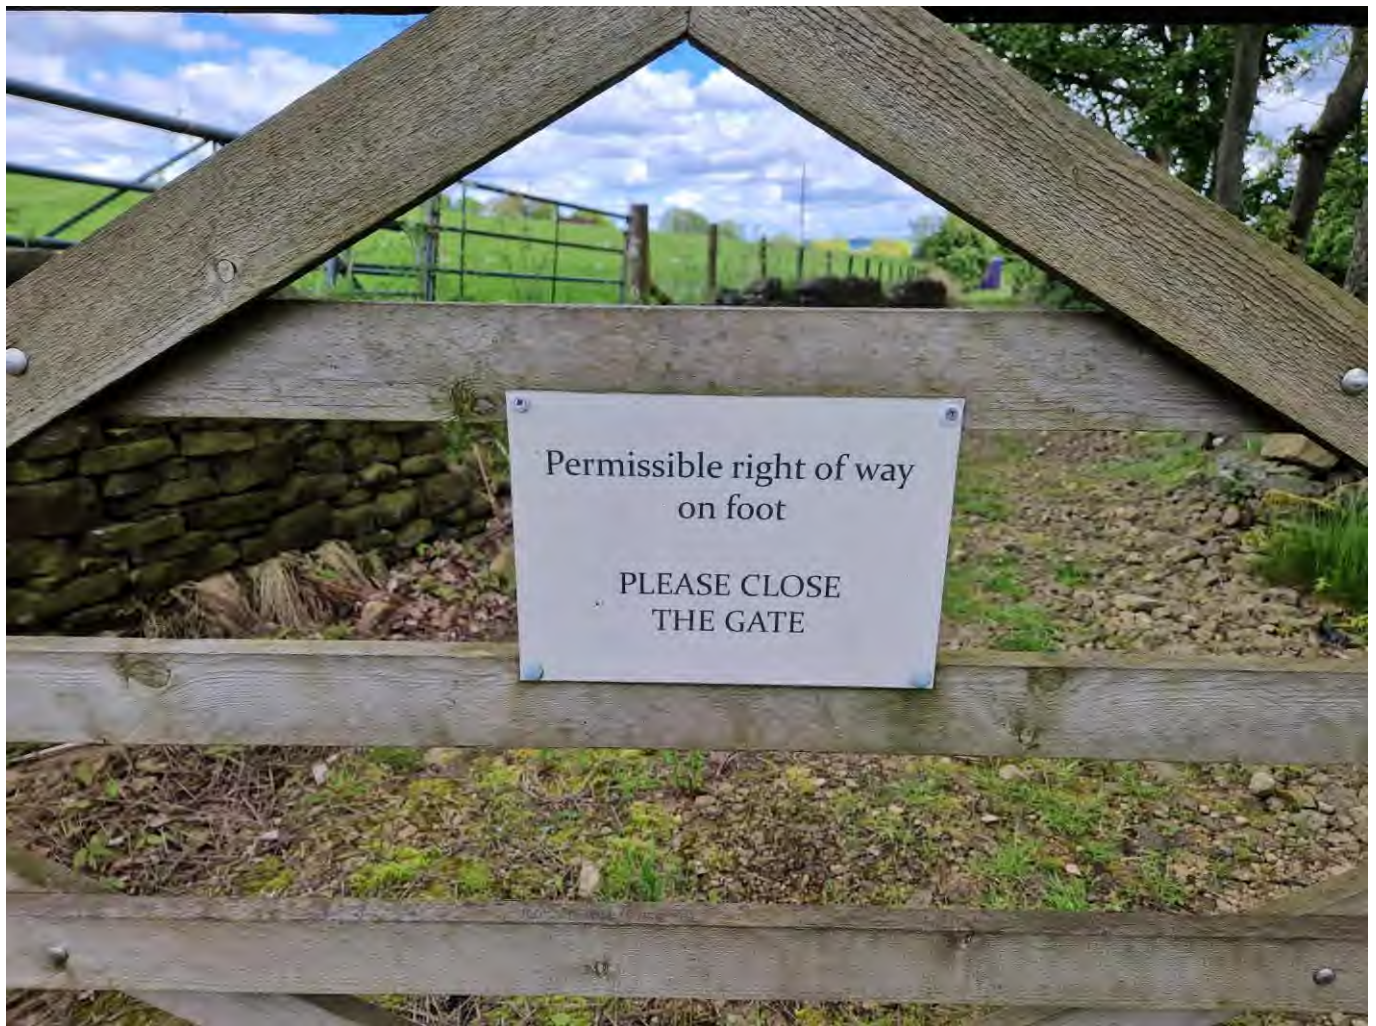
*Photo 3: Sign on the field gate states, 'Permissible right of way on foot PLEASE CLOSE THE GATE'. Sign recently erected in approximately 2020.*

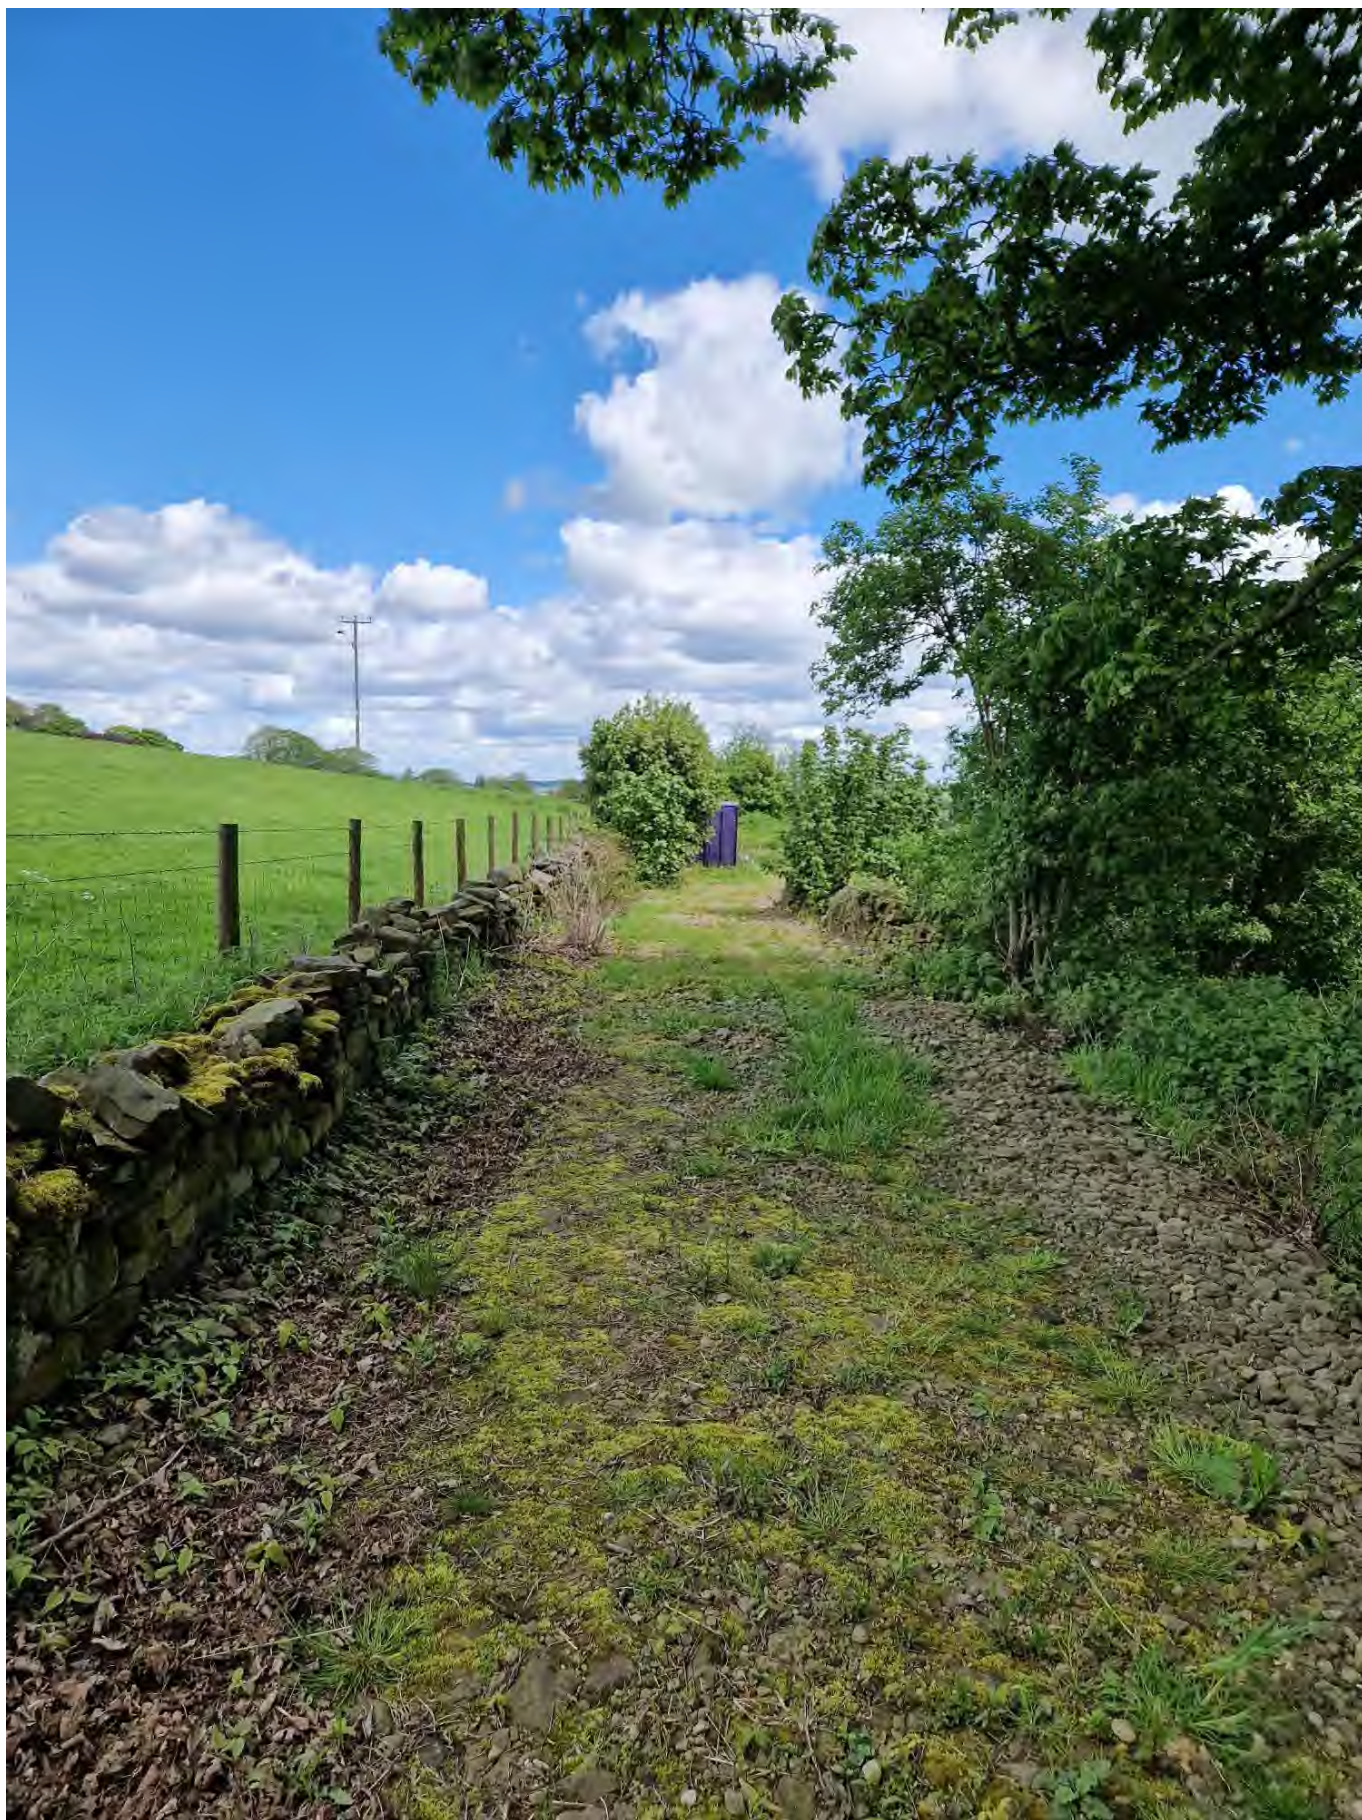
*Photo 4: Order route leads along wide maintained track approximately 3.5 metres wide.*

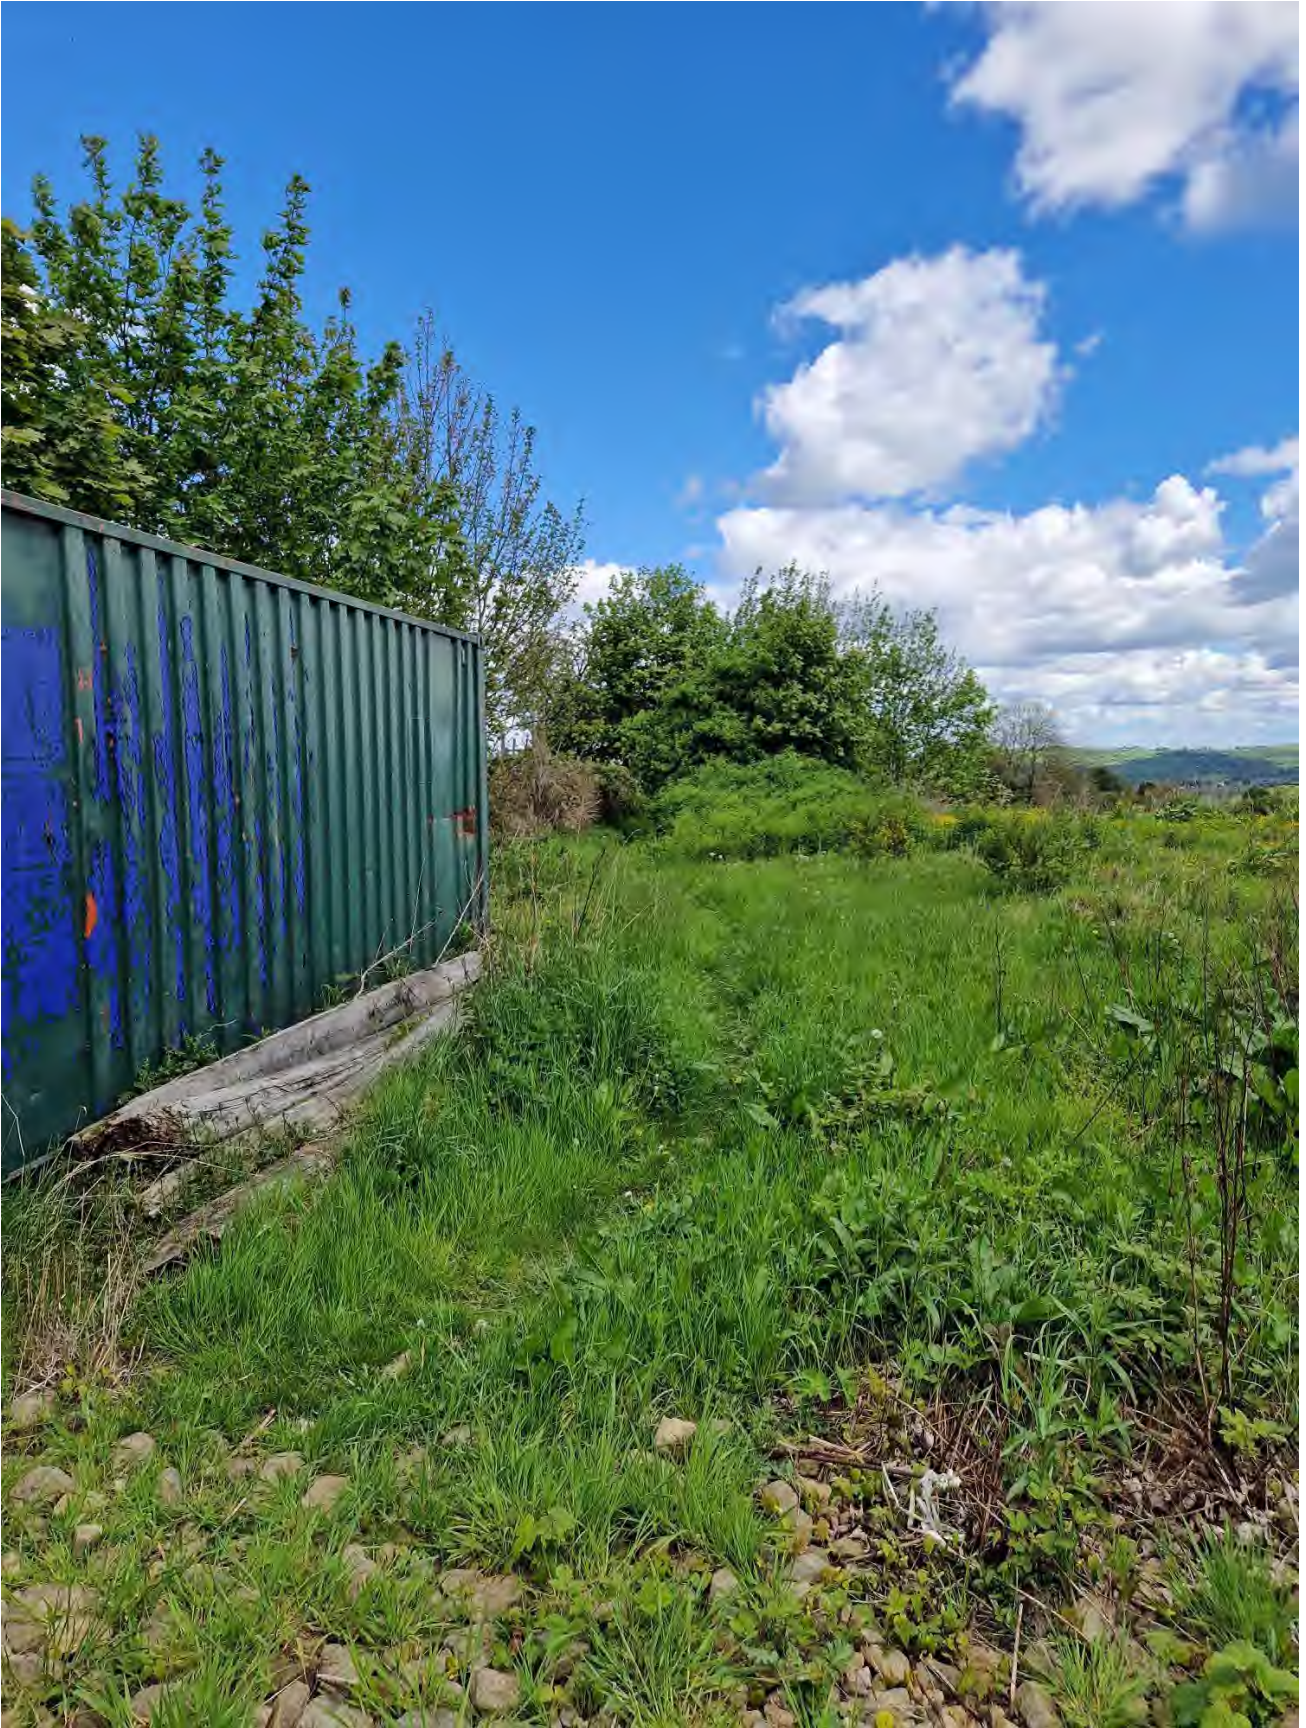
*Photo 5: Shipping container obstructs the Order route and was placed on the way recently in approximately 2021*

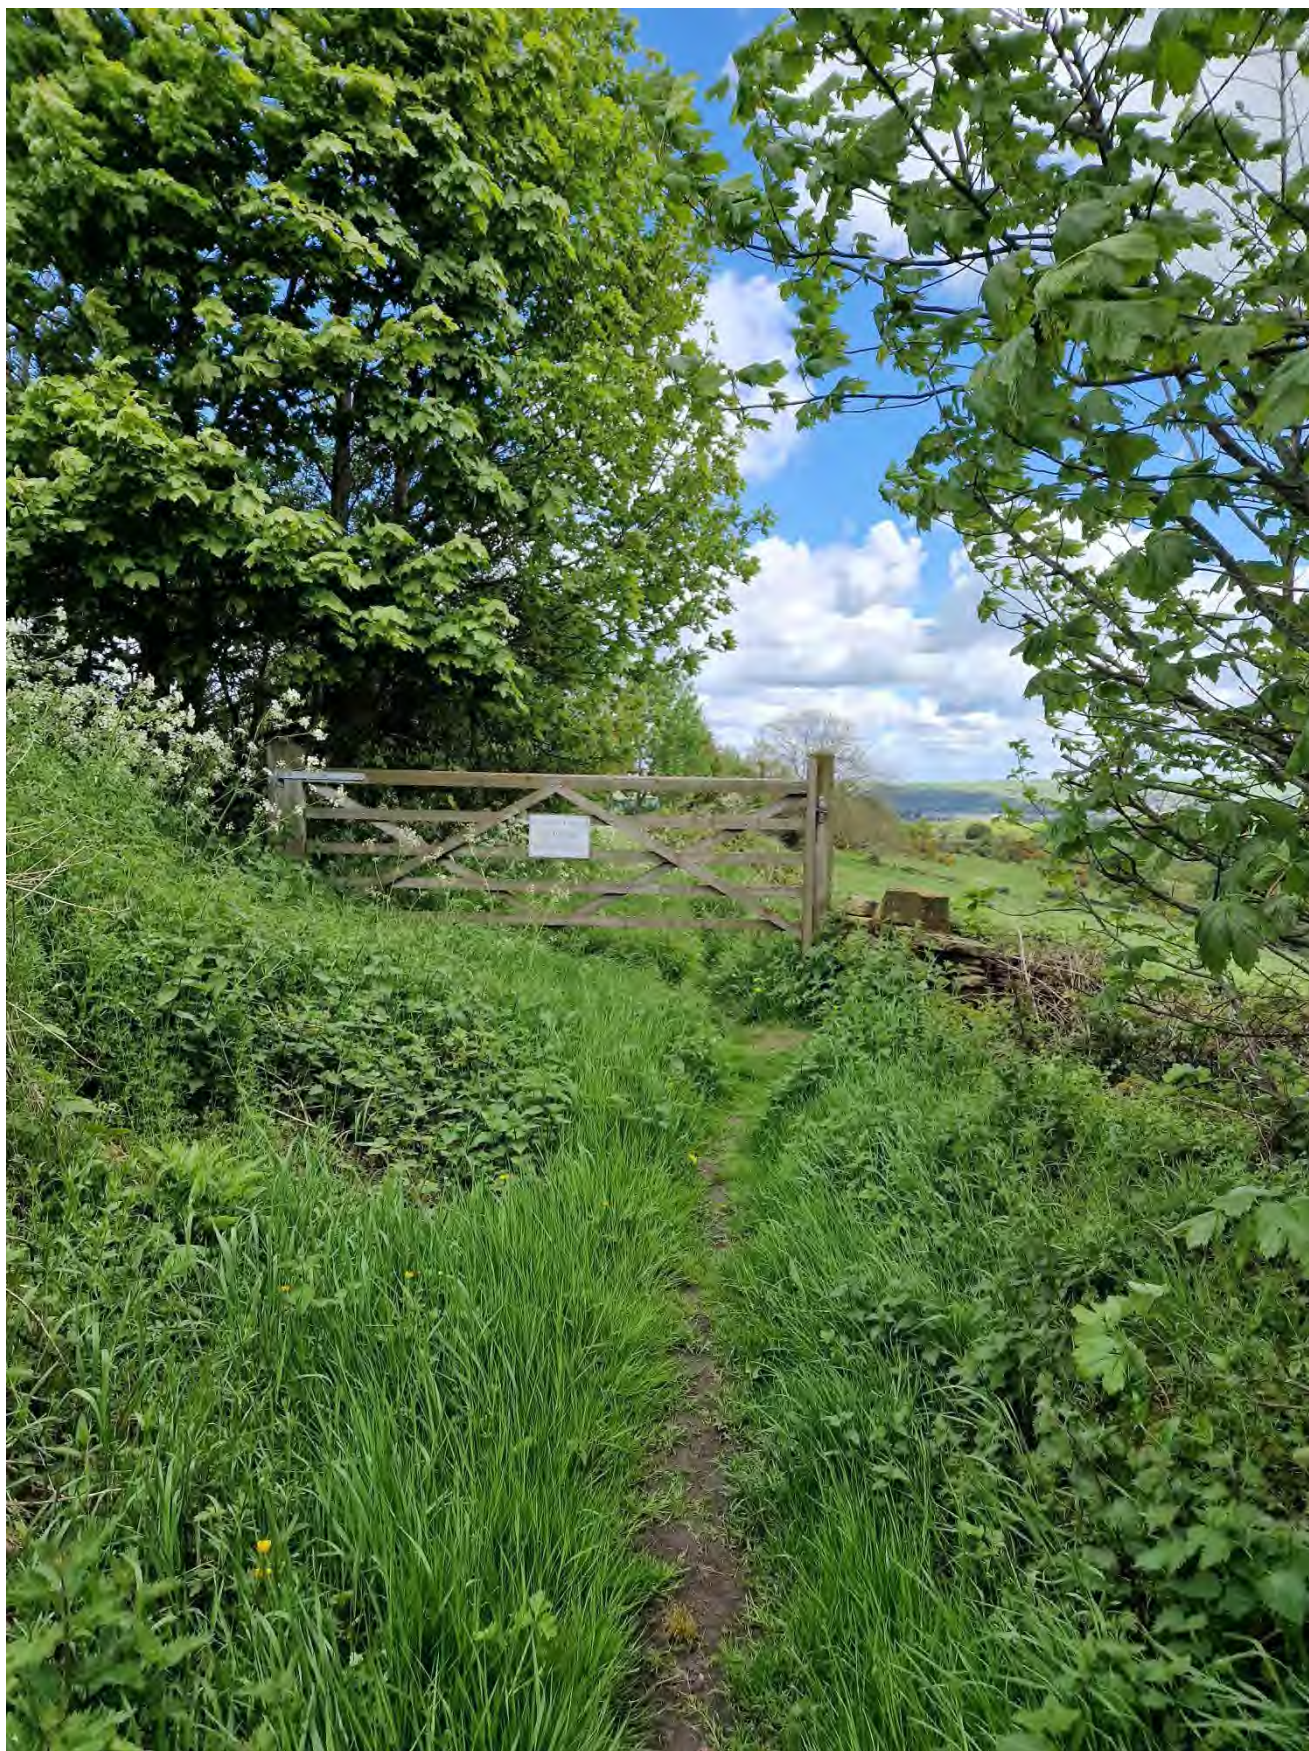
*Photo 6: Order route leads to second wooden field gate recently erected in approximately 2020 (Grid Reference SE 1676 1252).*

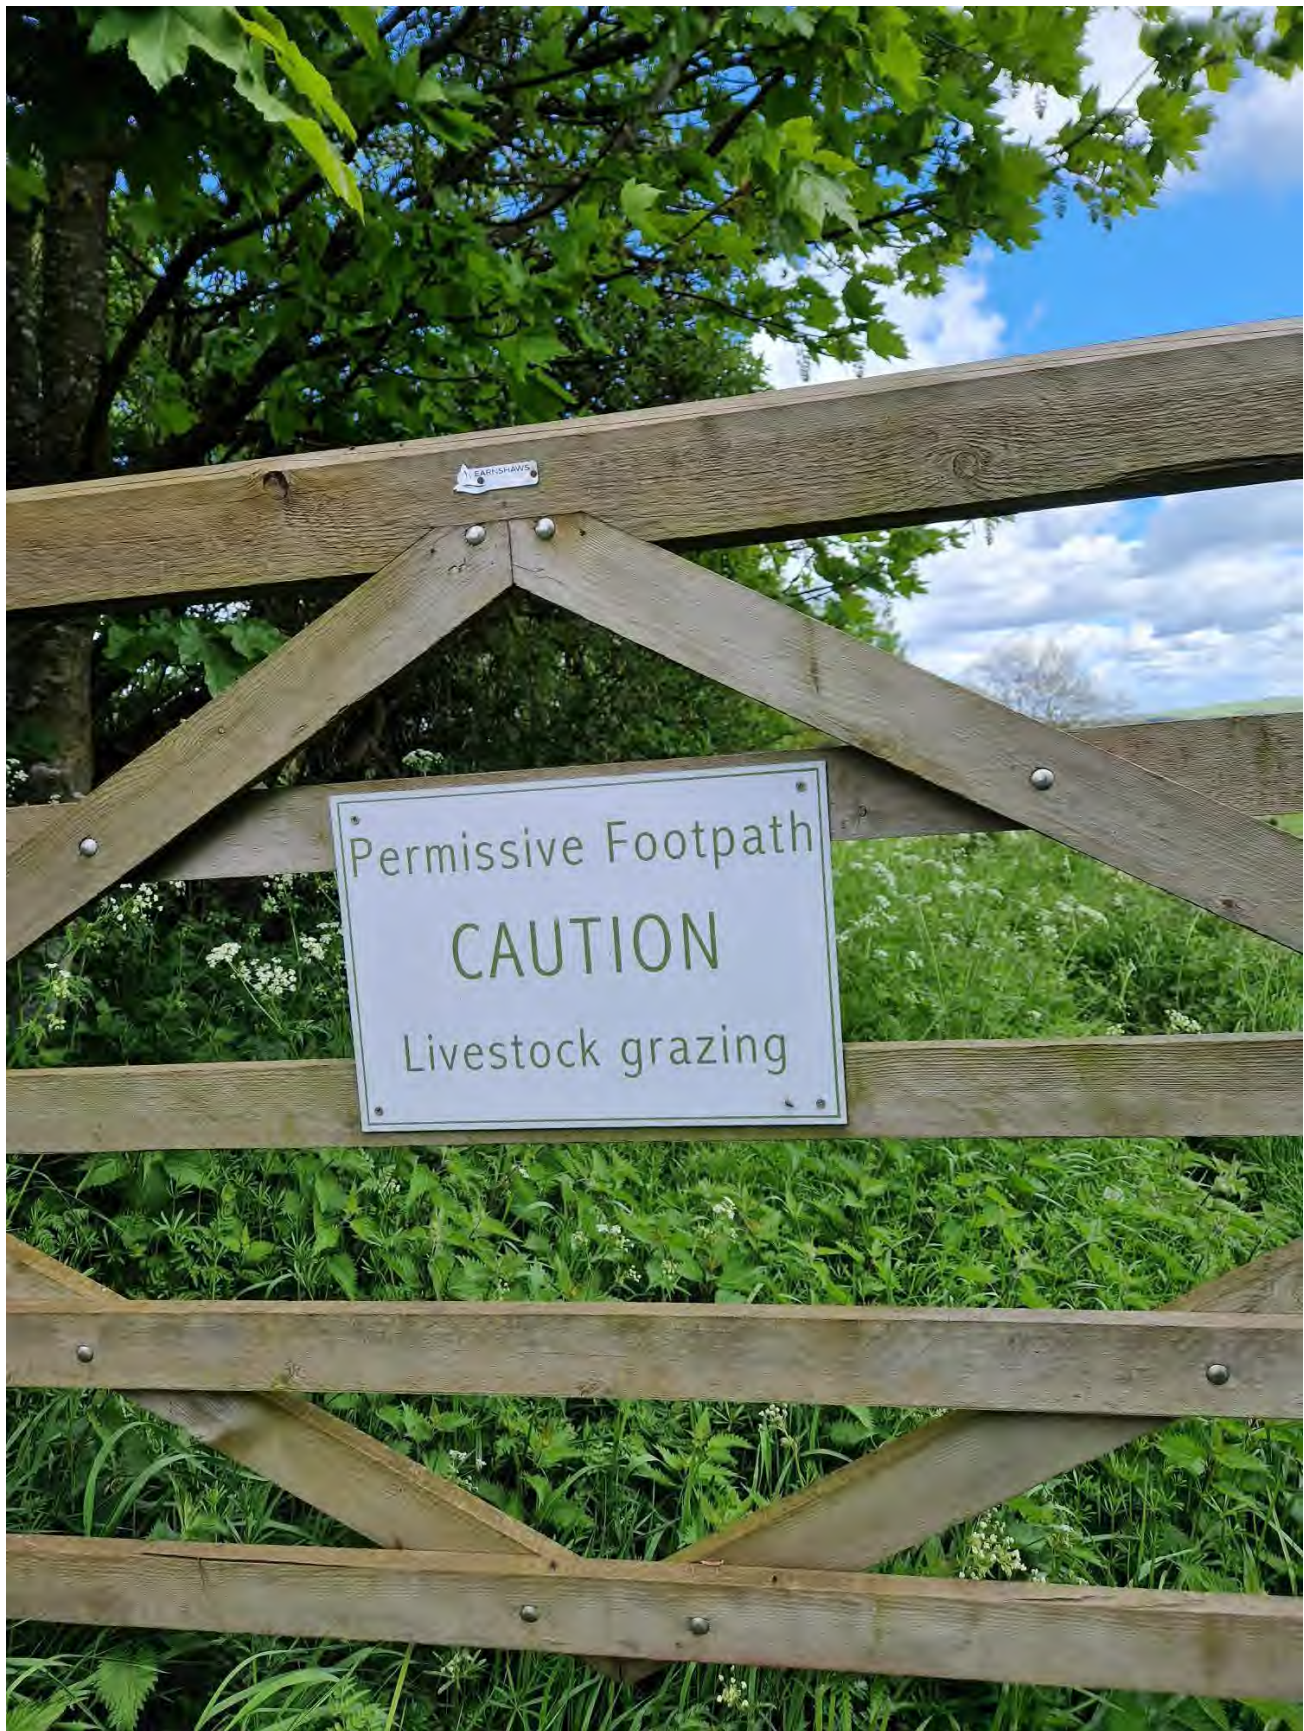
*Photo 7: Sign on field gate states, 'Permissive Footpath CAUTION Livestock grazing'.*

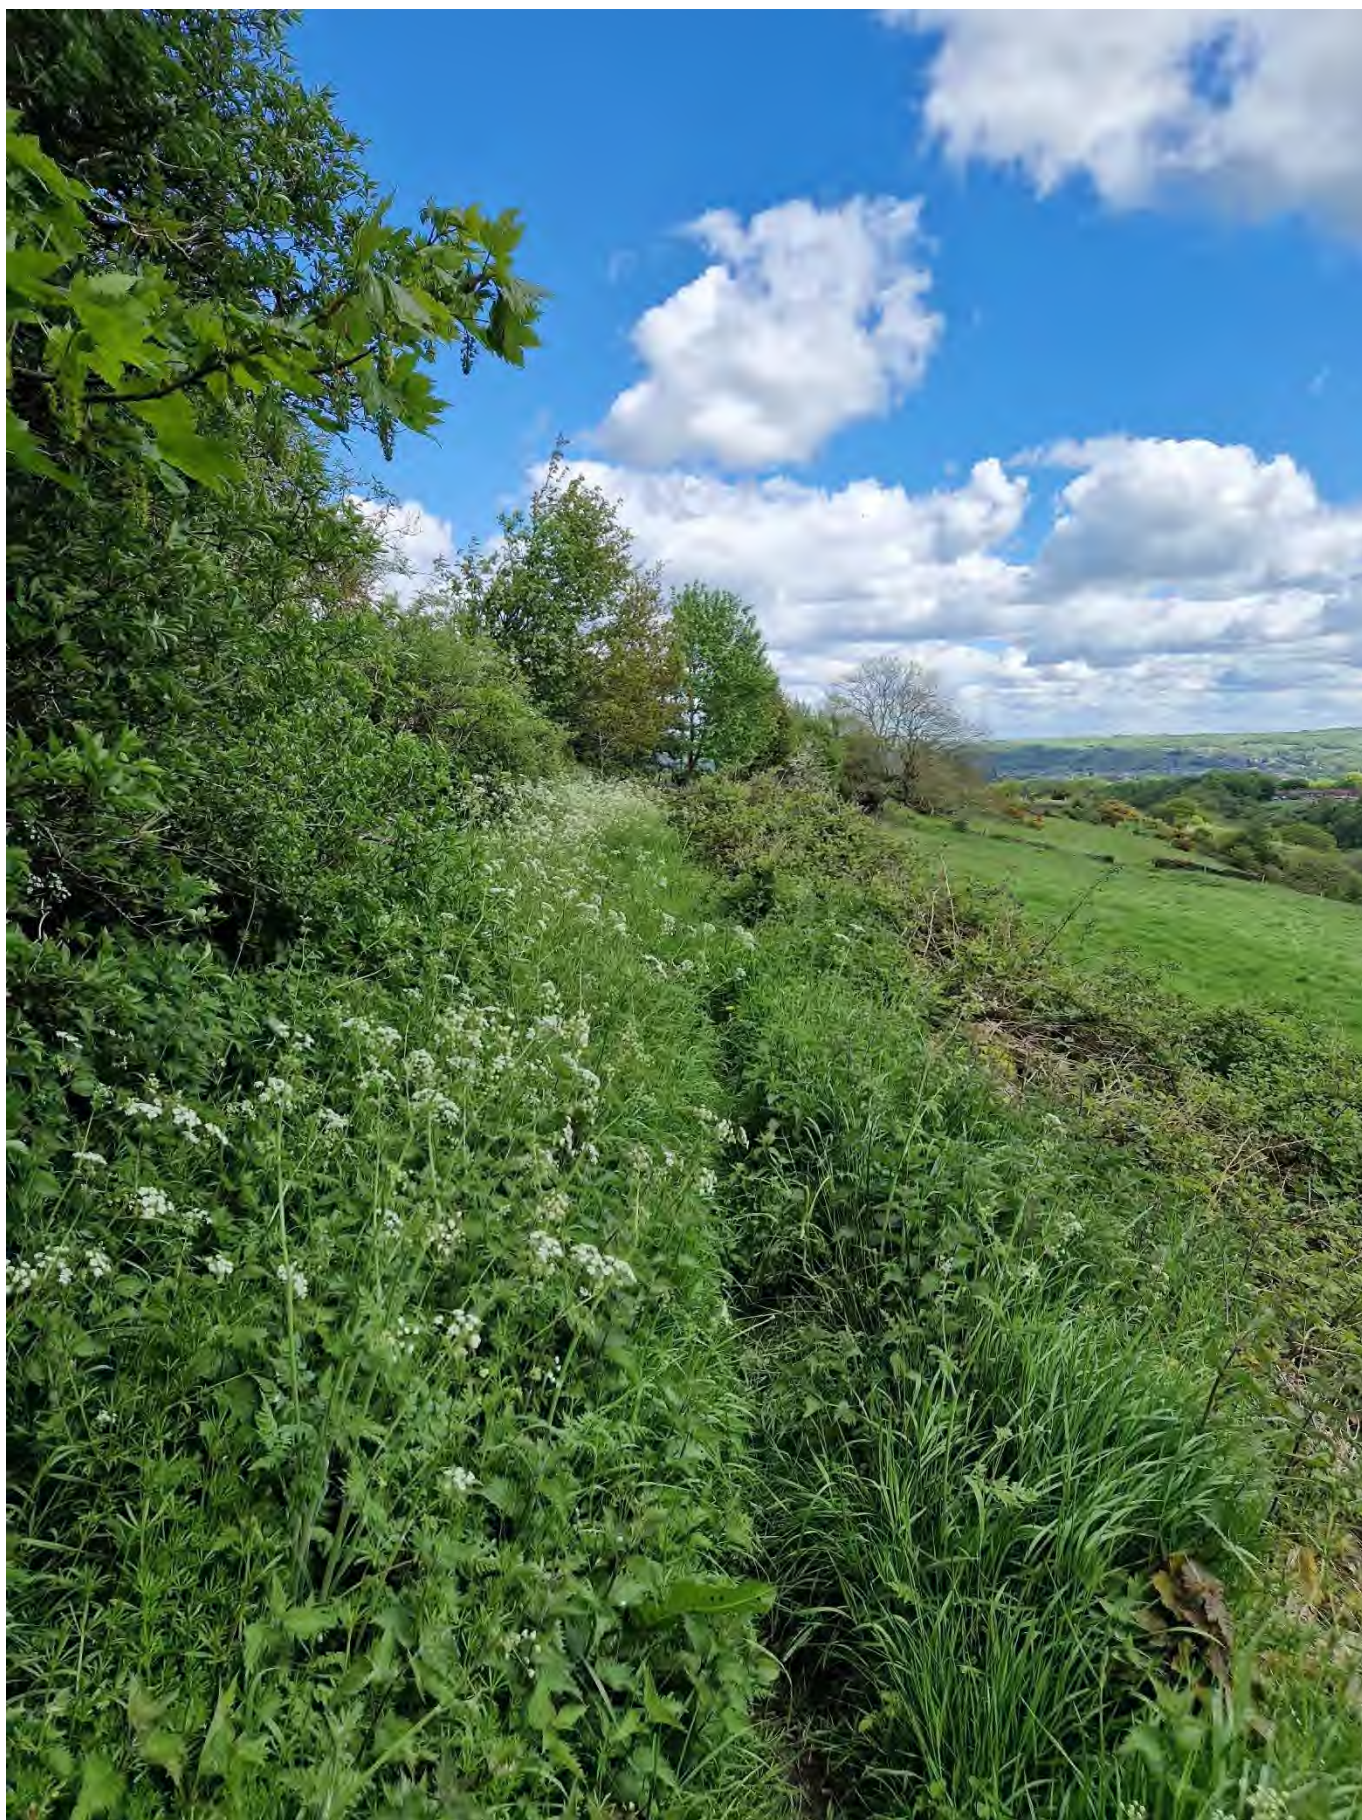
*Photo 8: Order route continues easterly. Trodden width of Order route narrows due to vegetation.*

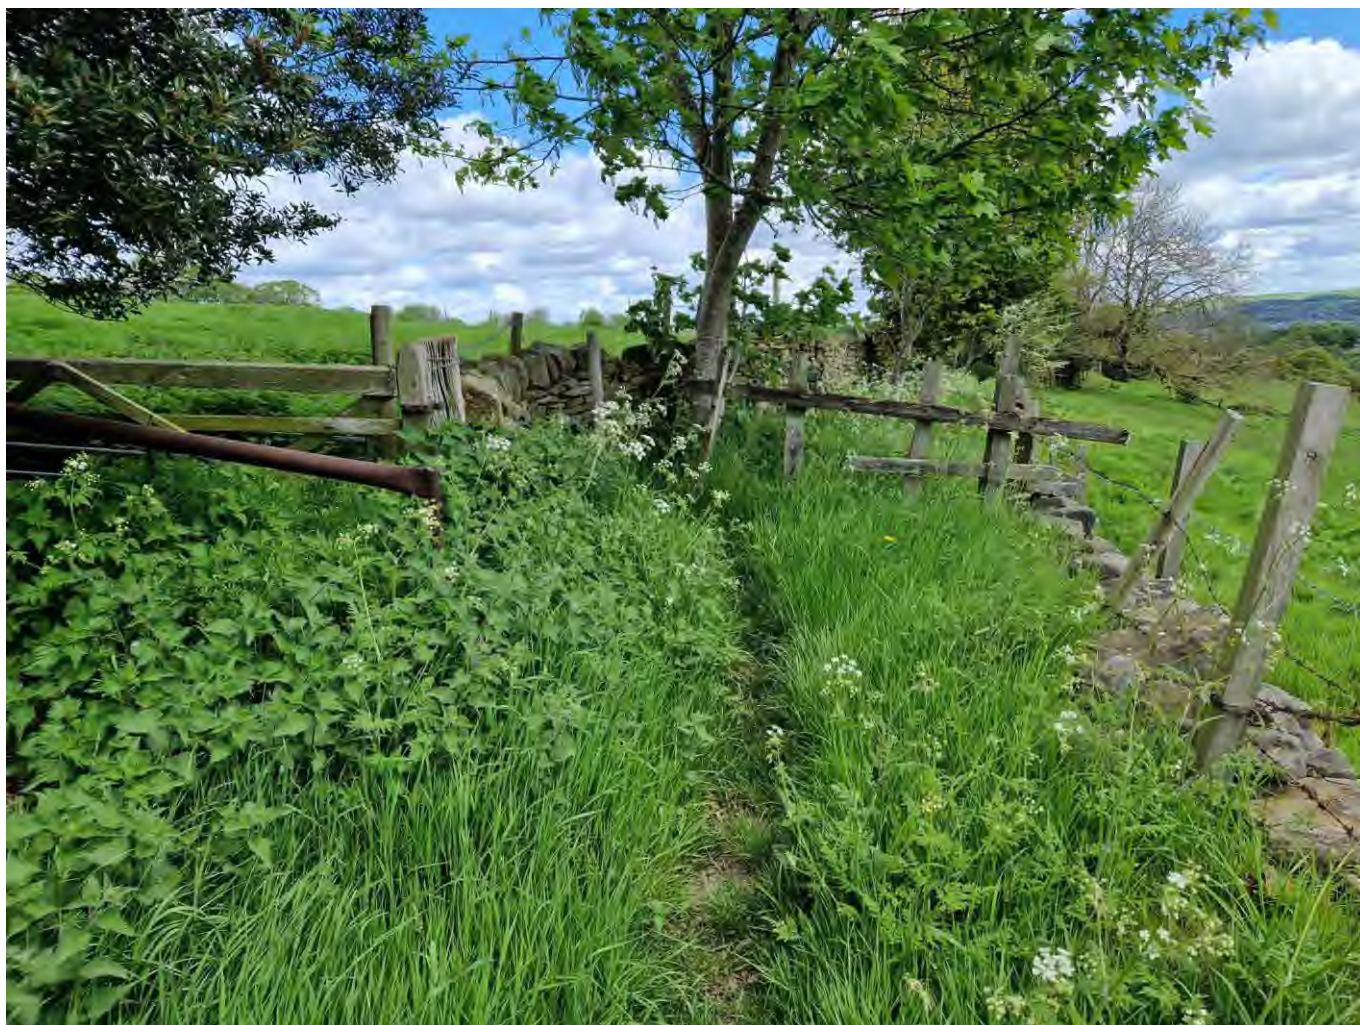
*Photo 9: Order route leads to wooden squeeze stile with a gap available on the northern side (Grid Reference SE 1680 1255).*

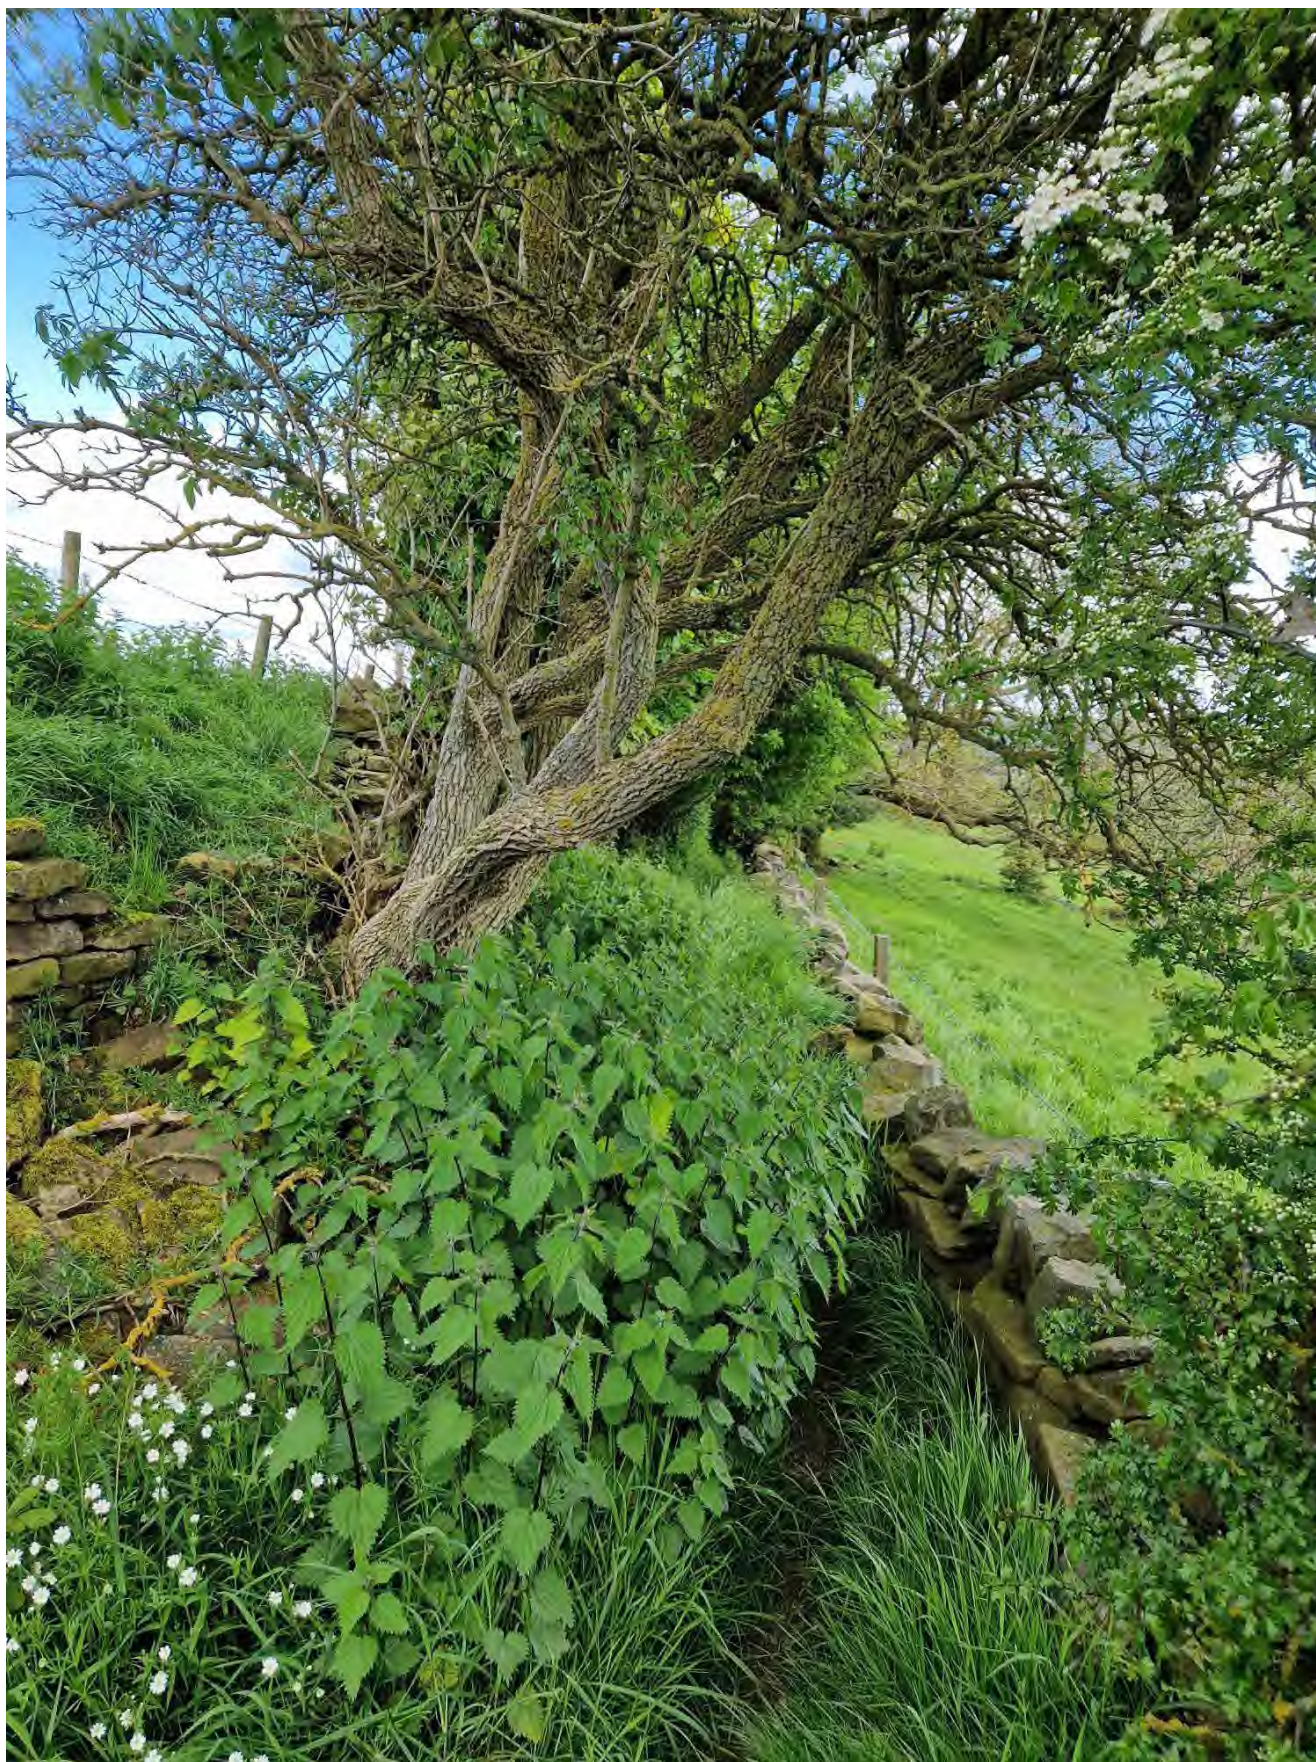
*Photo 10: Trees and vegetation grow from within the Order route narrowing the available width.*

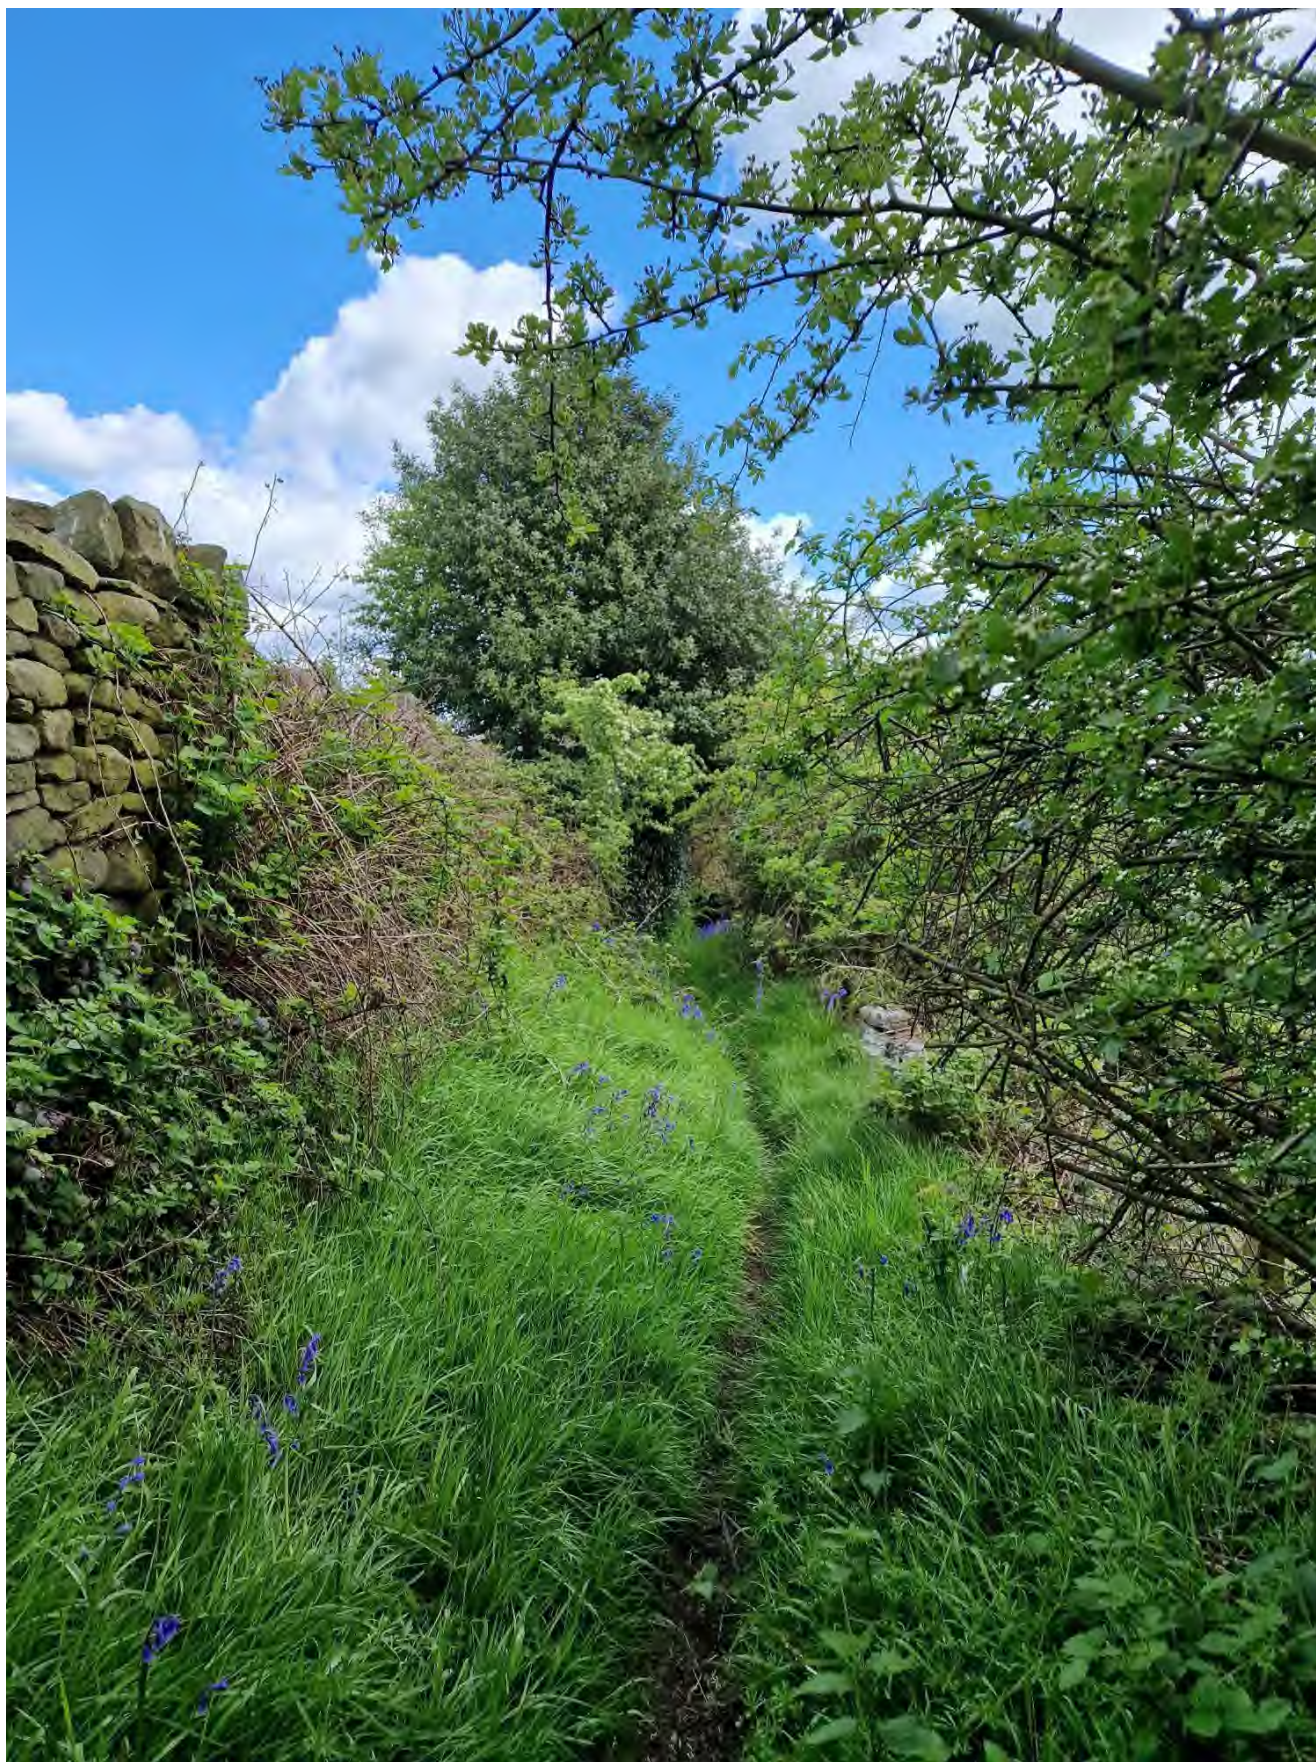
*Photo 11: Order route continues easterly as a grassy track.*
