## **Appendix B – Photos of Order Route**

**Wildlife & Countryside Act 1981 – Section 53  
West Yorkshire County Council Definitive Map and  
Statement for the Kirklees Area**

**Kirklees Council (Kirkburton 256 – Moor Lane) Definitive Map  
Modification Order 2024**

## Photos (1-25) dated 22.07.23

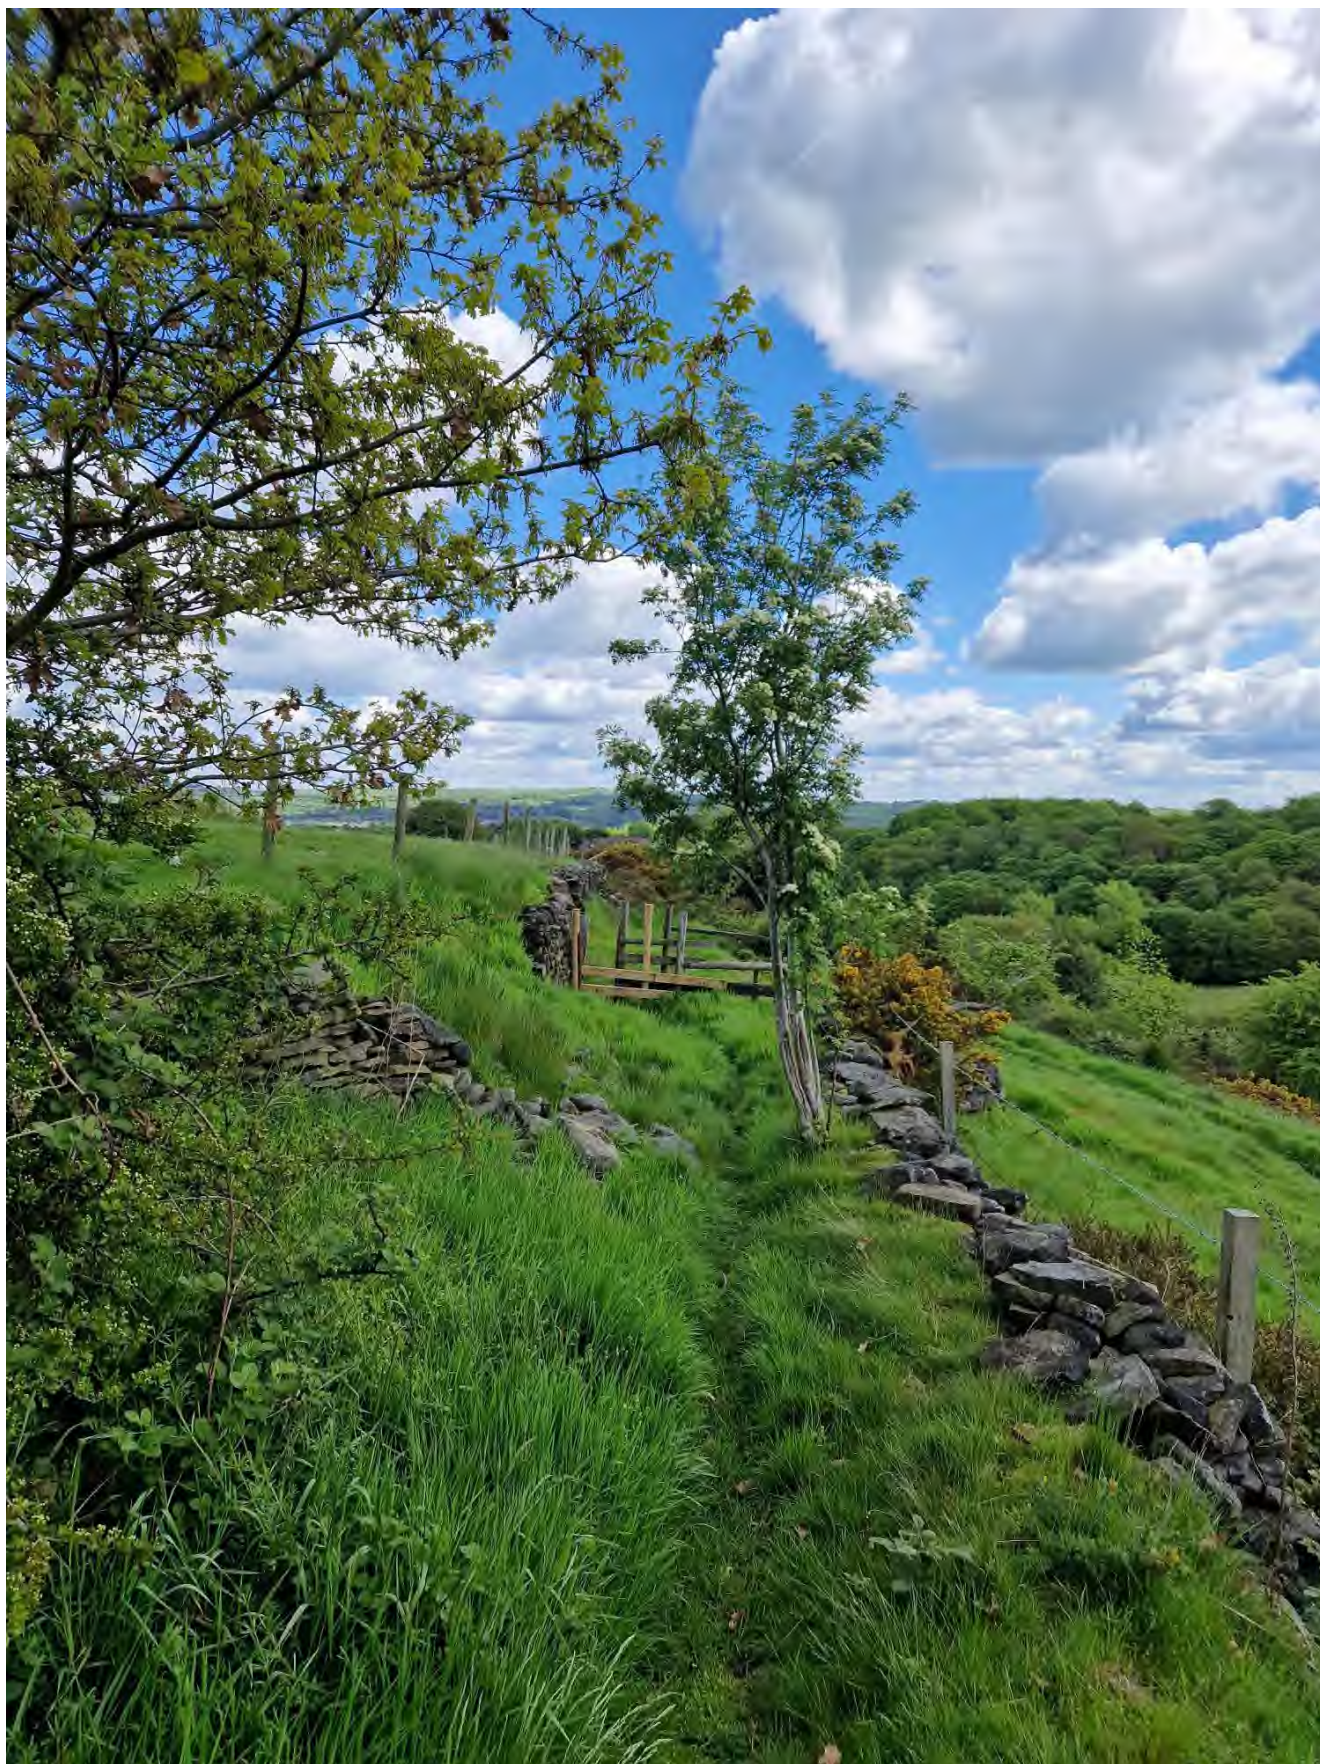
*Photo 12: Second wooden stile structure limits the available width of the Order route at a point where the drystone wall on the southern side has collapsed (Grid Reference SE 1697 1258).*

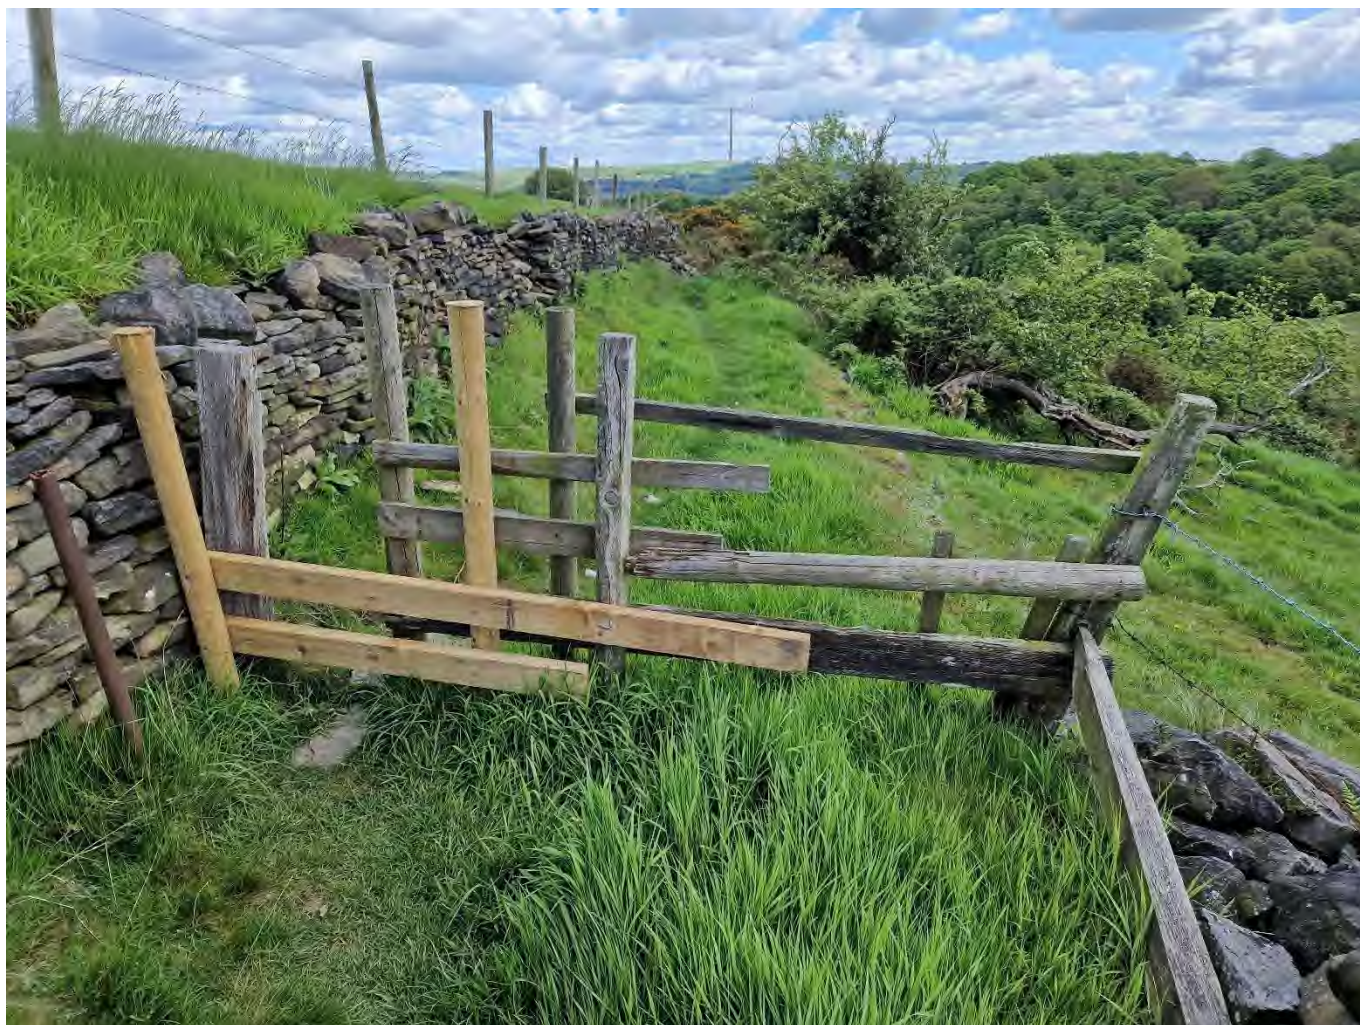
*Photo 13: Close-up of second wooden stile structure.*

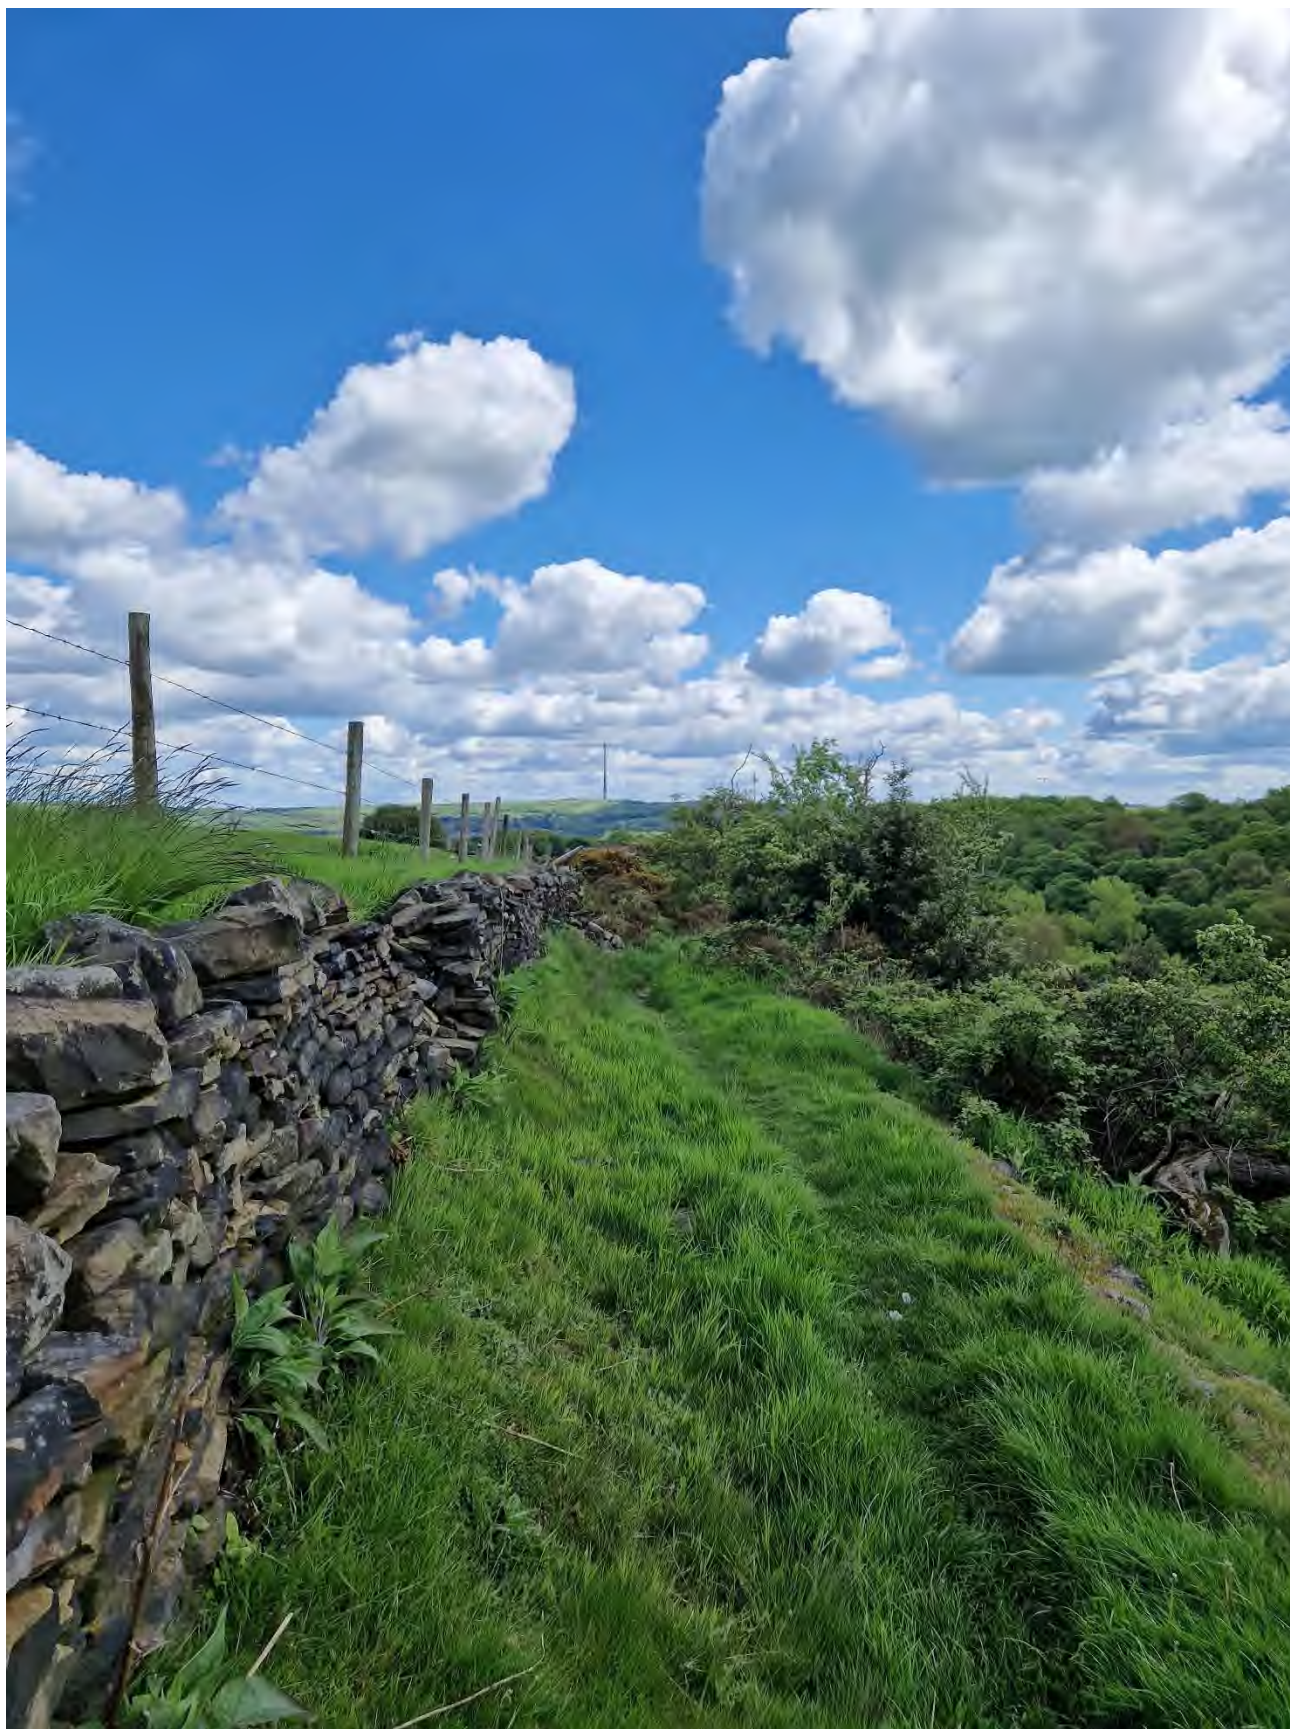
*Photo 14: Order route continues easterly with no drystone wall on its southern side and a relatively steep drop into the adjacent field.*

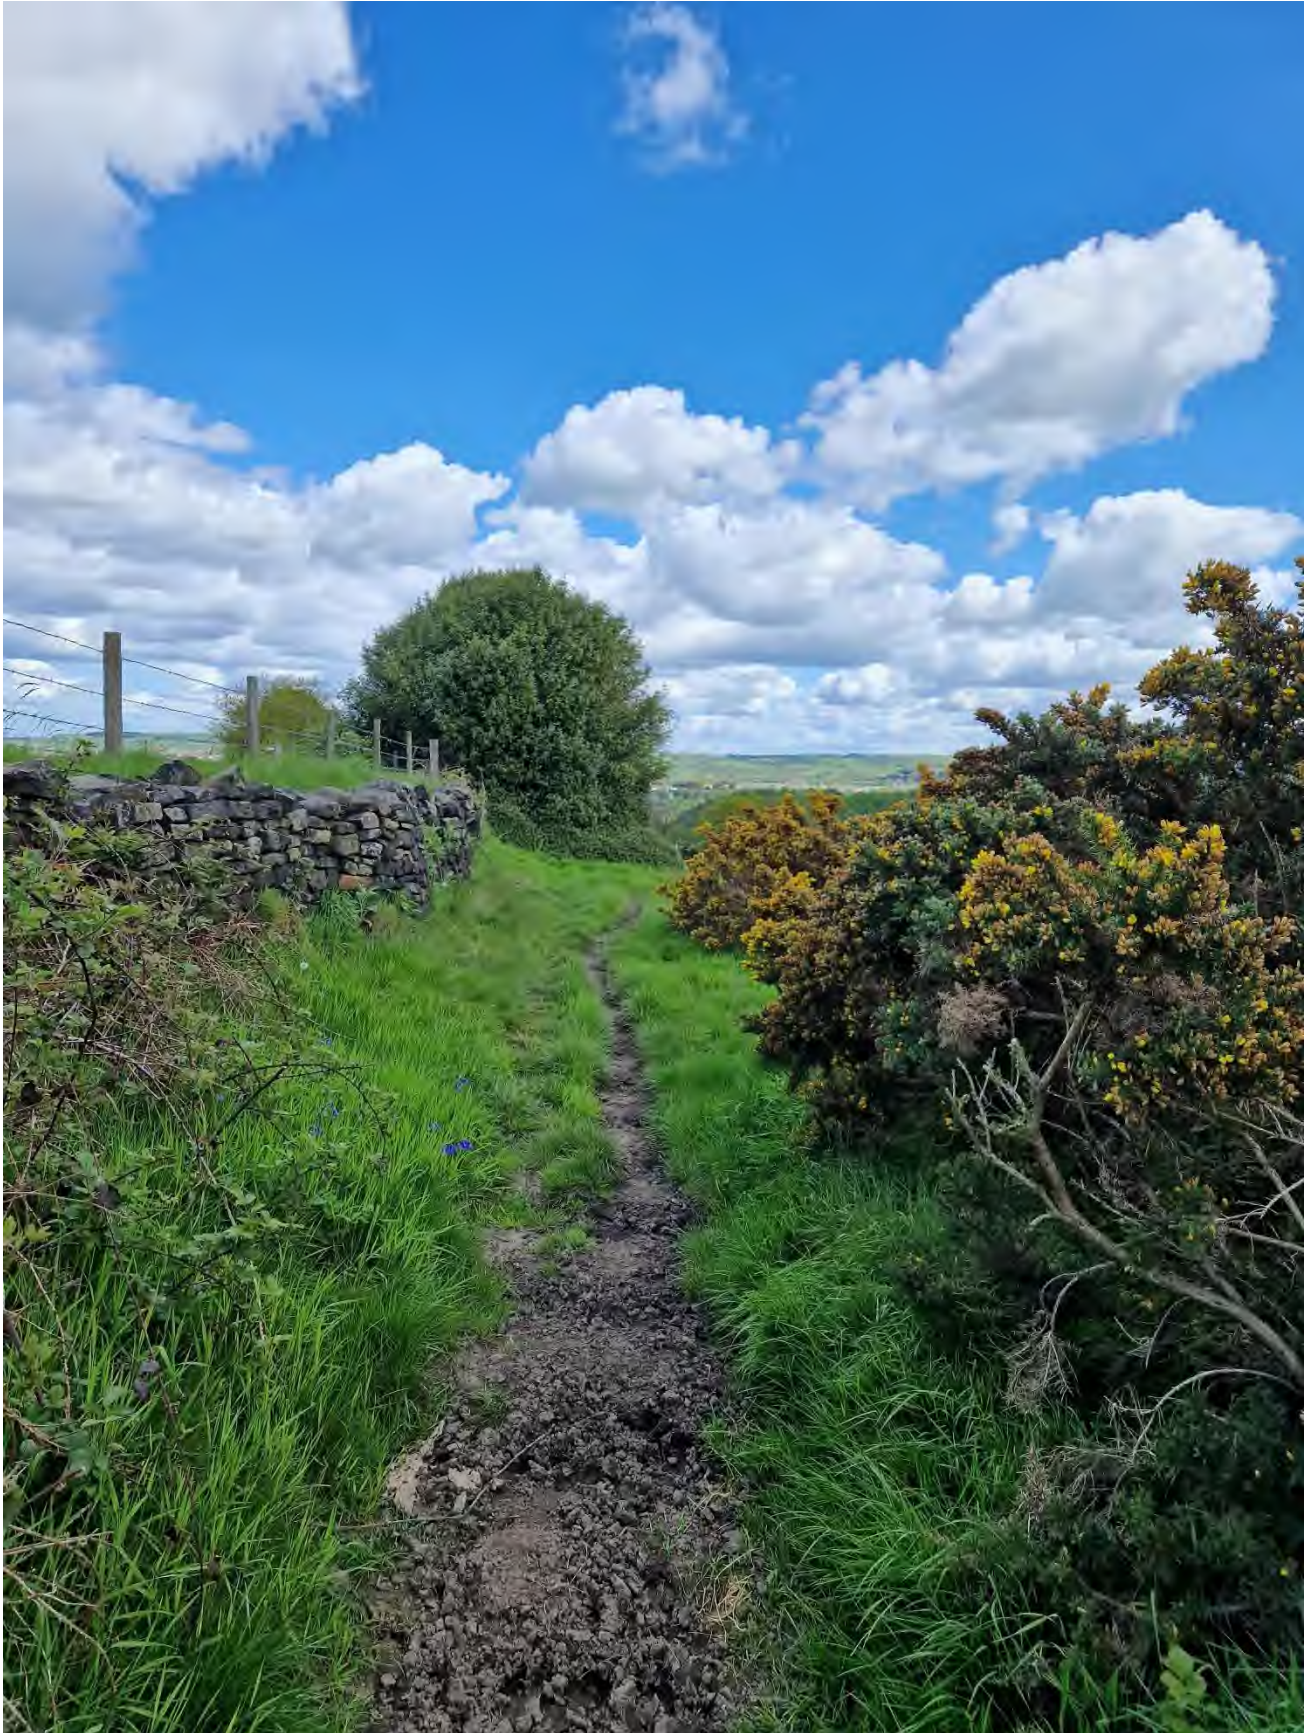
*Photo 15: Order route obstructed by a large overgrown tree.*

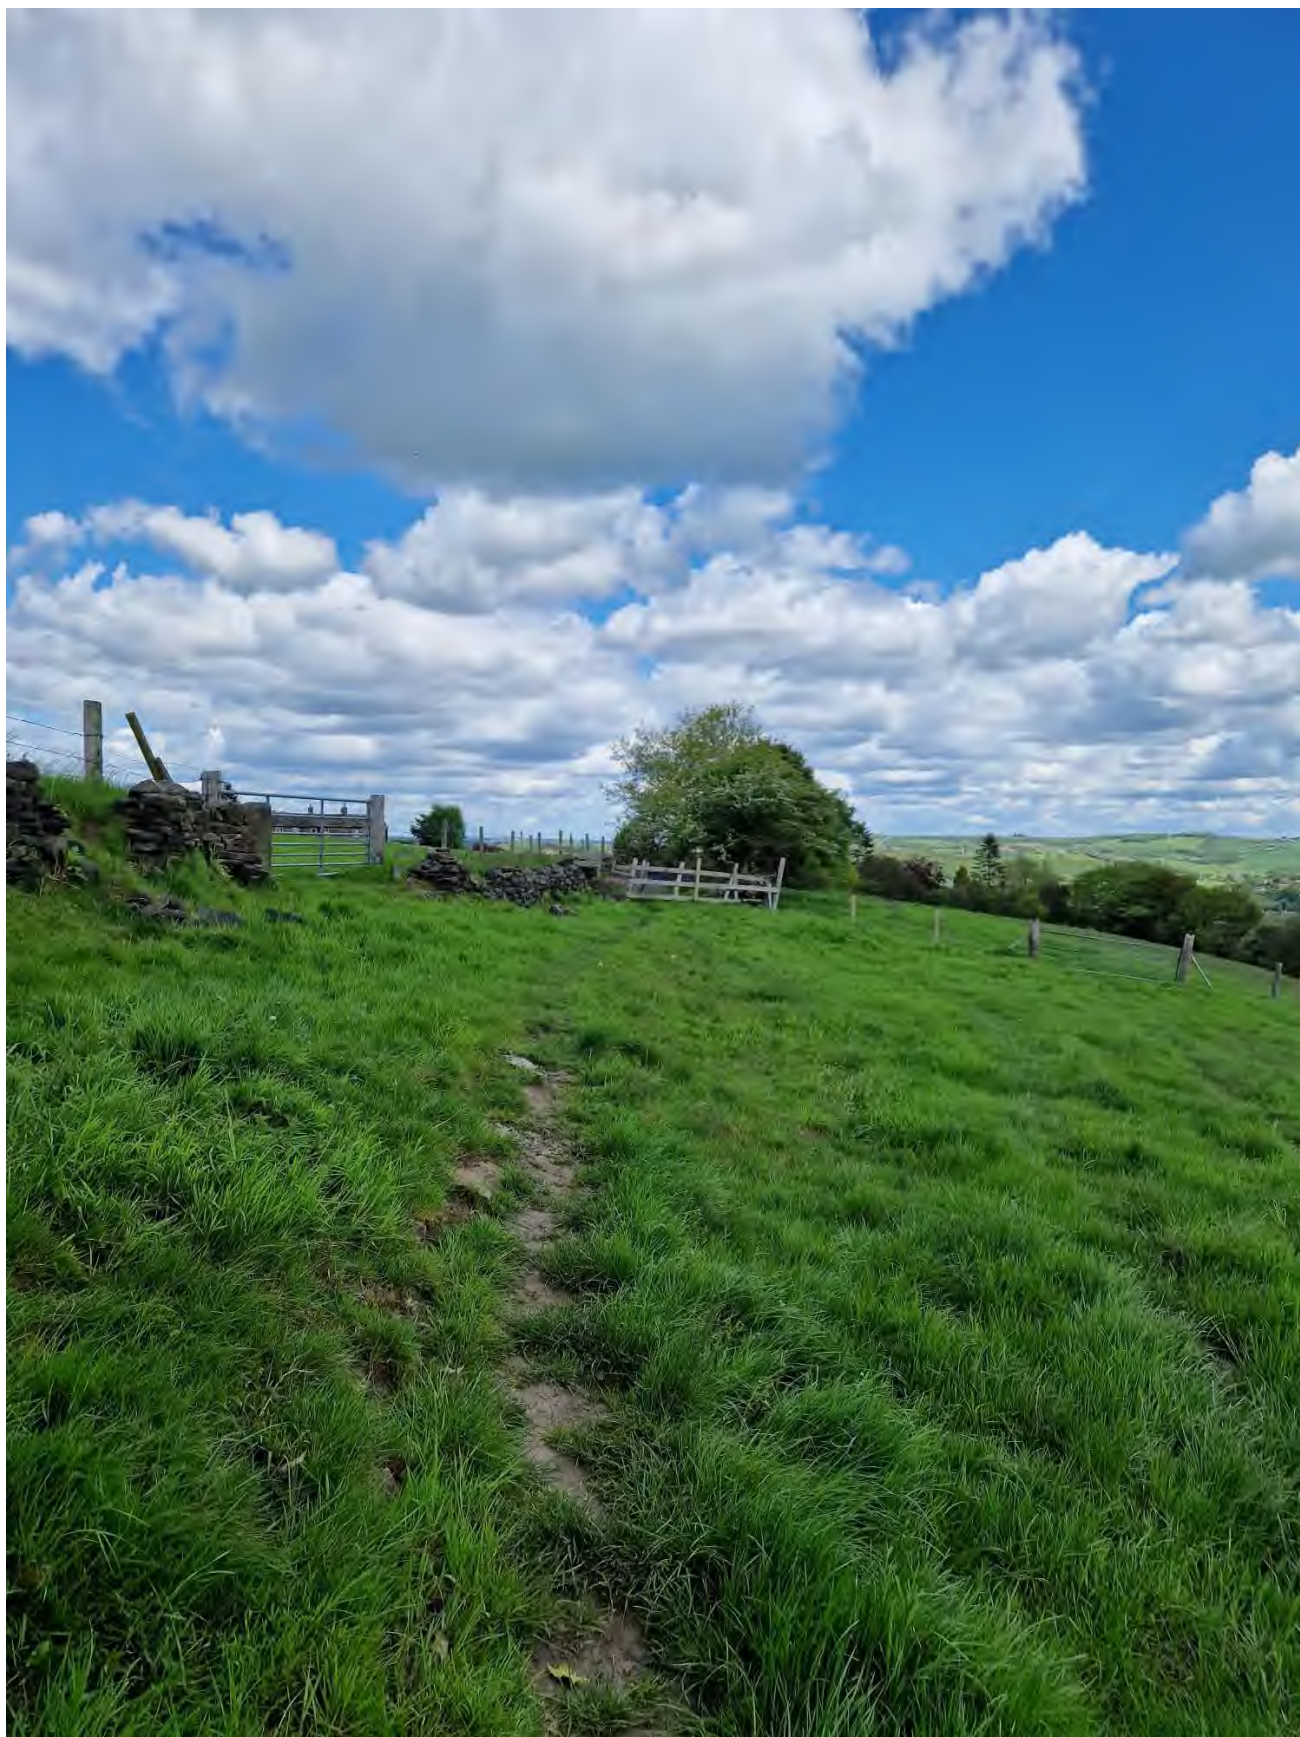
*Photo 16: Order route widens and leads across a field to a third wooden stile structure (Grid Reference SE 1708 1273).*

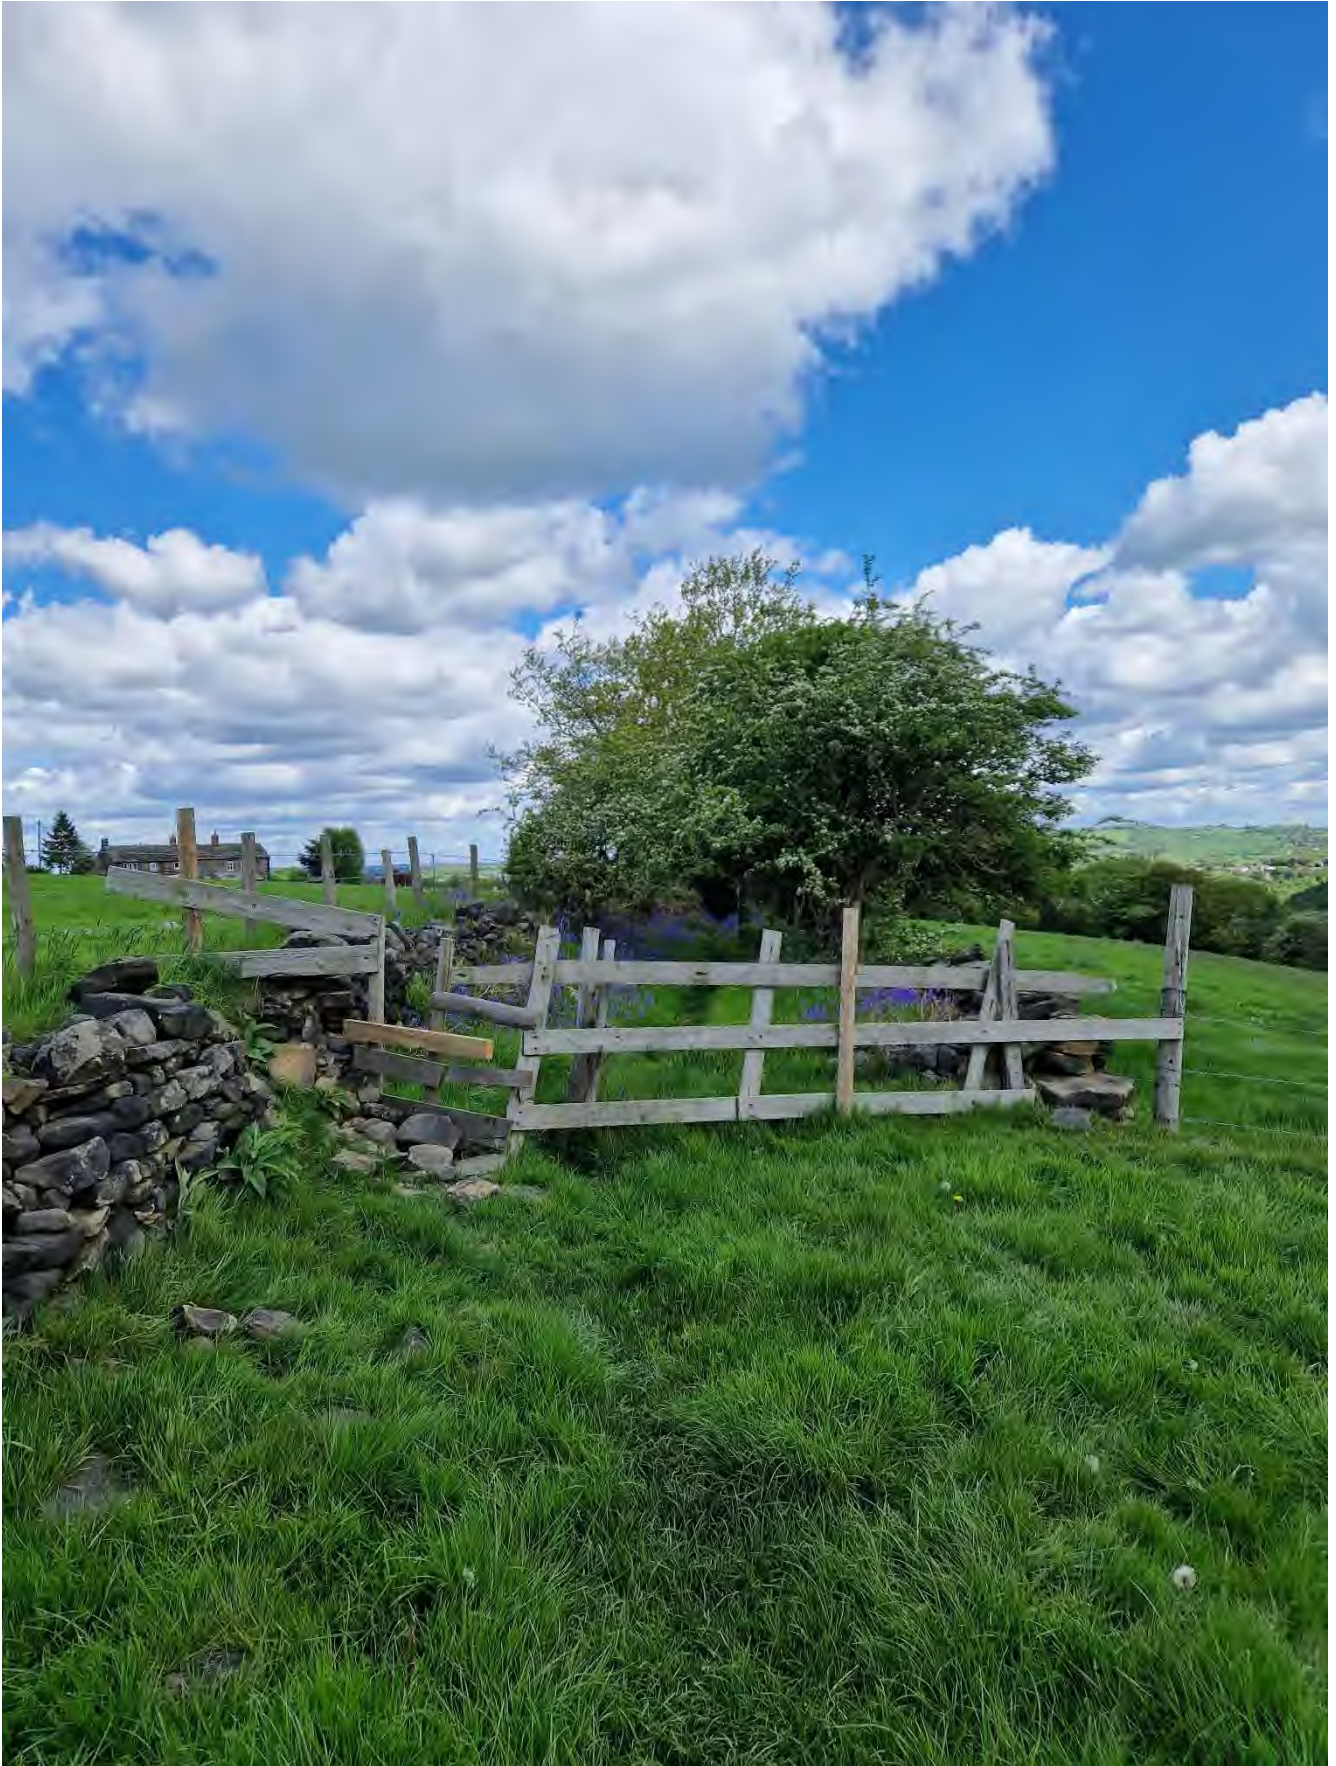
*Photo 17: Close-up of third wooden stile structure.*

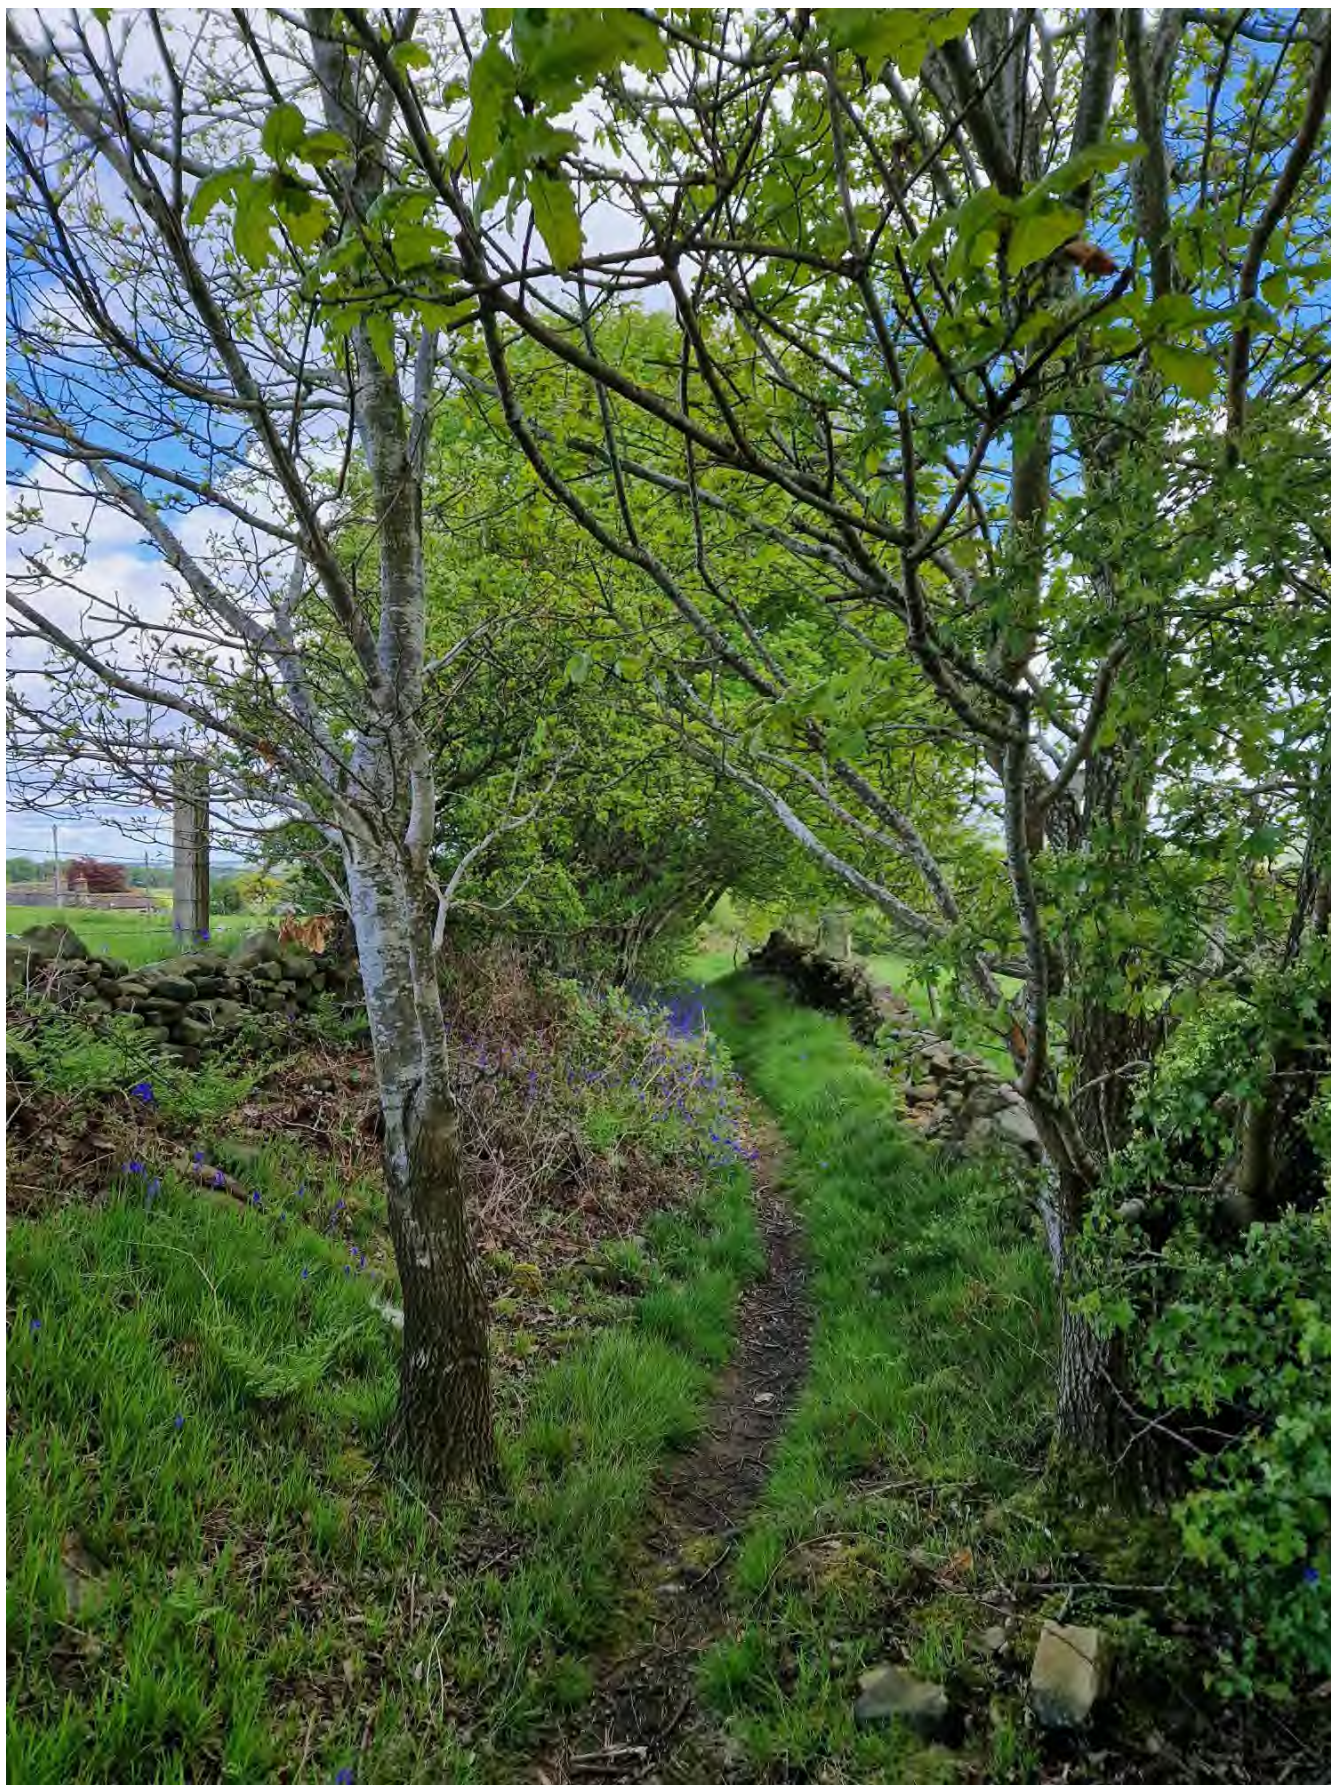
*Photo 18: Order route continues easterly between drystone walls. Trees grow within the Order route, creating pinch points.*

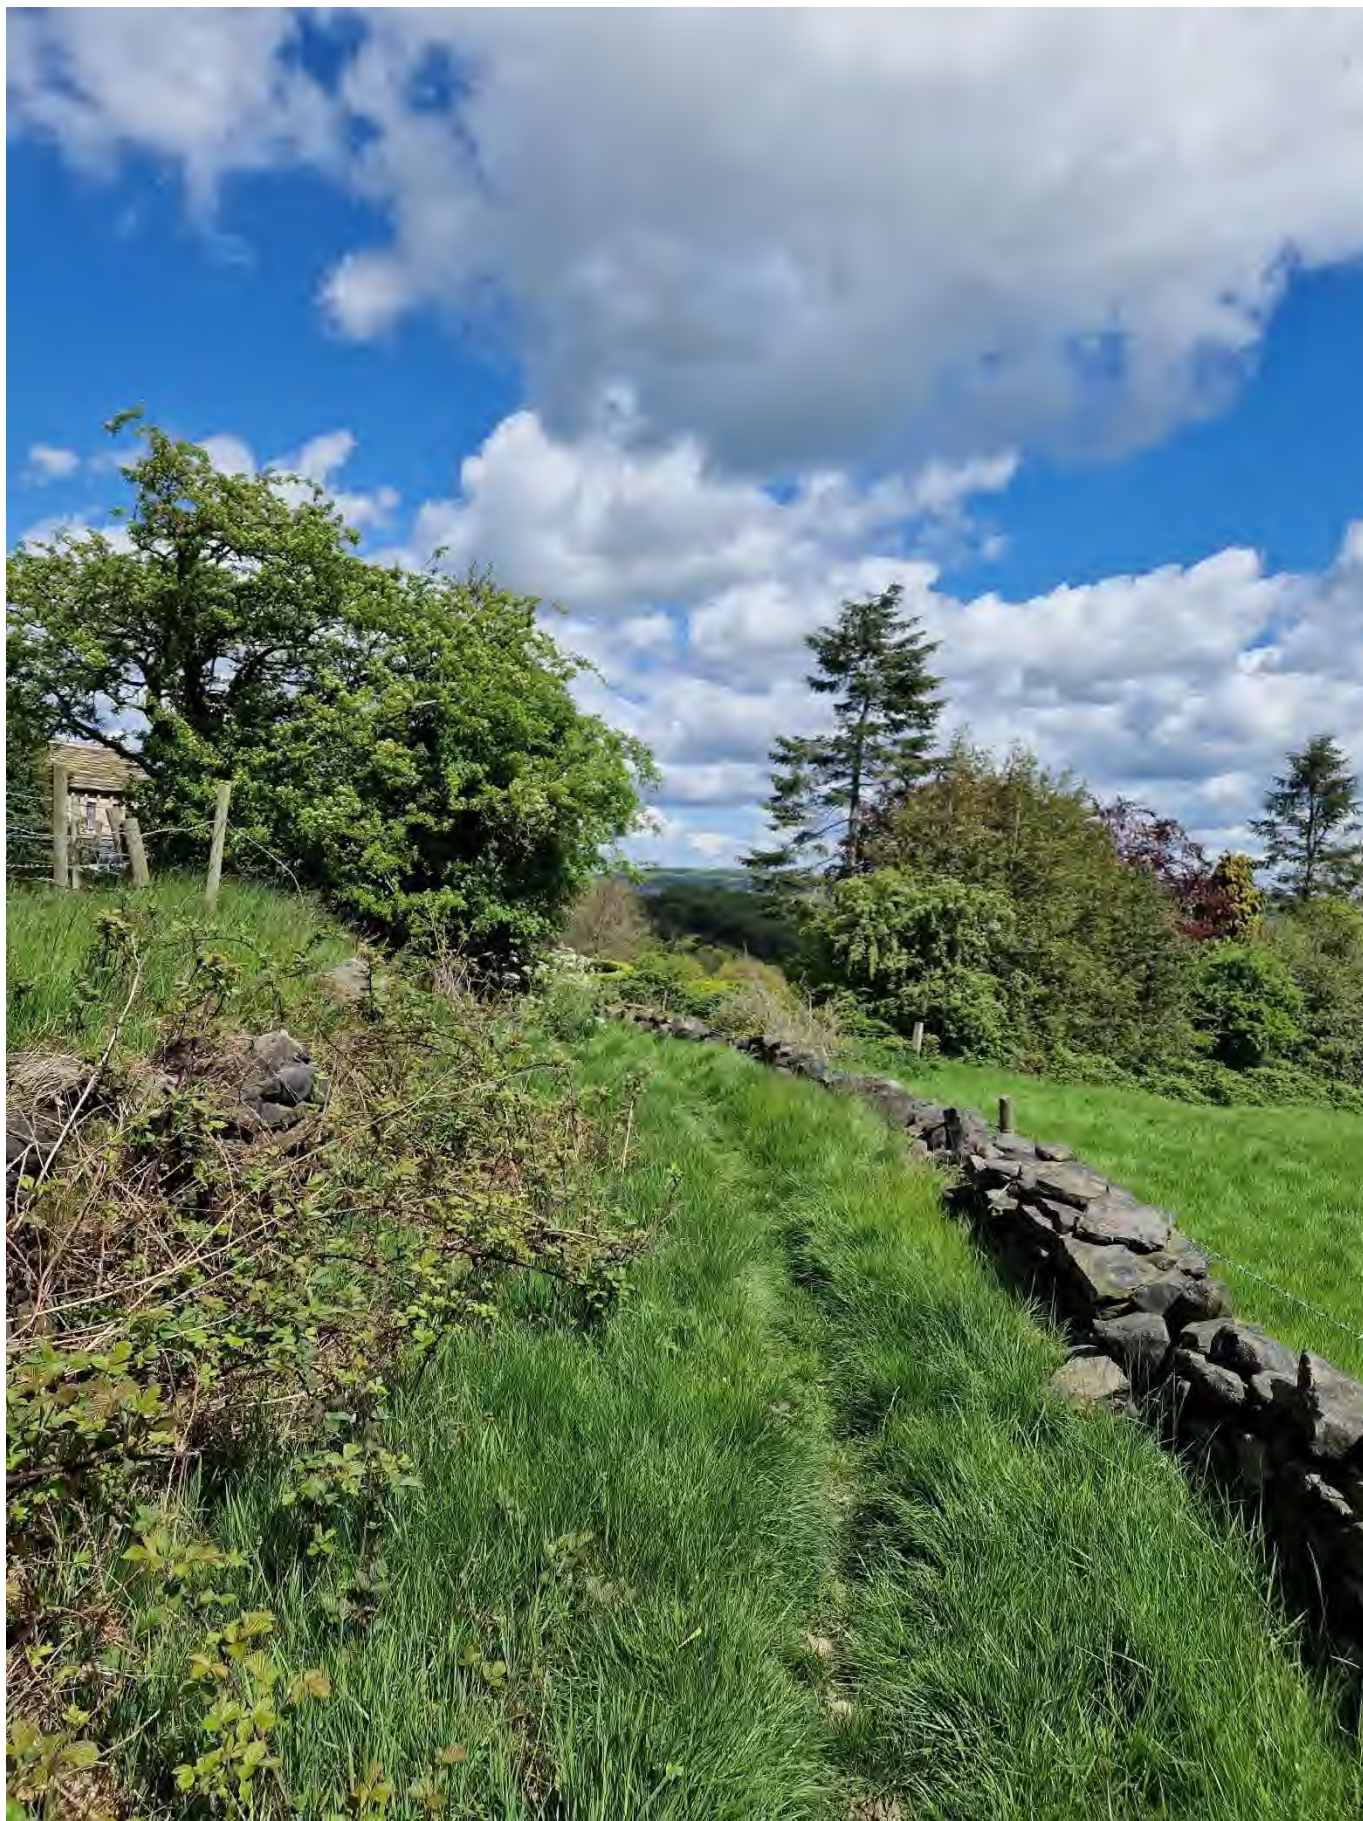
*Photo 19: Order route begins to turn northerly at a bend.*

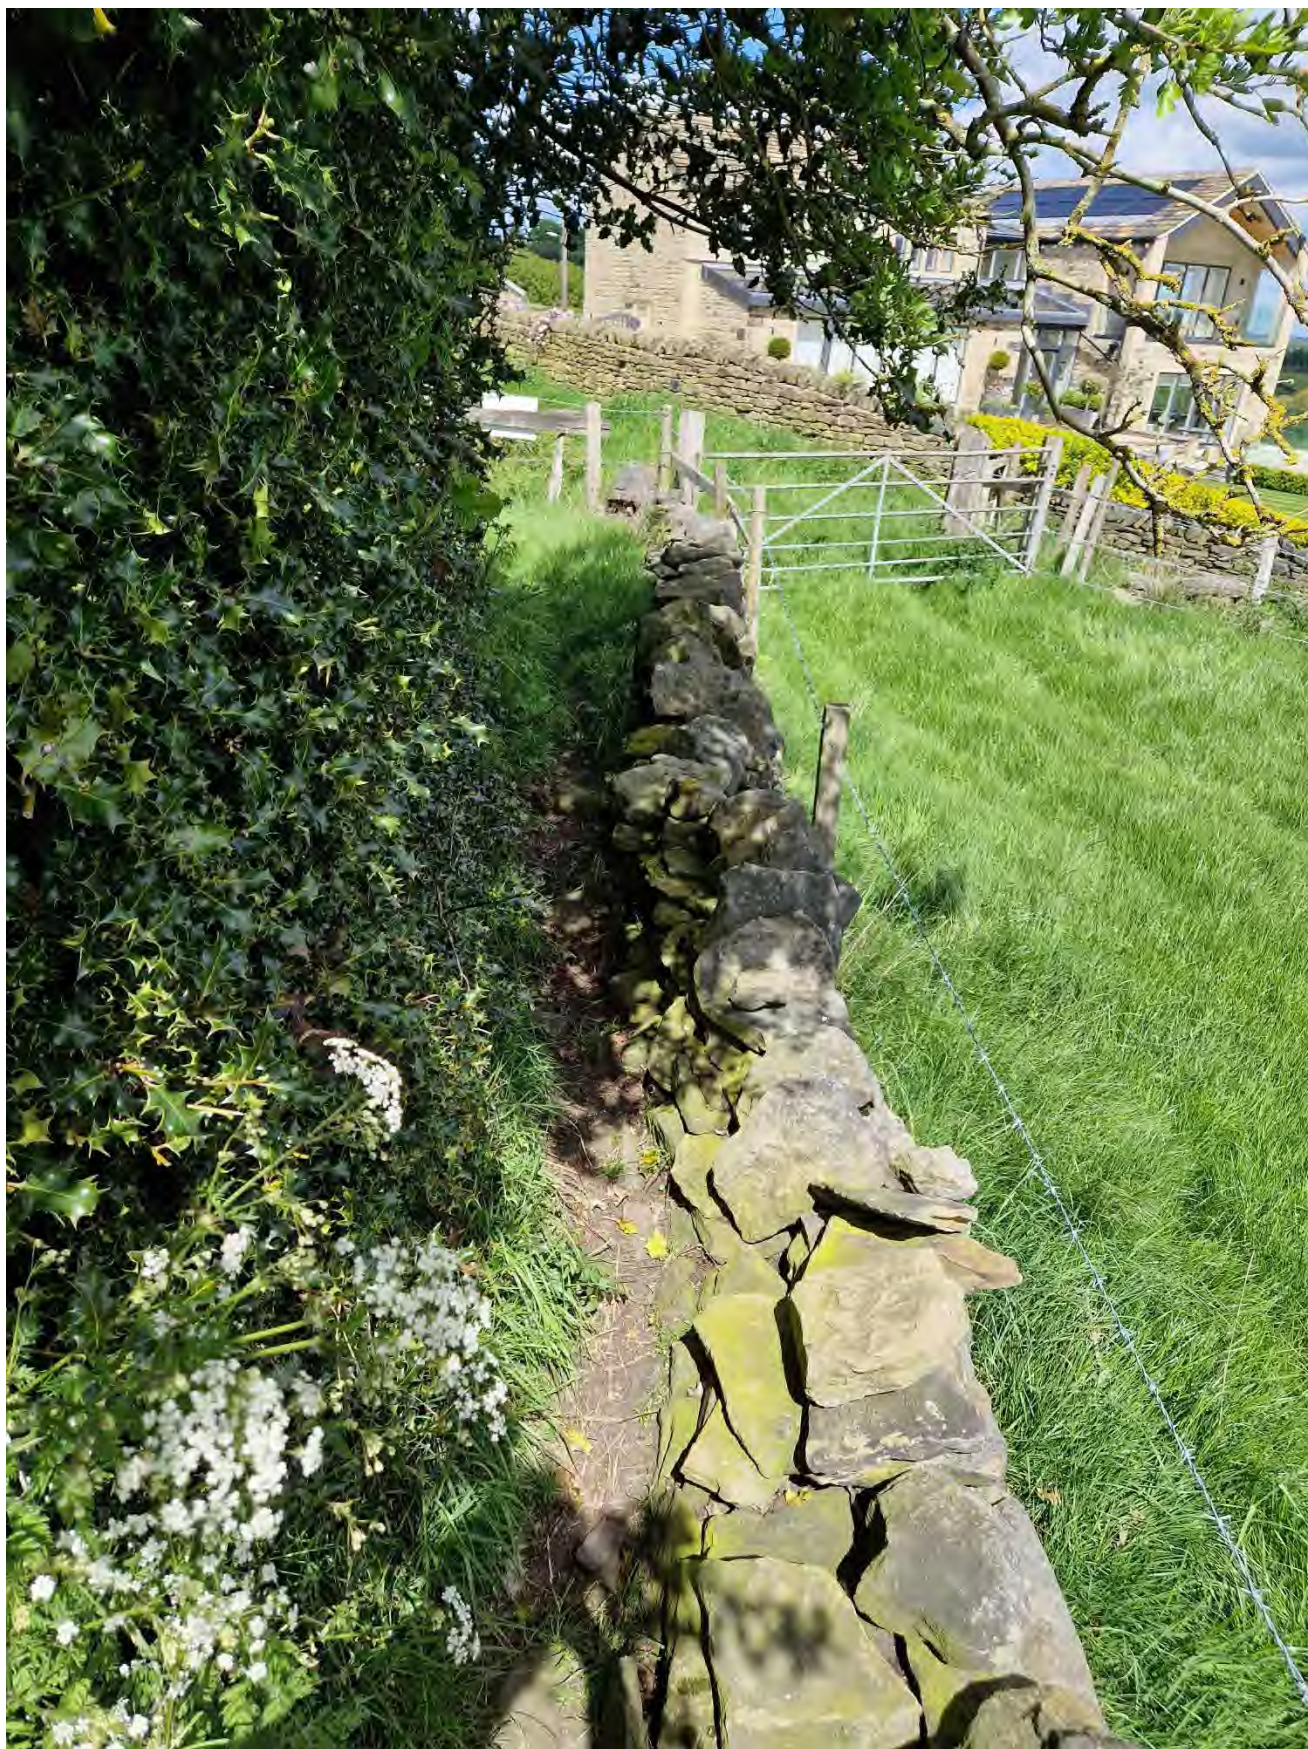
*Photo 20: The width of the Order is severely limited by overgrown hedge near its junction with Crab Lane.*

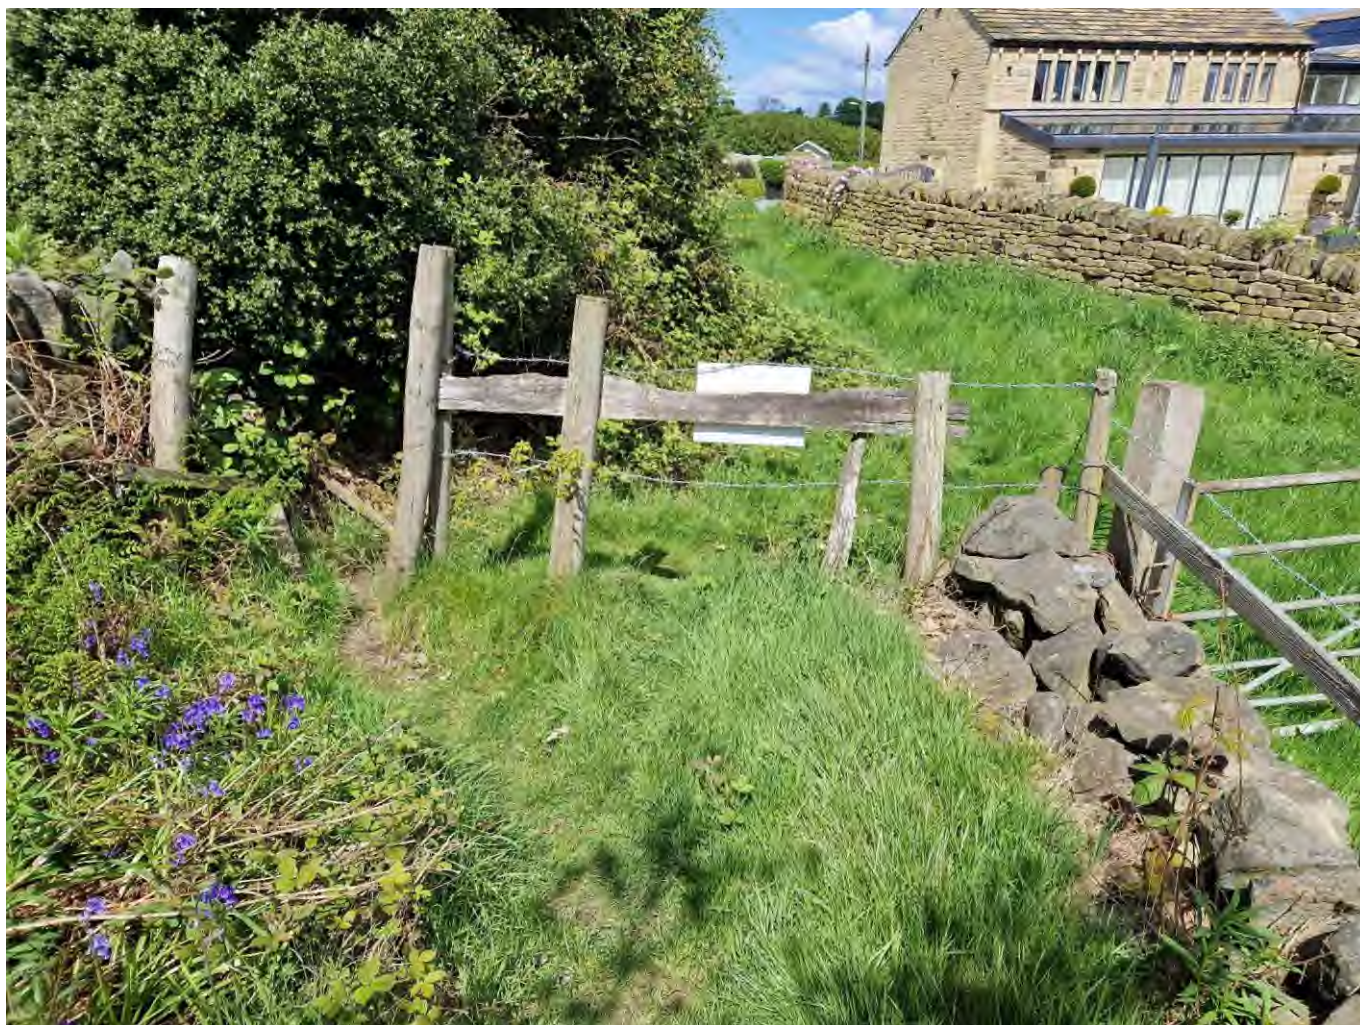
*Photo 21: At its junction with Crab Lane, the Order route is limited by a wooden fence/squeeze stile structure lined with barbed wire, with a gap on its western side (Grid Reference SE 1718 1273).*
