## **Appendix B – Photos of Order Route**

**Wildlife & Countryside Act 1981 – Section 53  
West Yorkshire County Council Definitive Map and  
Statement for the Kirklees Area**

**Kirklees Council (Kirkburton 256 – Moor Lane) Definitive Map  
Modification Order 2024**

## Photos (1-25) dated 22.07.23

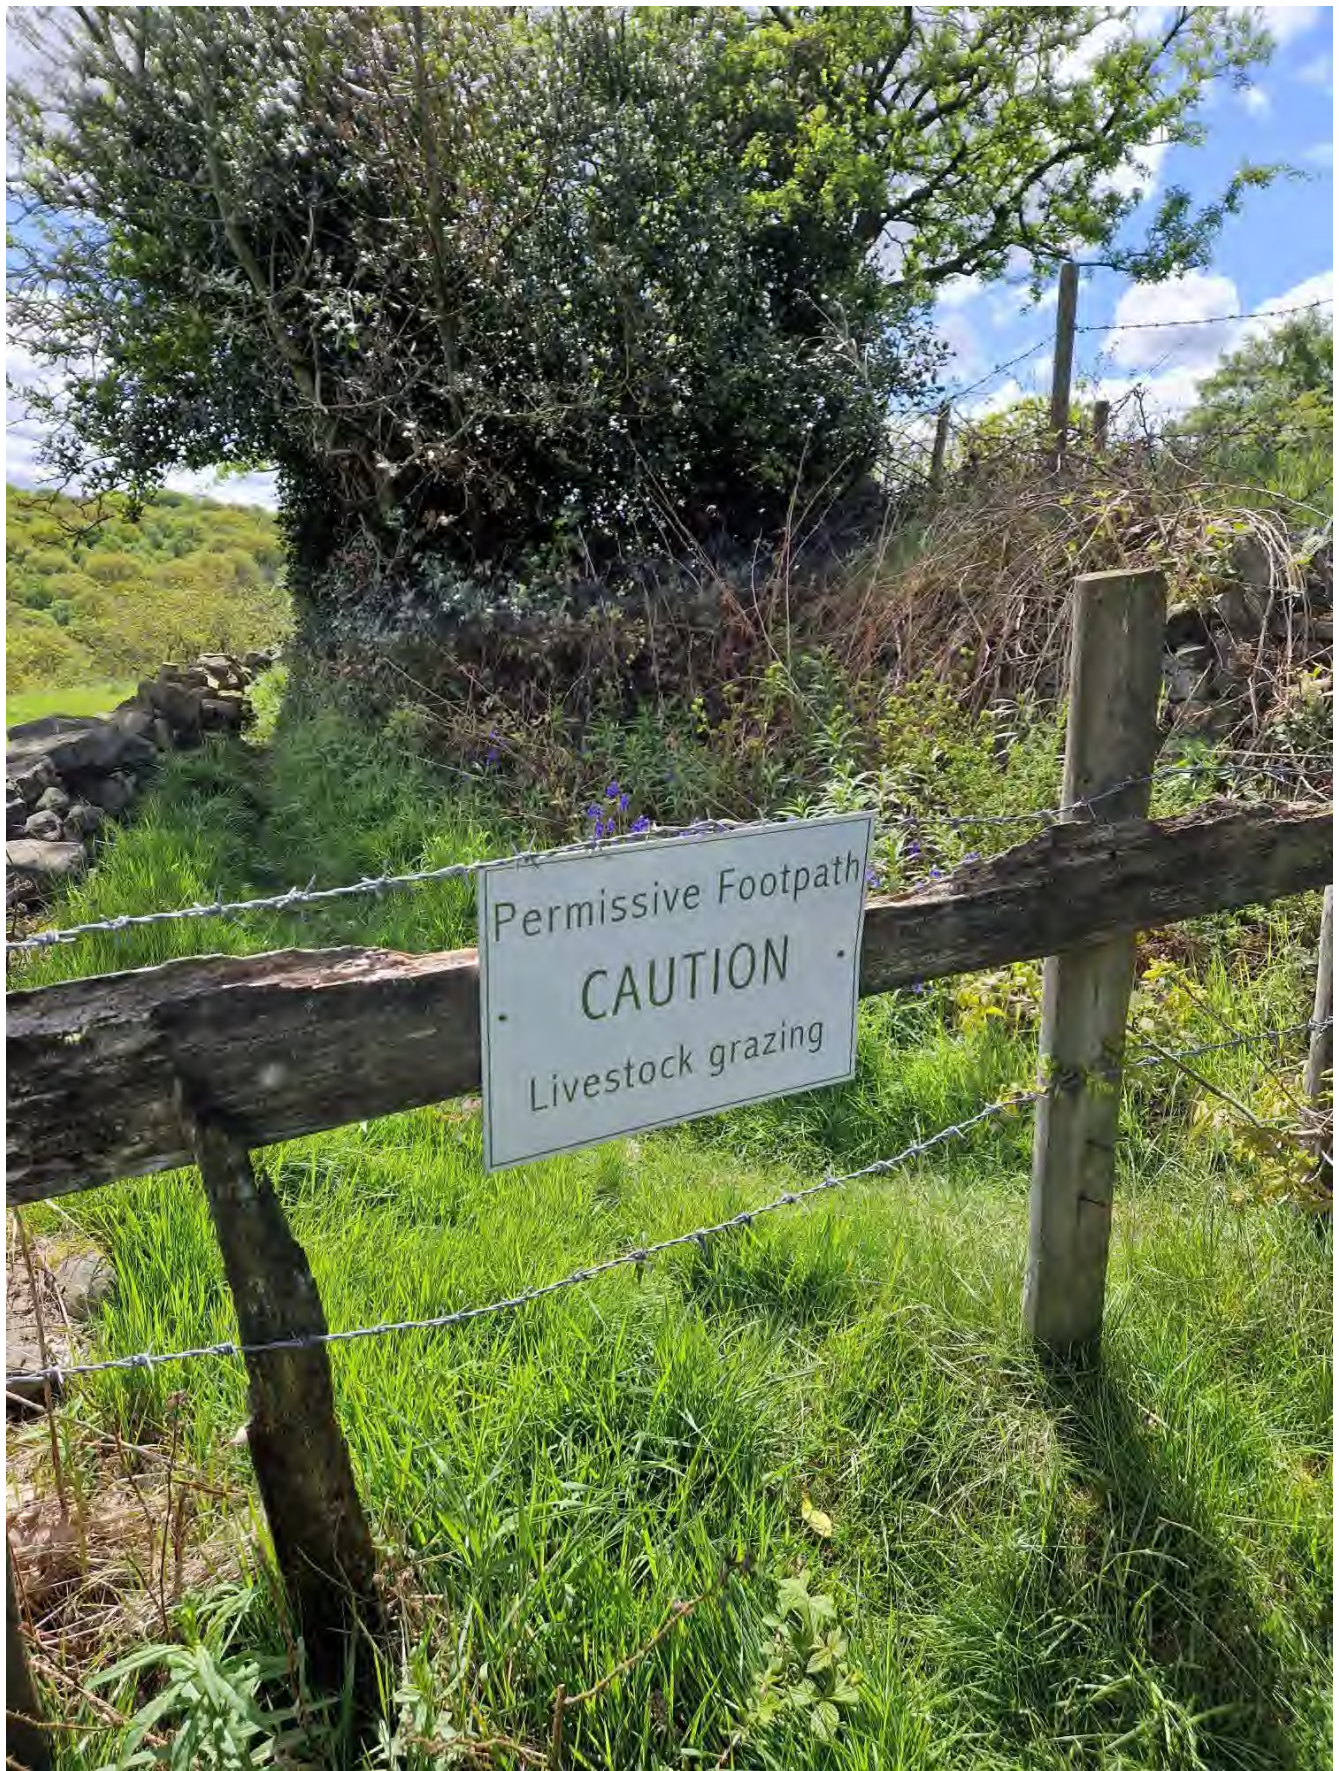
*Photo 22: Sign on fourth wooden stile structure states, "Permissive Footpath CAUTION Livestock grazing", and was recently erected in approximately 2020.*

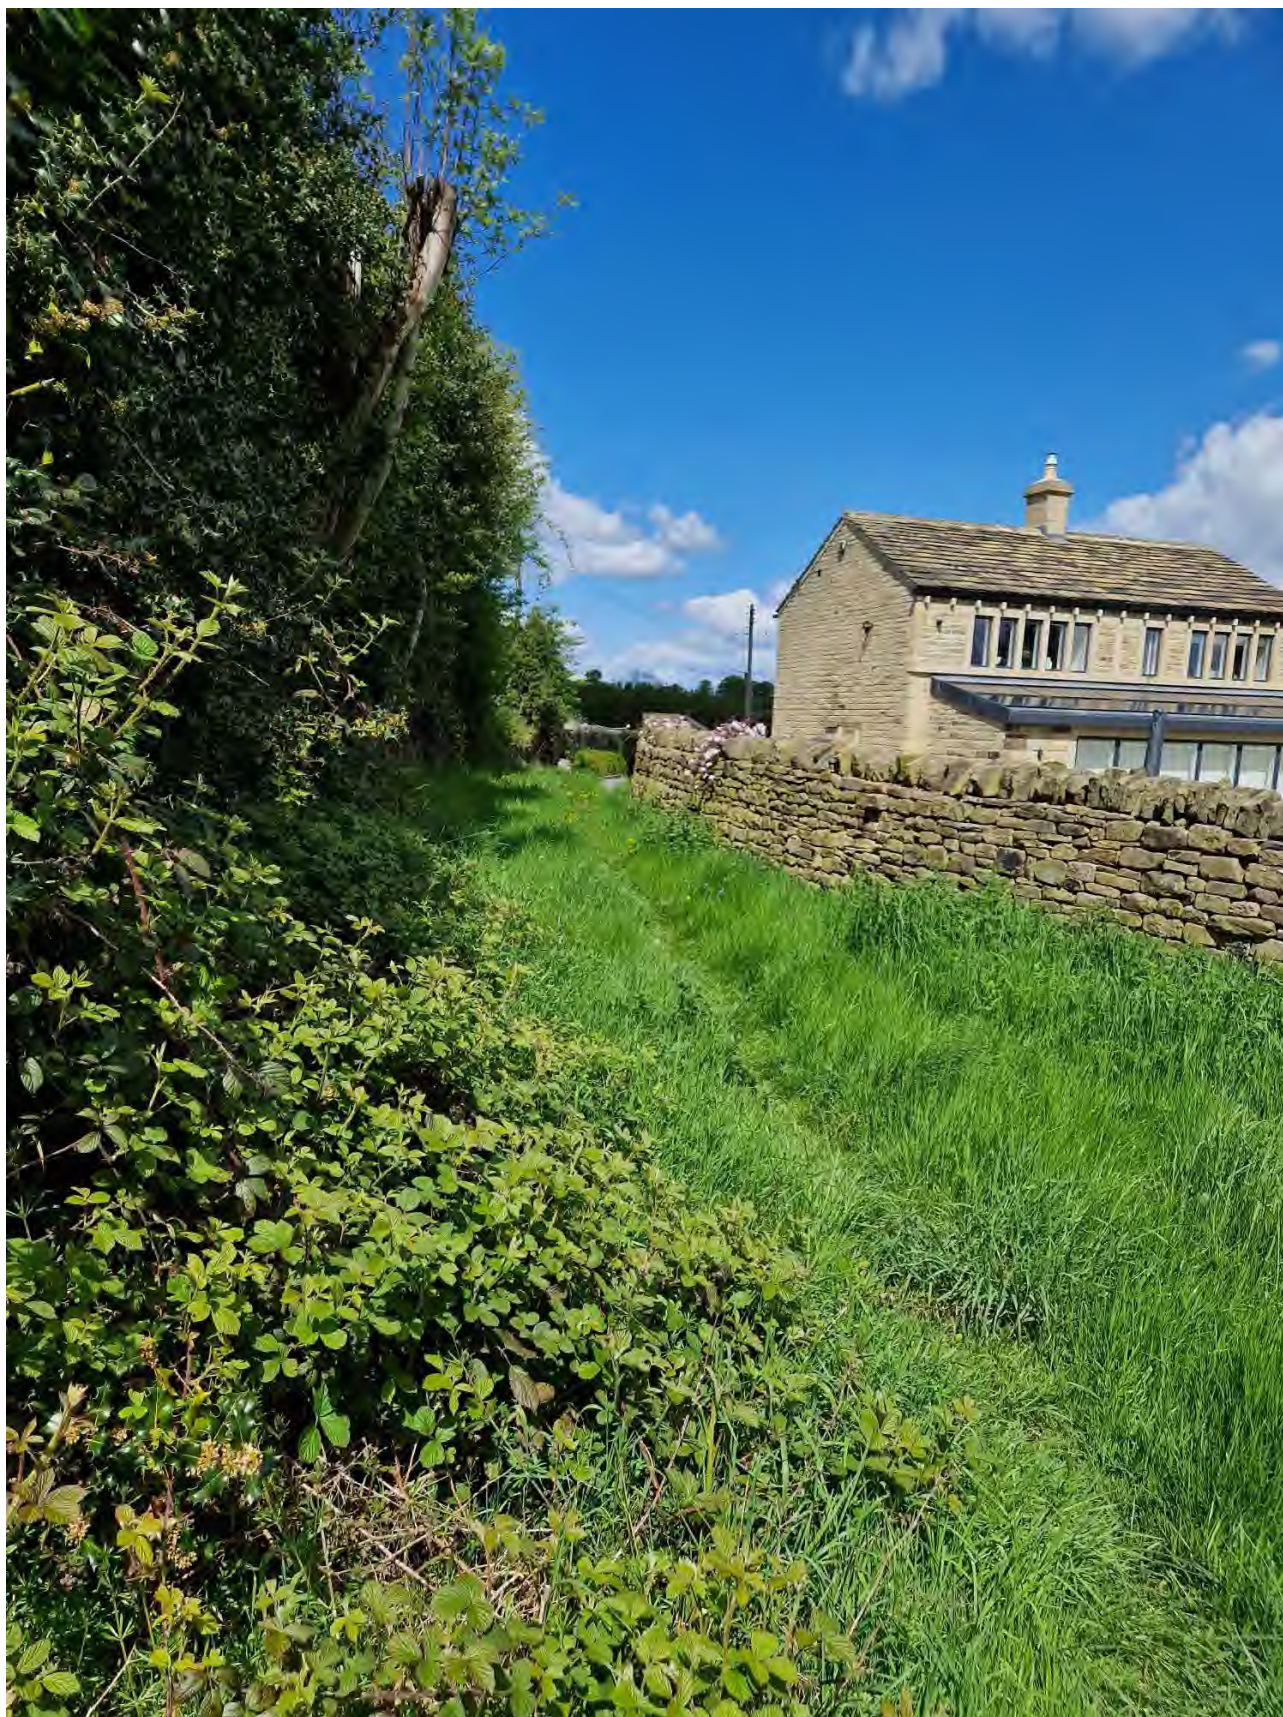
*Photo 23: Order route continues northerly from its junction with Crab Lane as a wide grassy route towards its junction with Manor Road.*

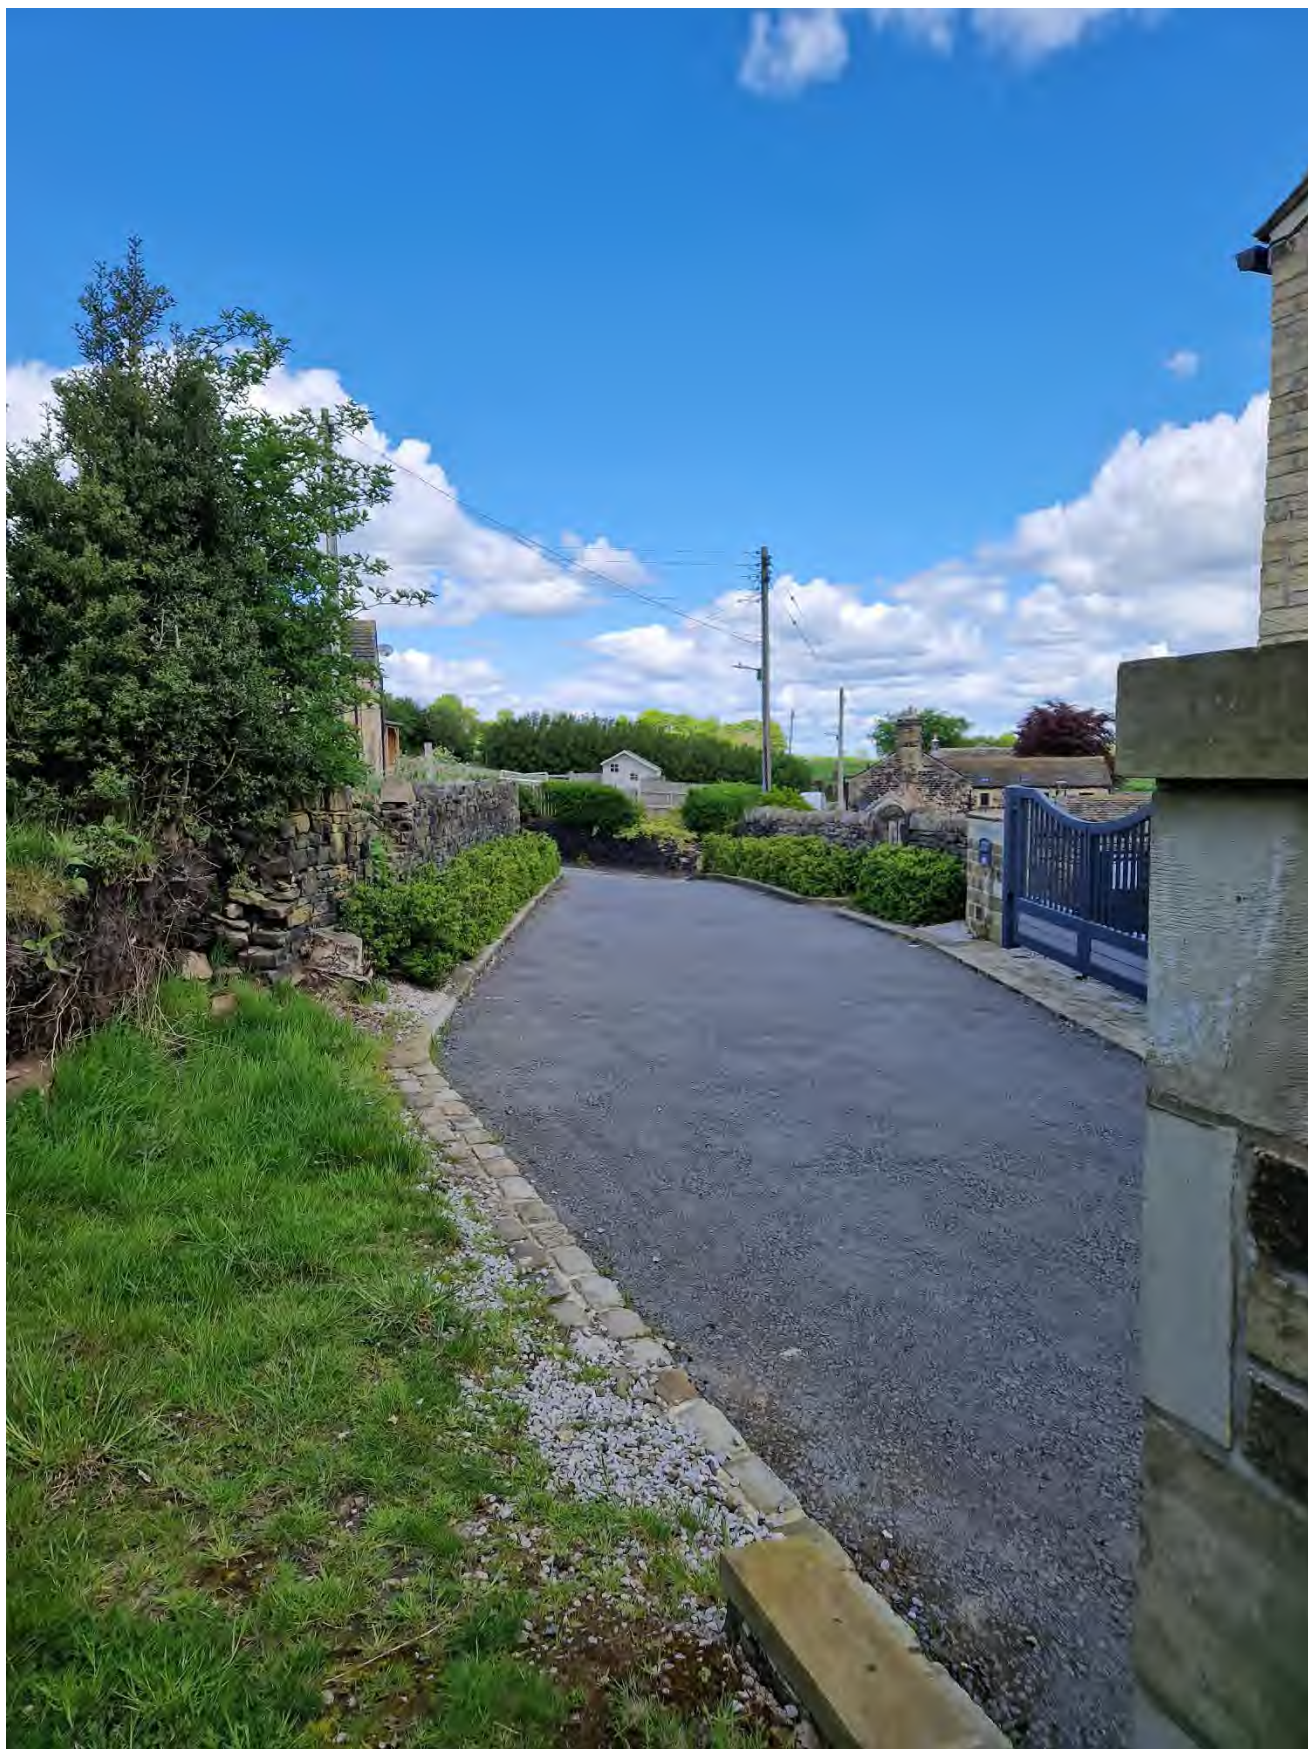
*Photo 24: Order route continues northerly along tarmac driveway leading to No. 40 Manor Road, recently laid in approximately 2015.*

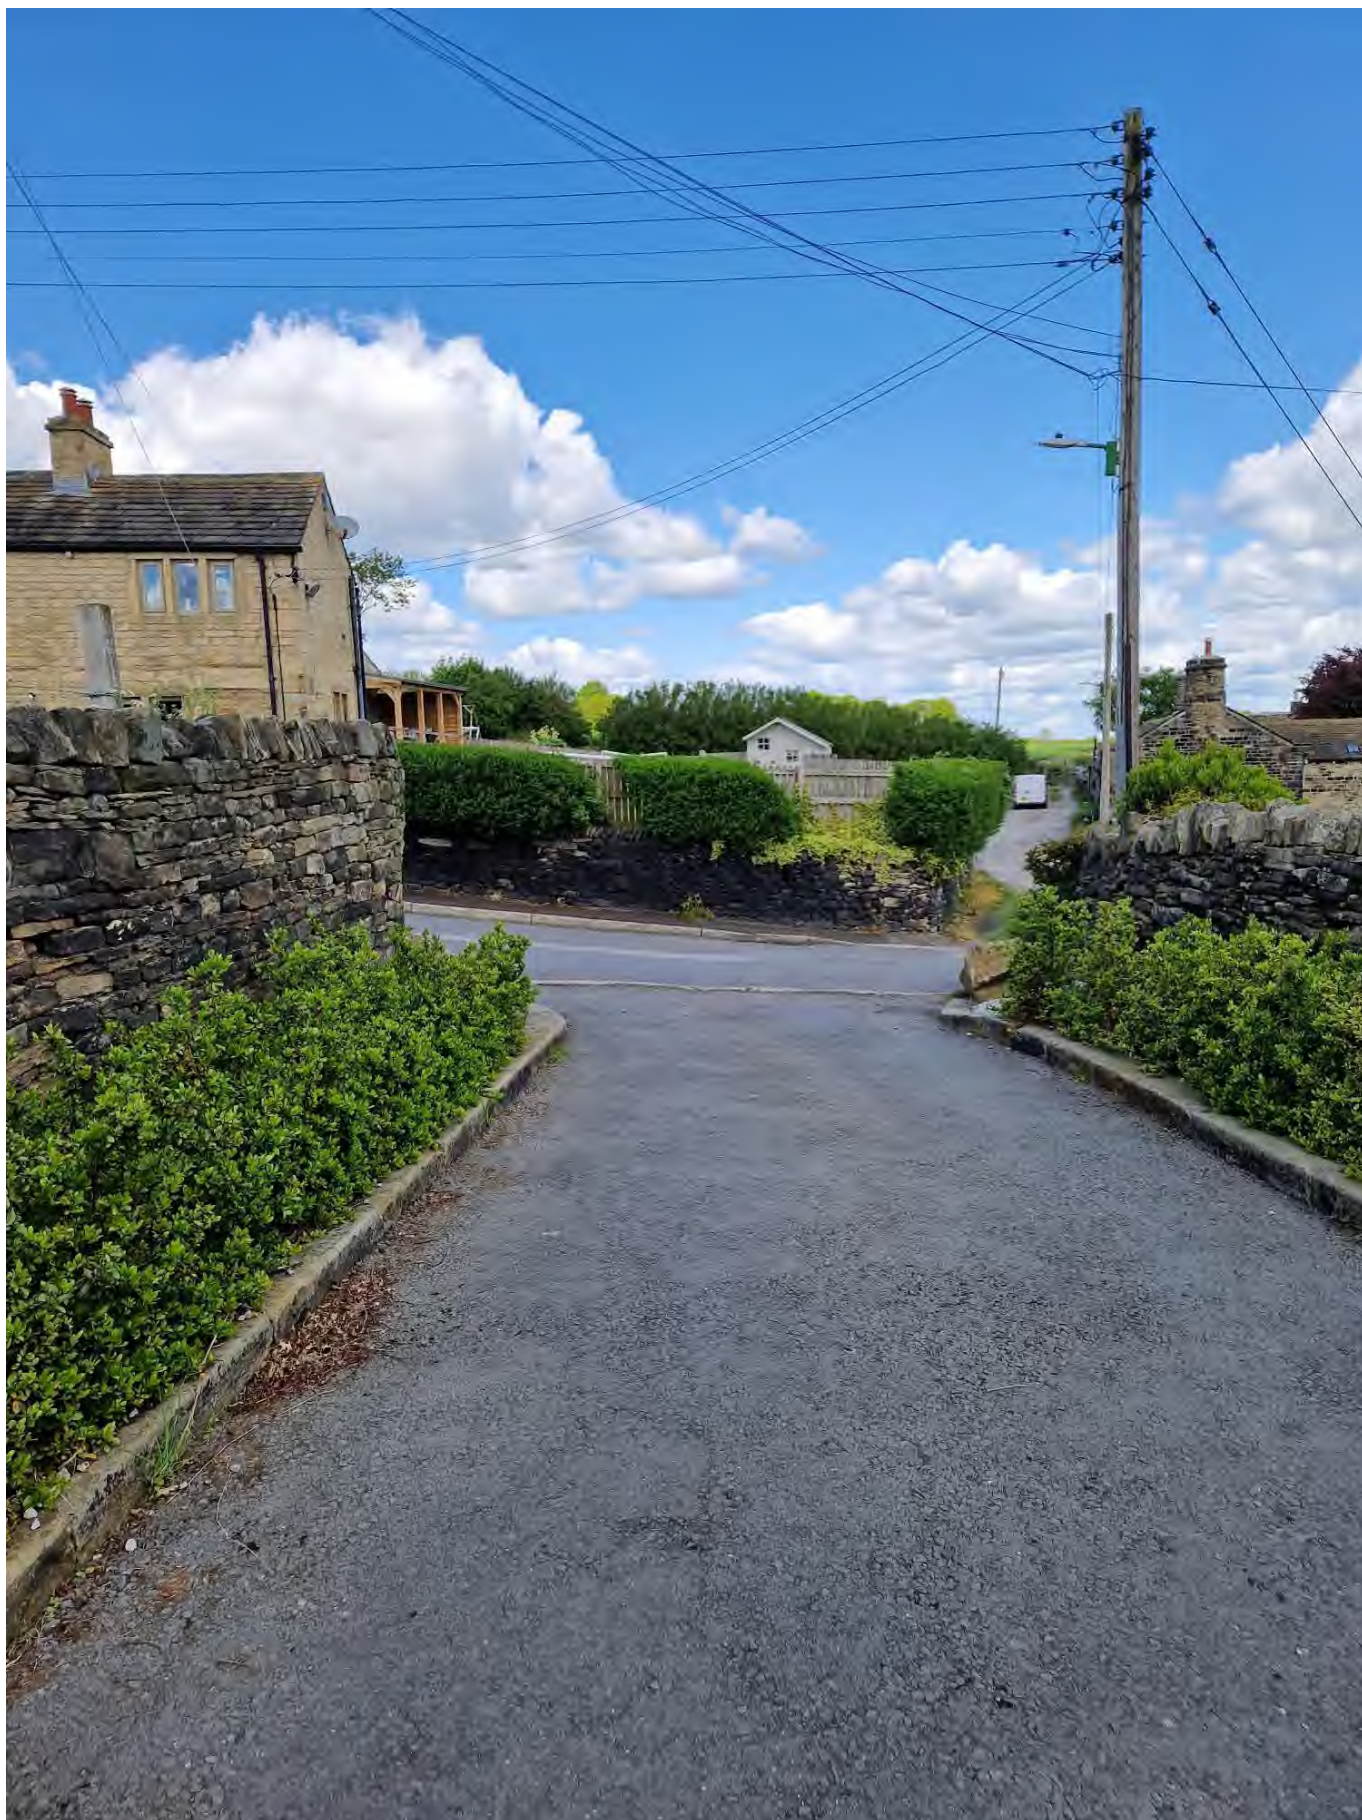
*Photo 25: Order route joins Manor Road (Point A on the Order Map).*

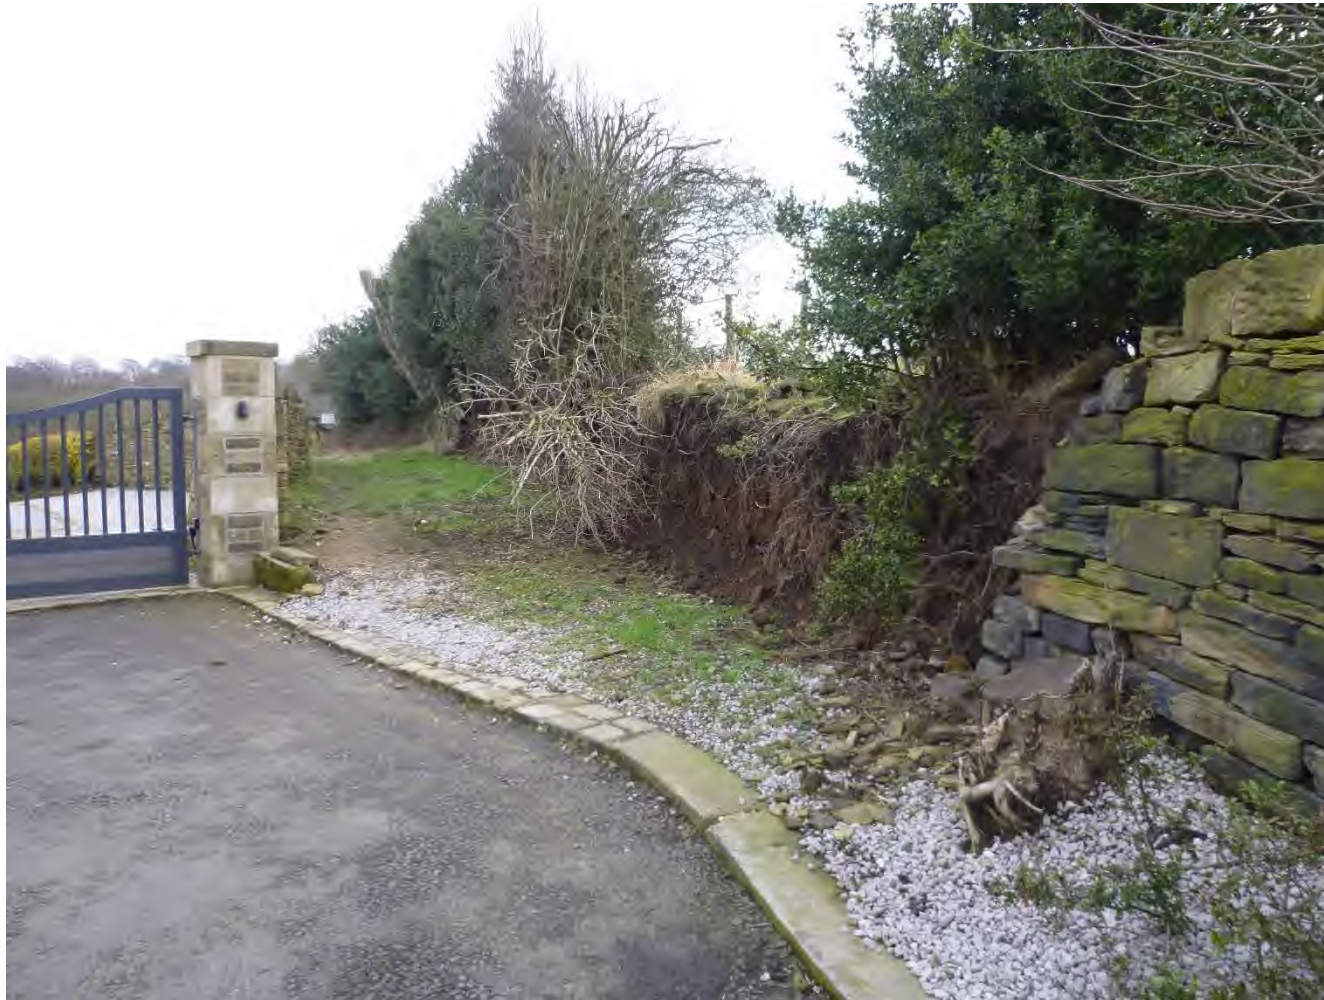
*Photo 26: Leading southerly along Order route passed No. 40 Manor Road*

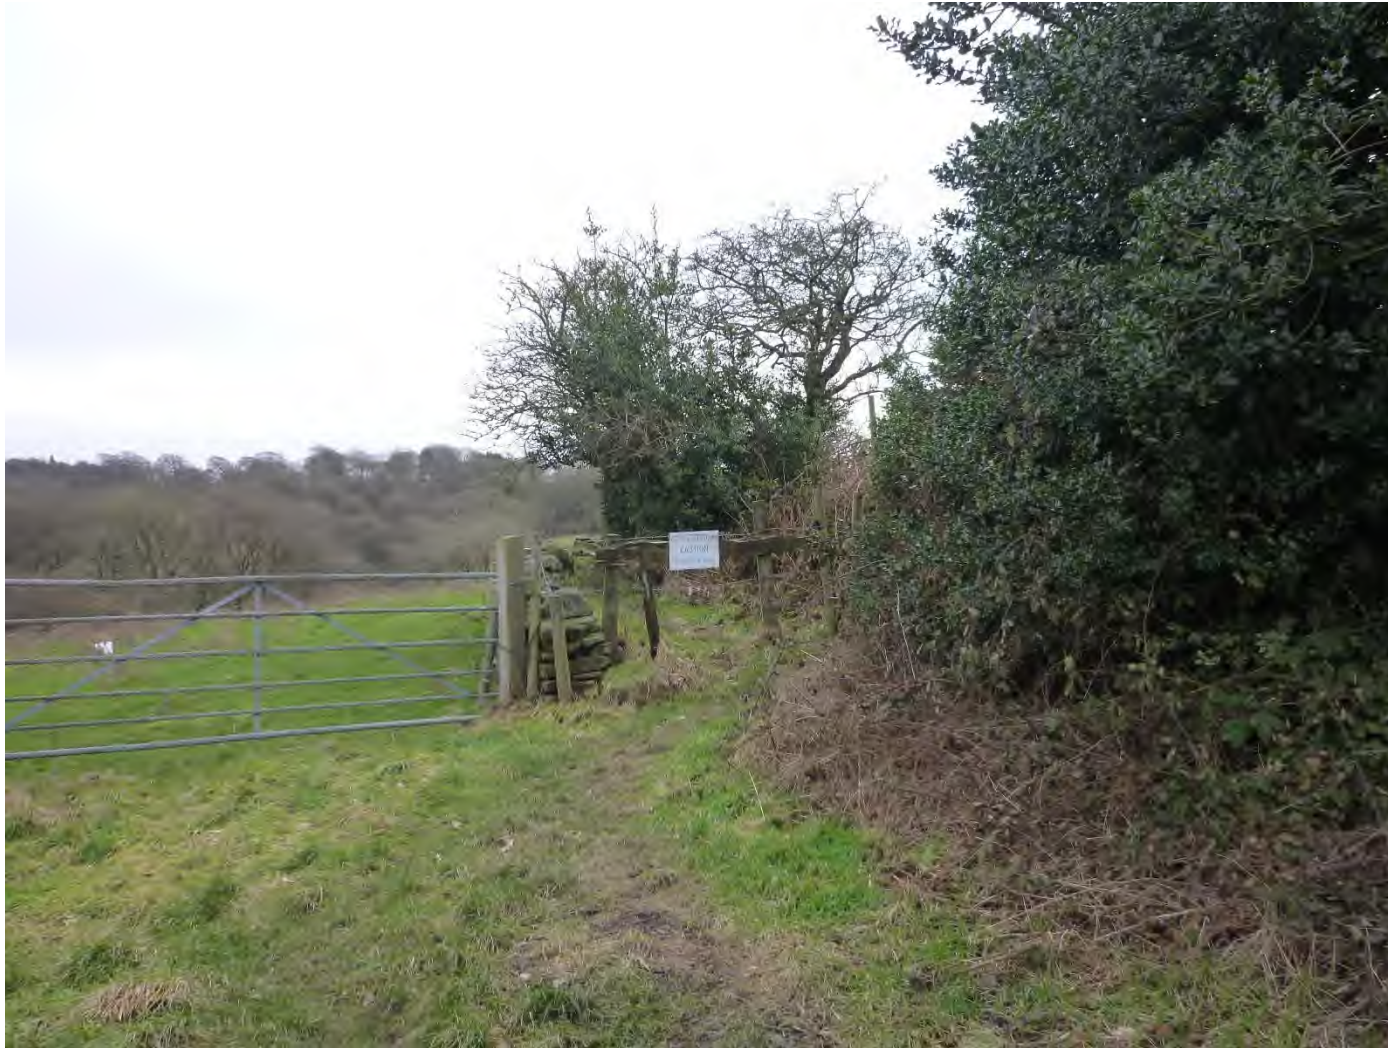
*Photo 27: At the Order routes junction with Crab Lane. 'Fourth wooden stile' structure and first documentary image of sign stating, "Permissive Footpath CAUTION Livestock grazing".*

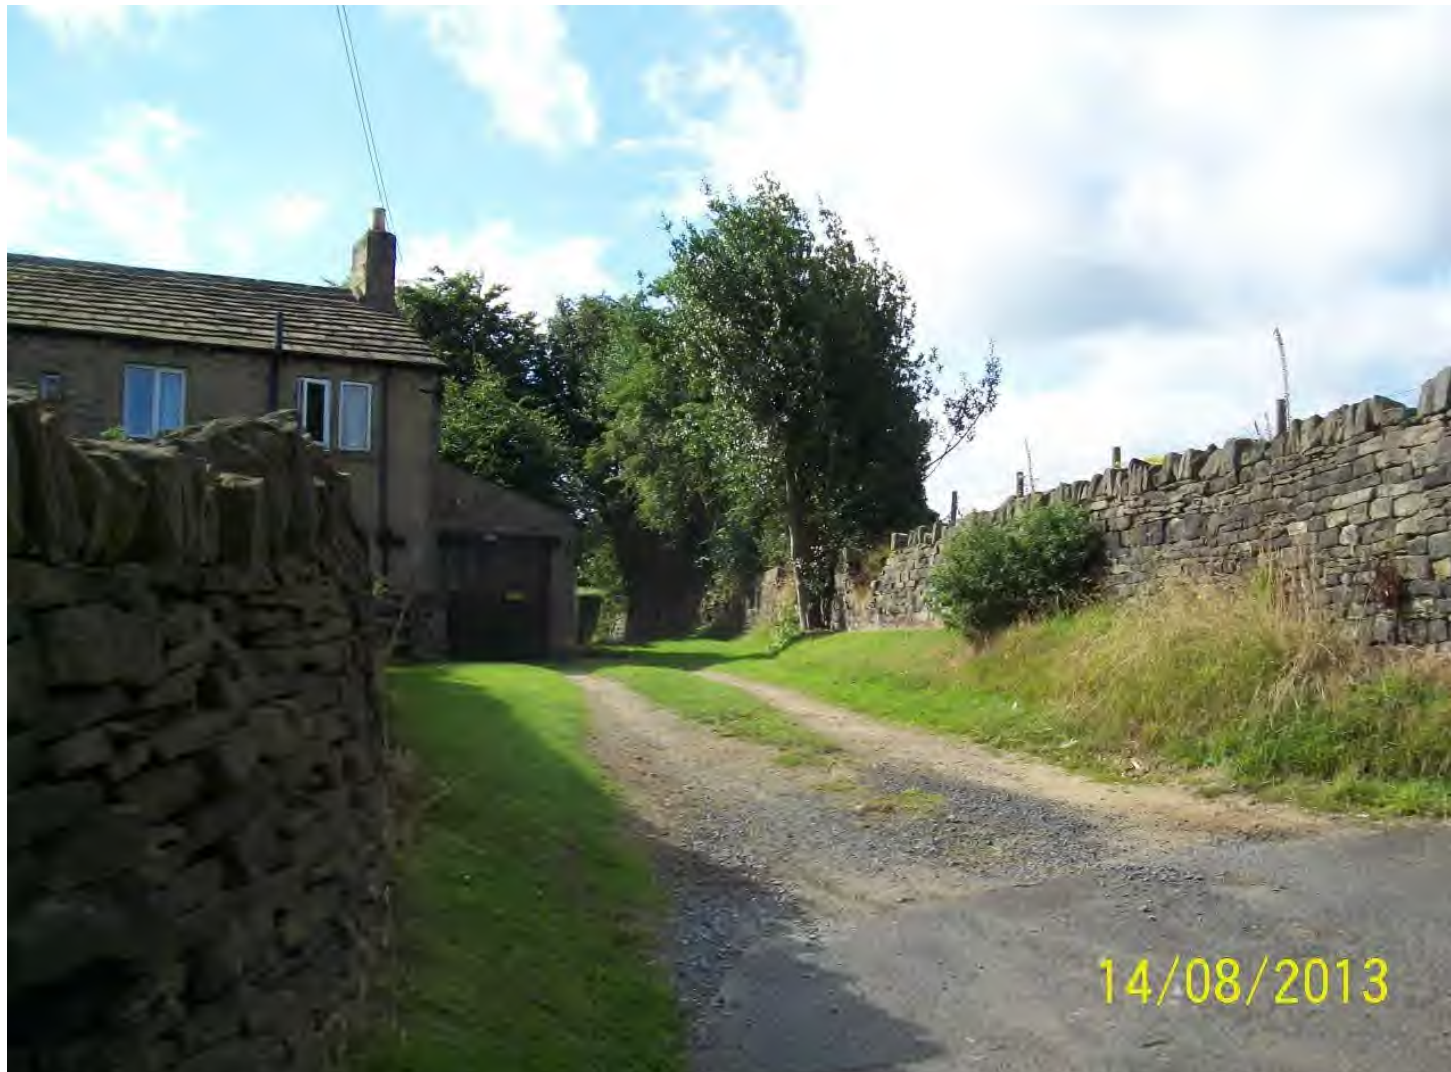
*Photo 28: Point A on the Order Map at its junction with Manor Road before part of the surface of the Order route was tarmacked.*

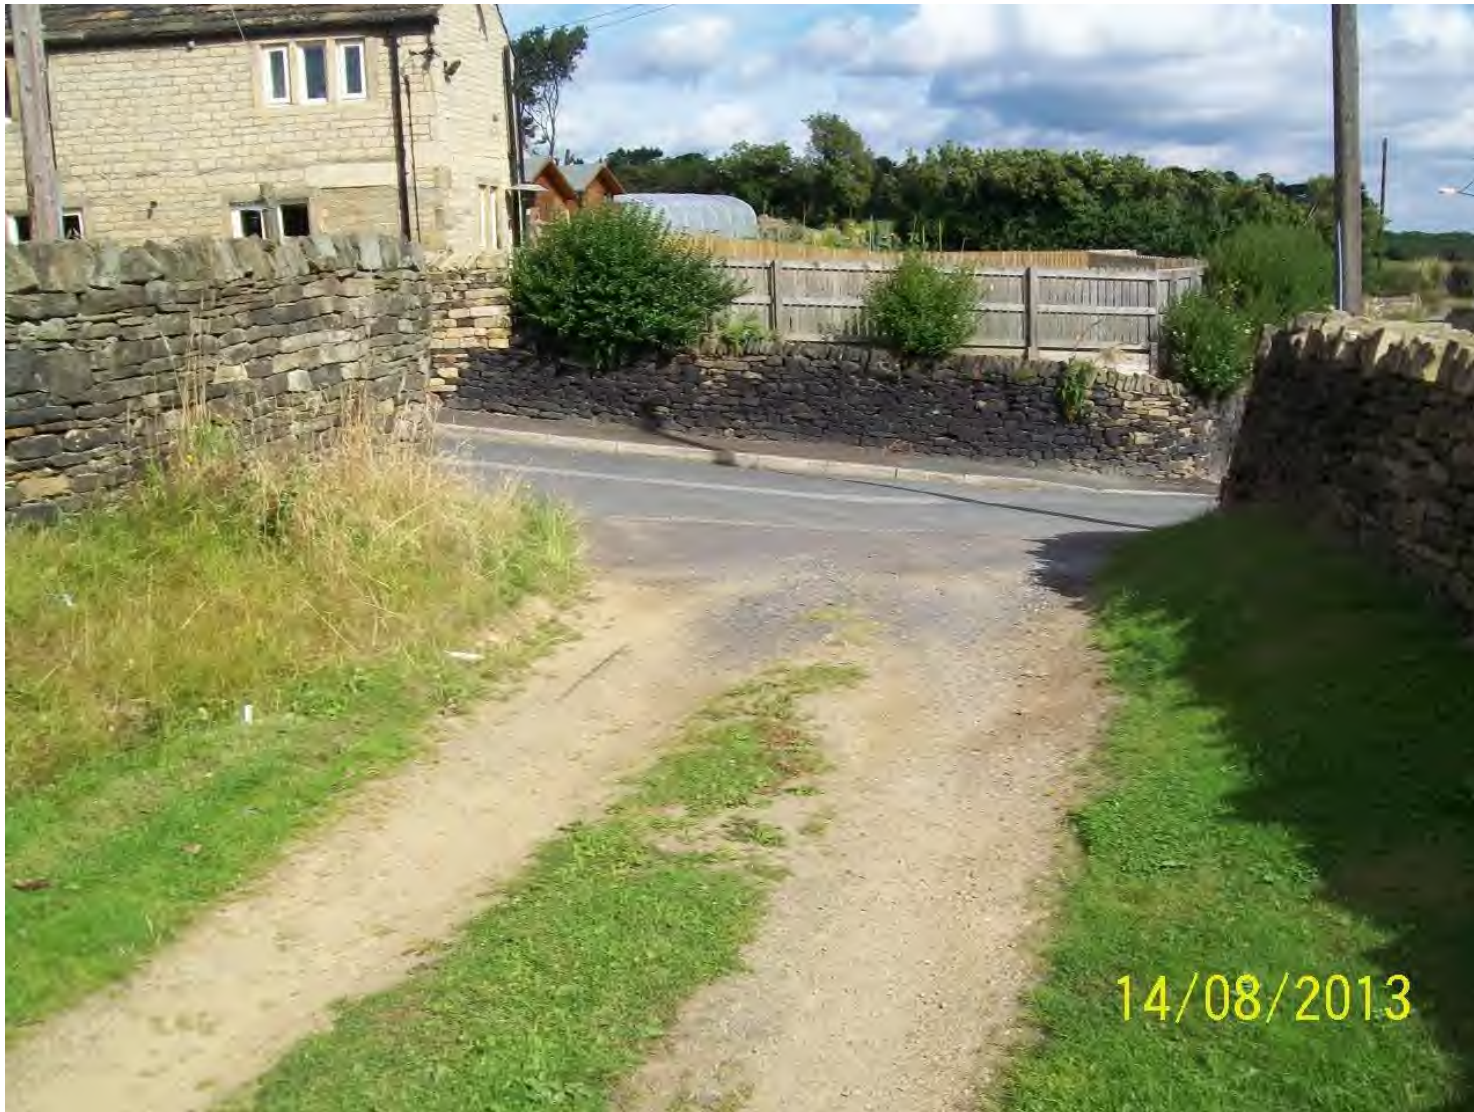
*Photo 29: Point A on the Order Map at the Order routes junction with Manor Road.*

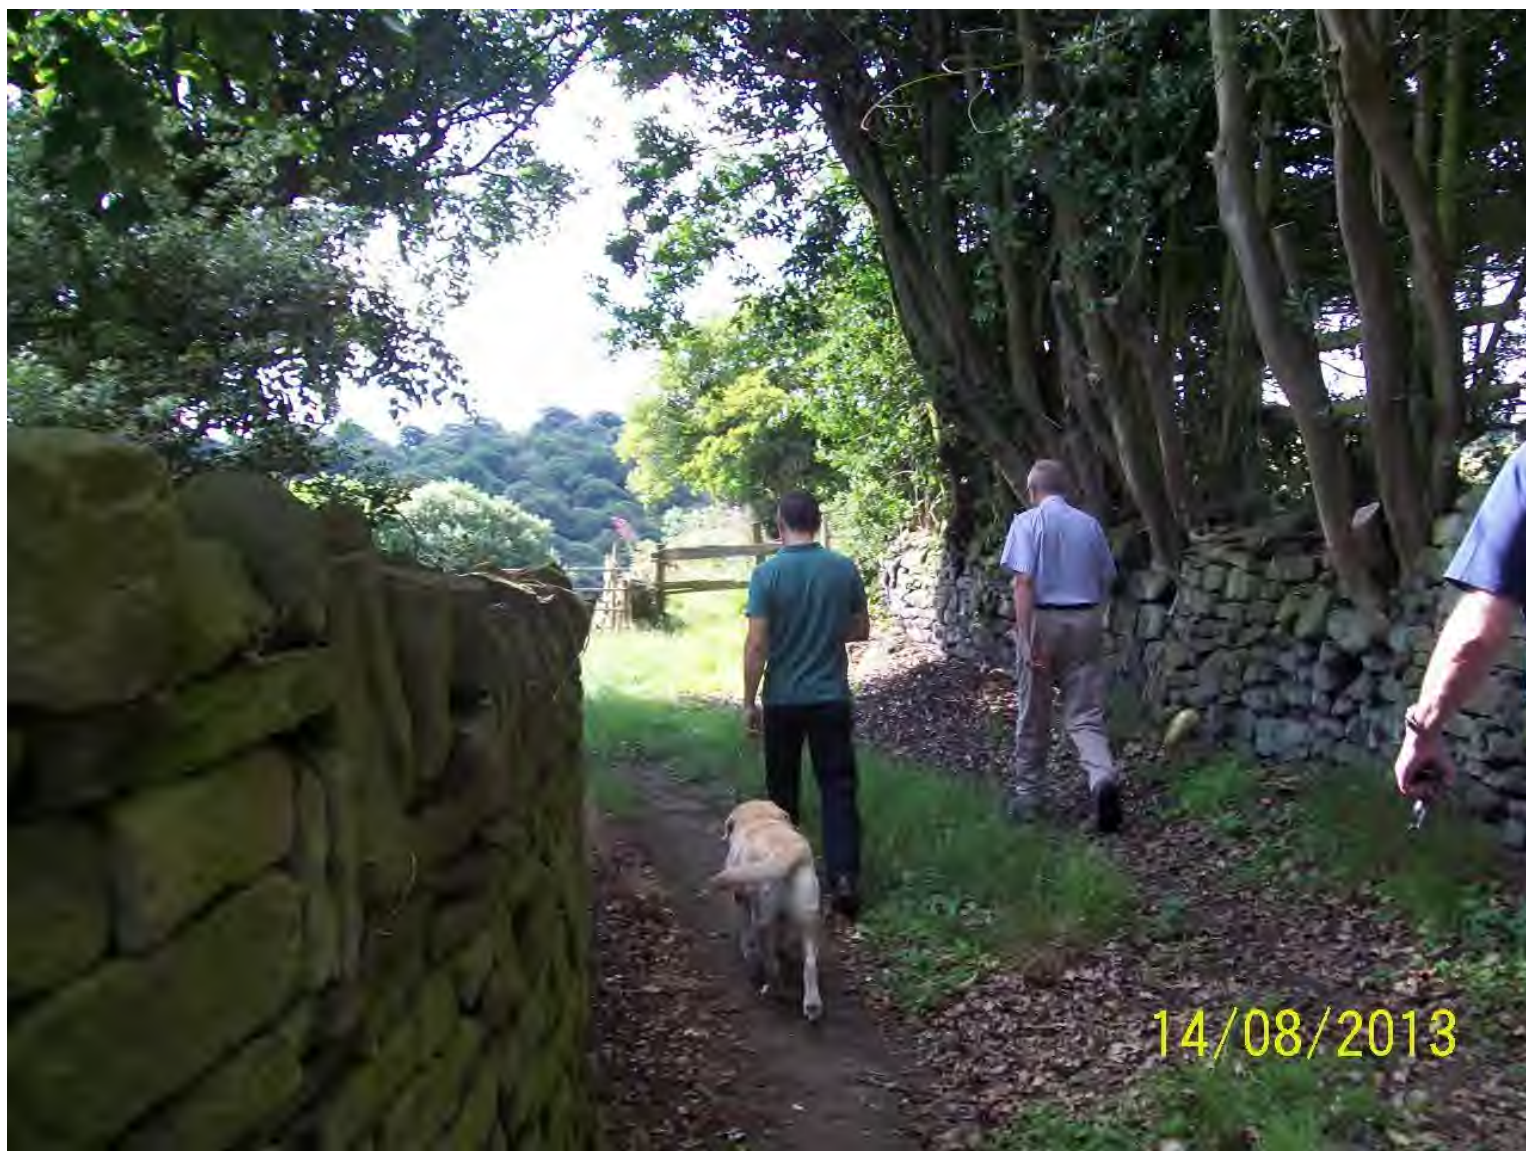
*Photo 30: Order route leads southerly to wooden stile structure.*

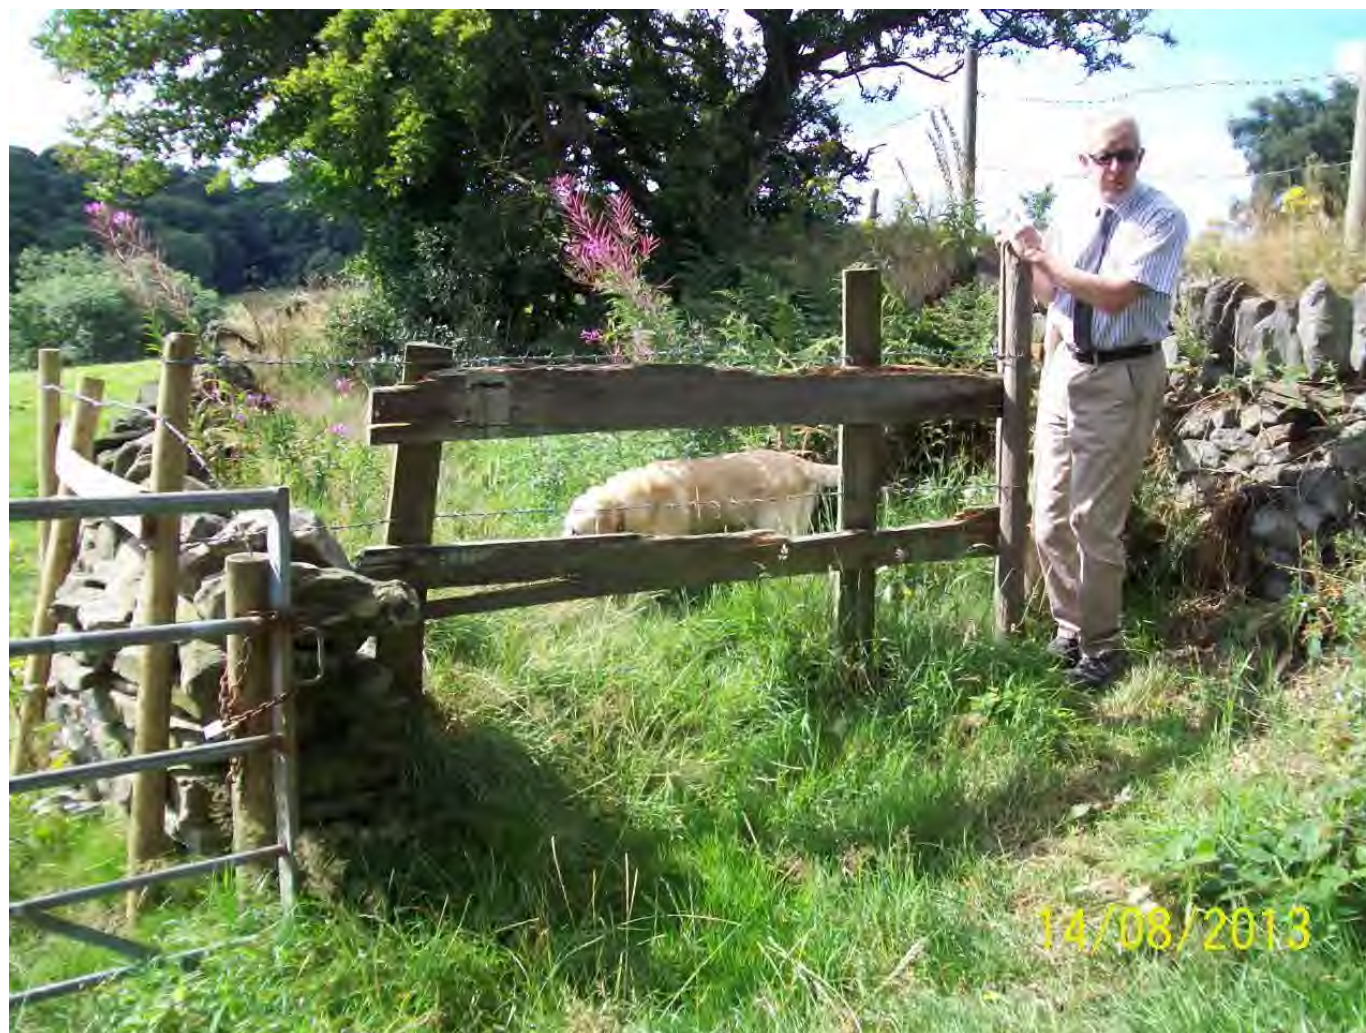
*Photo 31: 'Fourth wooden stile' structure across the Order route at its junction with Crab Lane  
(Grid Reference SE 1718 1273)*

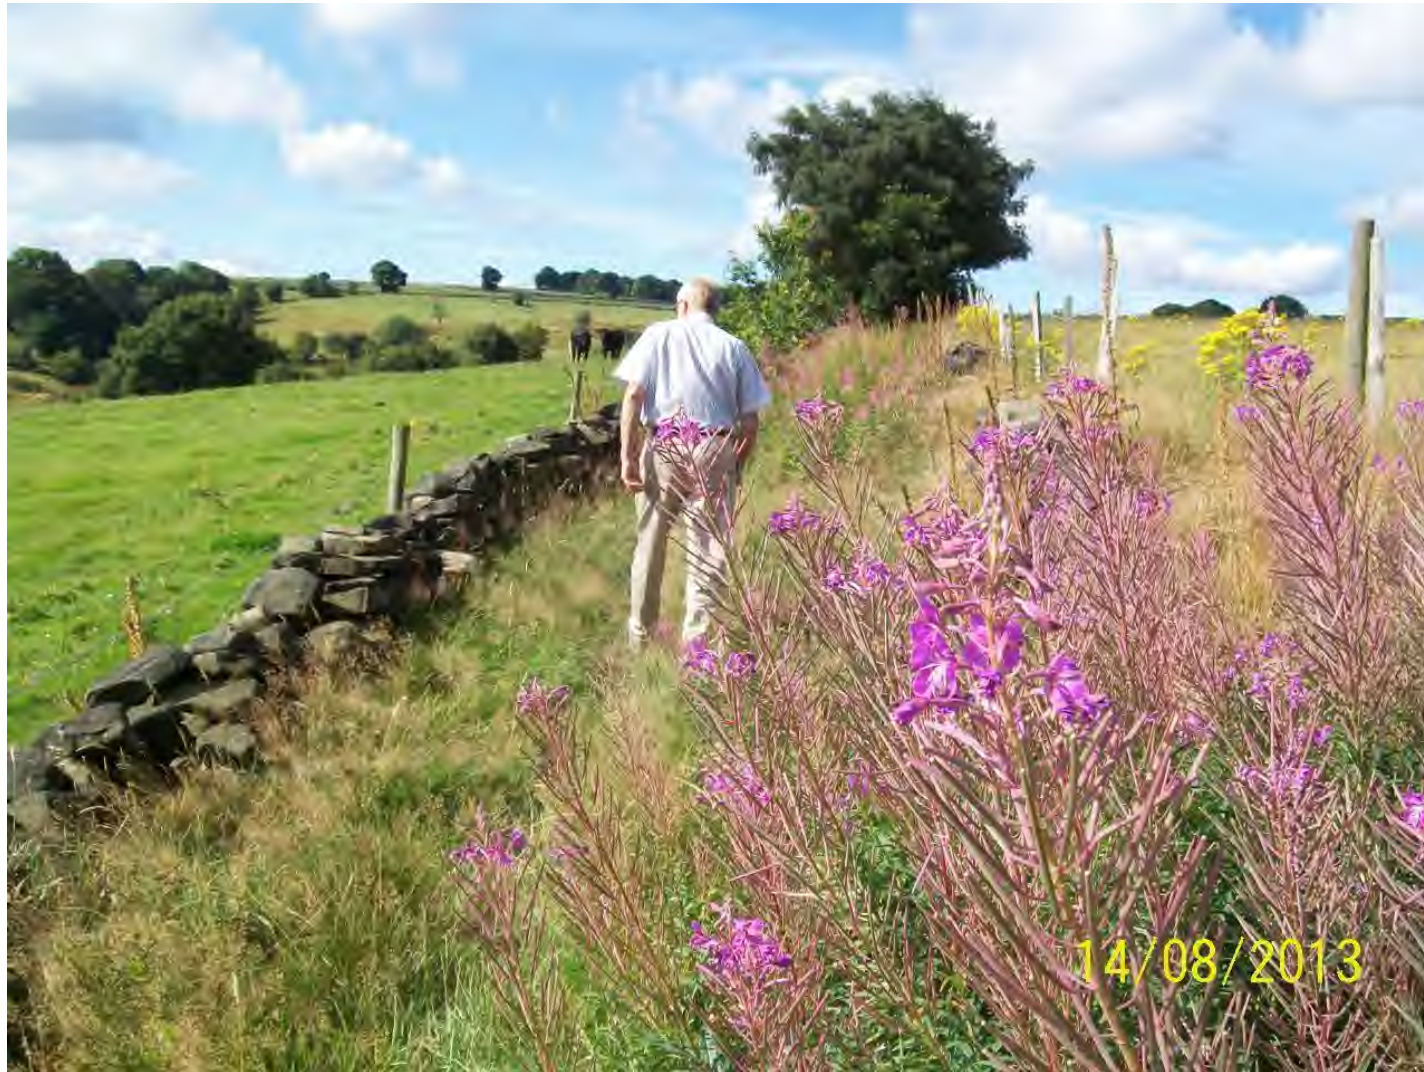
*Photo 32: Order route leads westerly. Livestock present in adjacent southern field.*

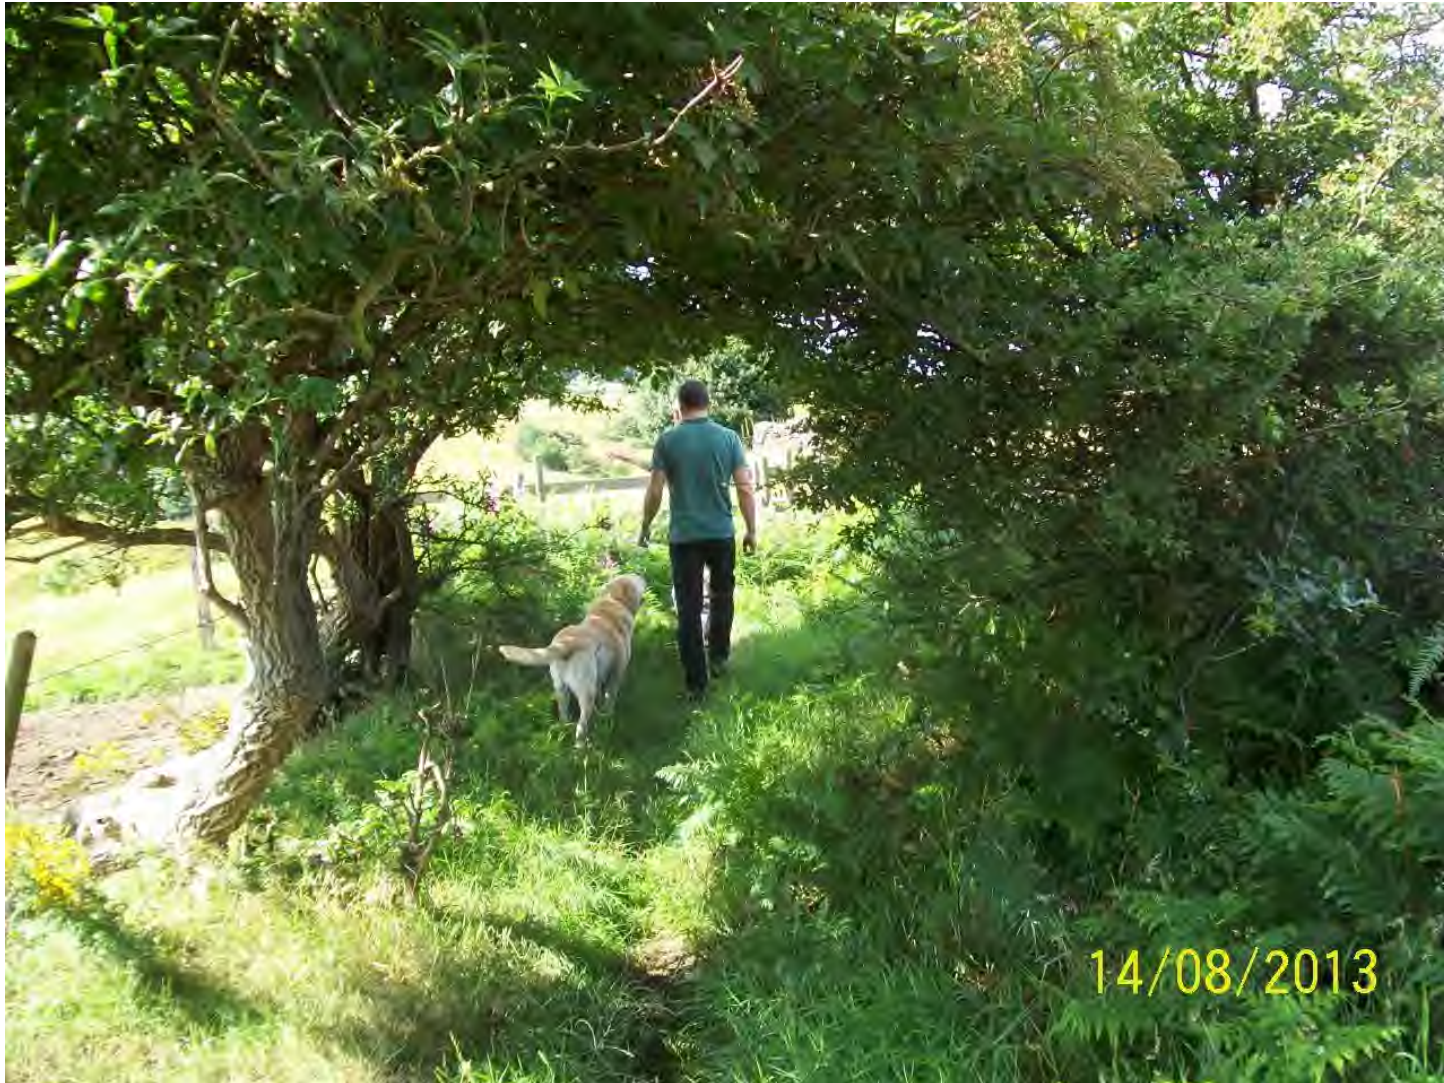
*Photo 33: Order route continues westerly towards wooden stile structure and is limited by trees and overgrown vegetation.*

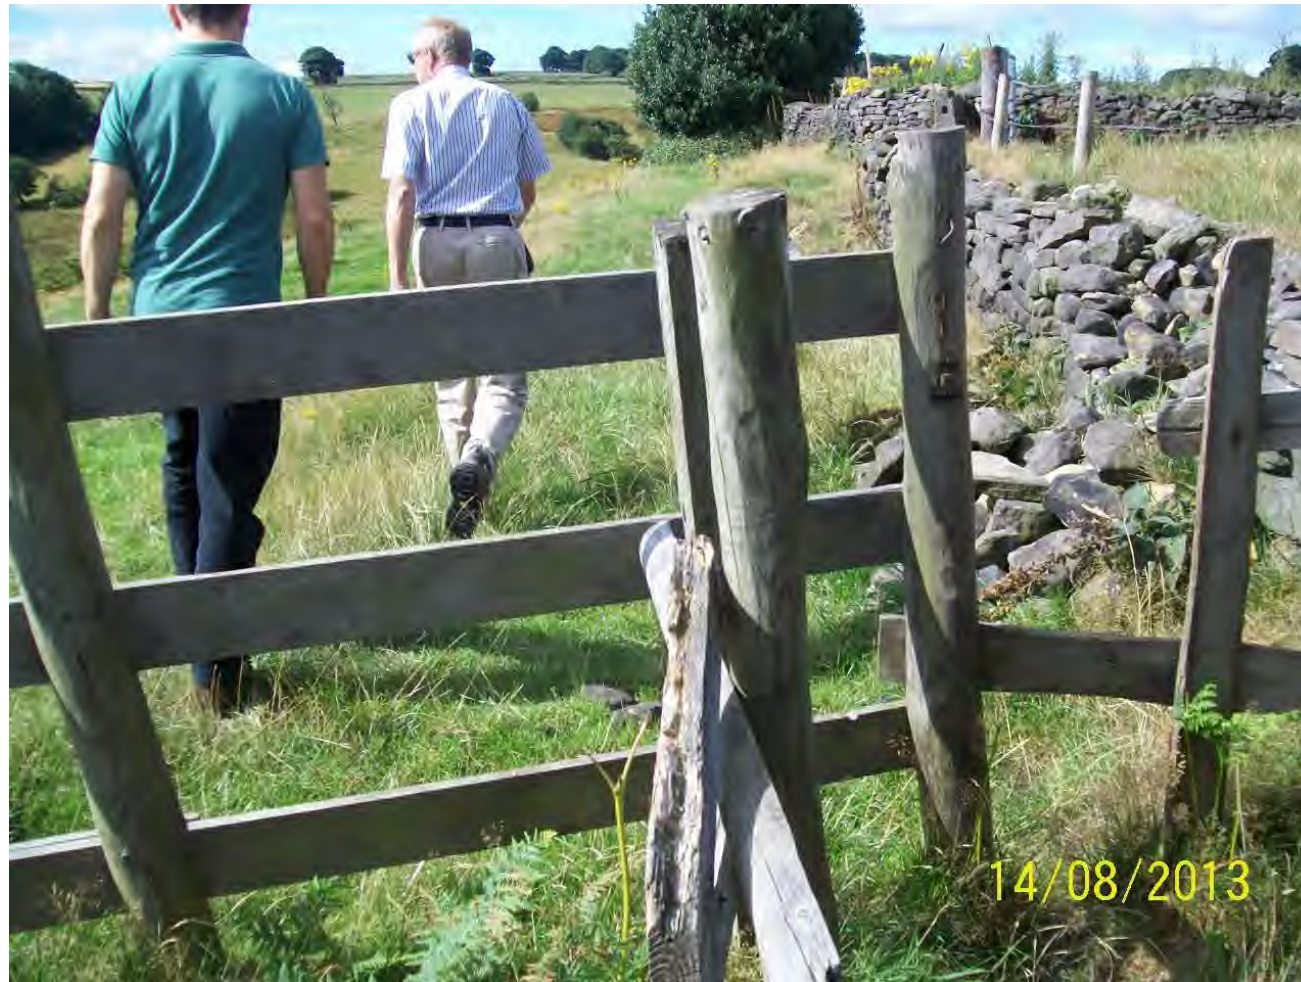
*Photo 34: Close-up of 'third wooden stile' structure and overgrown tree in the background (Grid Reference SE 1708 1273).*
