## **Appendix B – Photos of Order Route**

**Wildlife & Countryside Act 1981 – Section 53  
West Yorkshire County Council Definitive Map and  
Statement for the Kirklees Area**

**Kirklees Council (Kirkburton 256 – Moor Lane) Definitive Map  
Modification Order 2024**

## Photos (1-25) dated 22.07.23

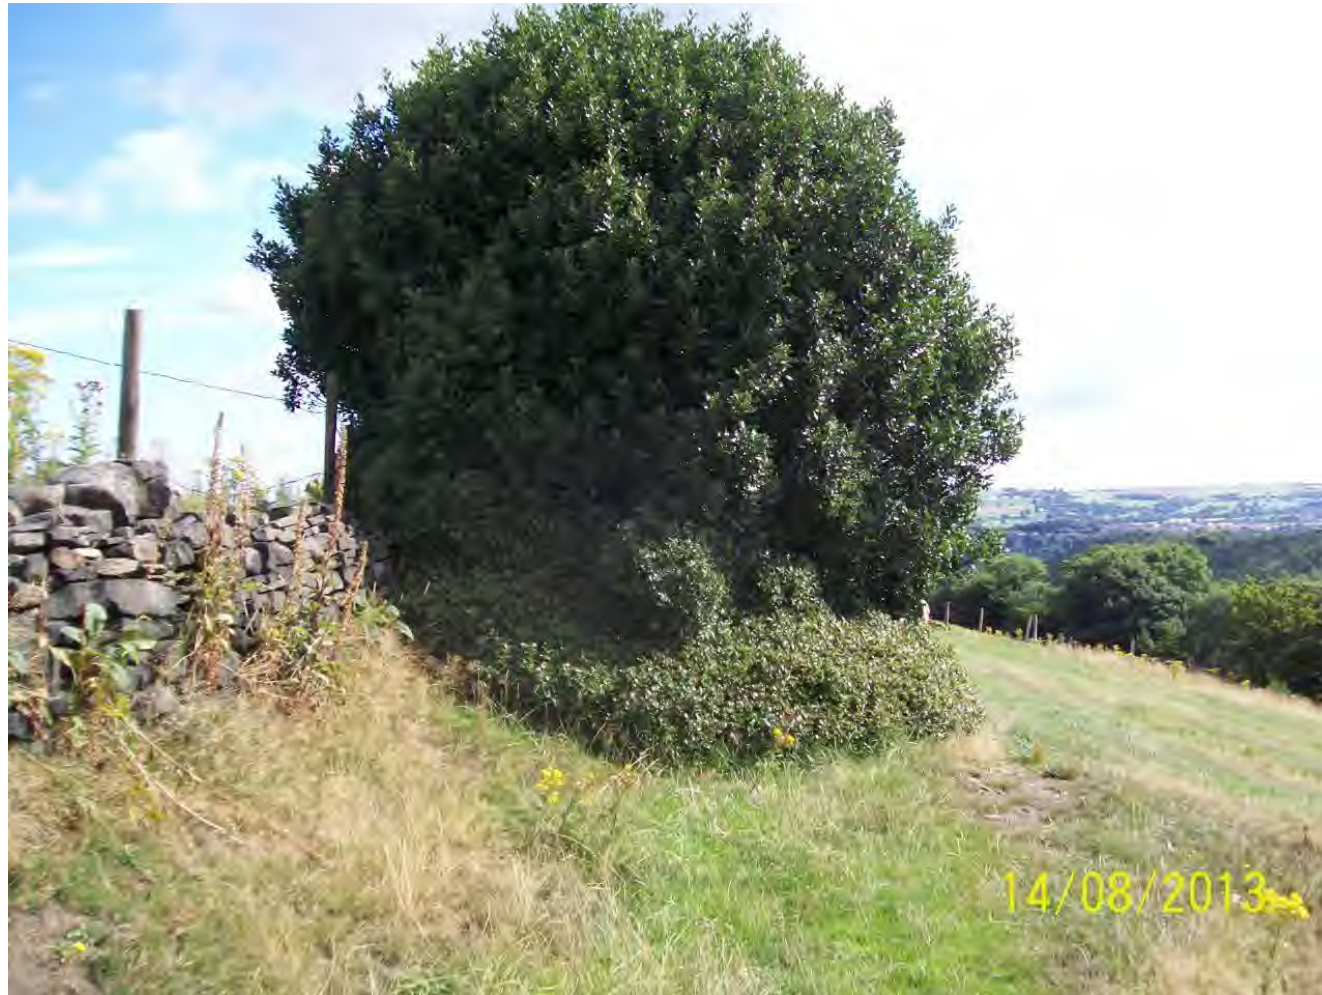
*Photo 35: Photo taken looking easterly along Order route showing overgrown tree obstructing use of the Order route.*

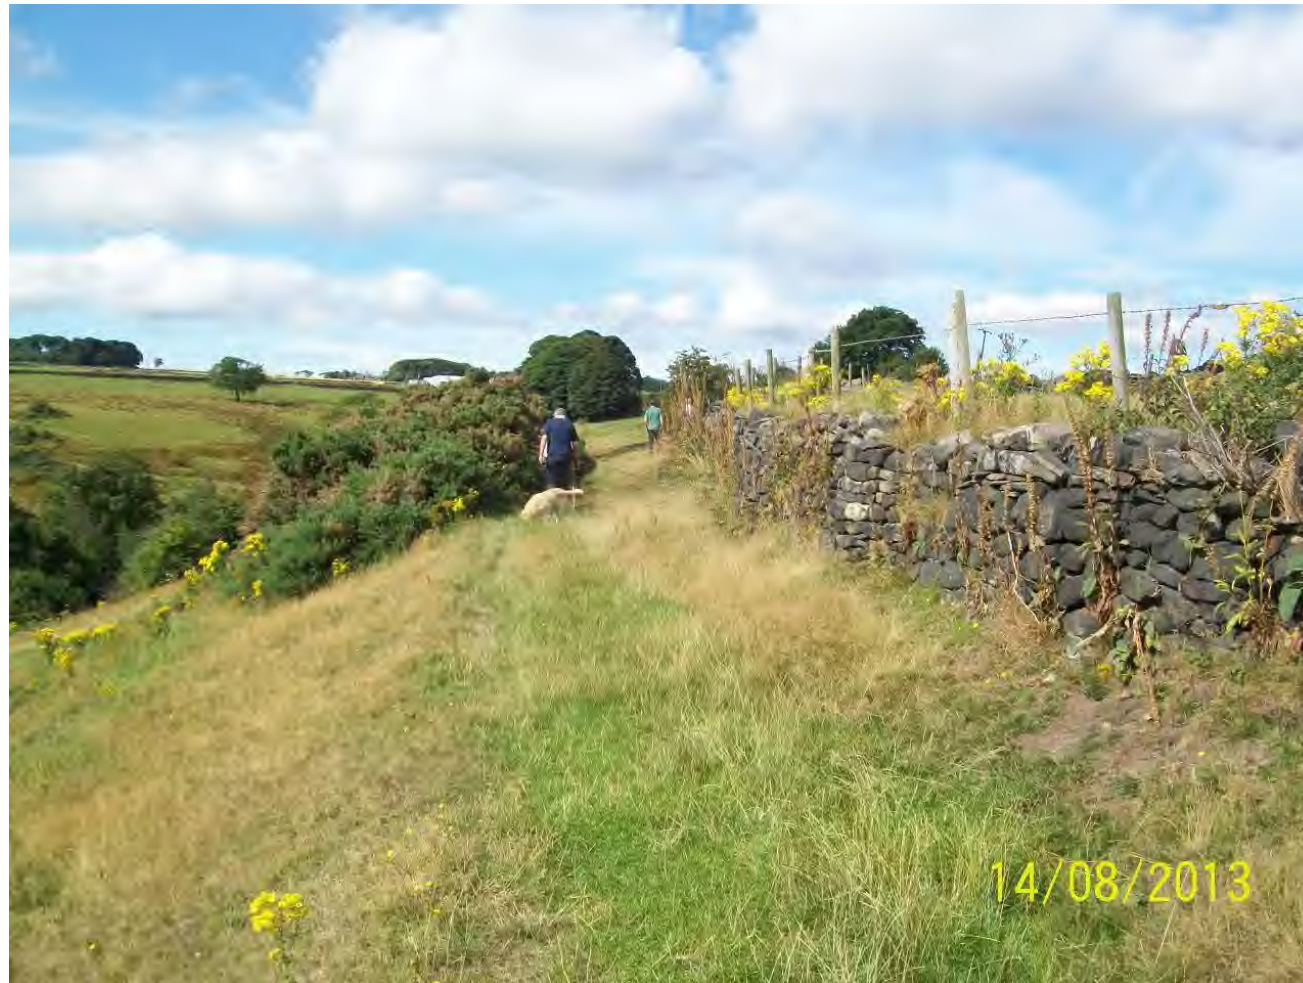
*Photo 36: Order route continues westerly bounded by a drystone wall on its northern side and unenclosed on its southern side with a relatively steep decline into the adjacent field.*

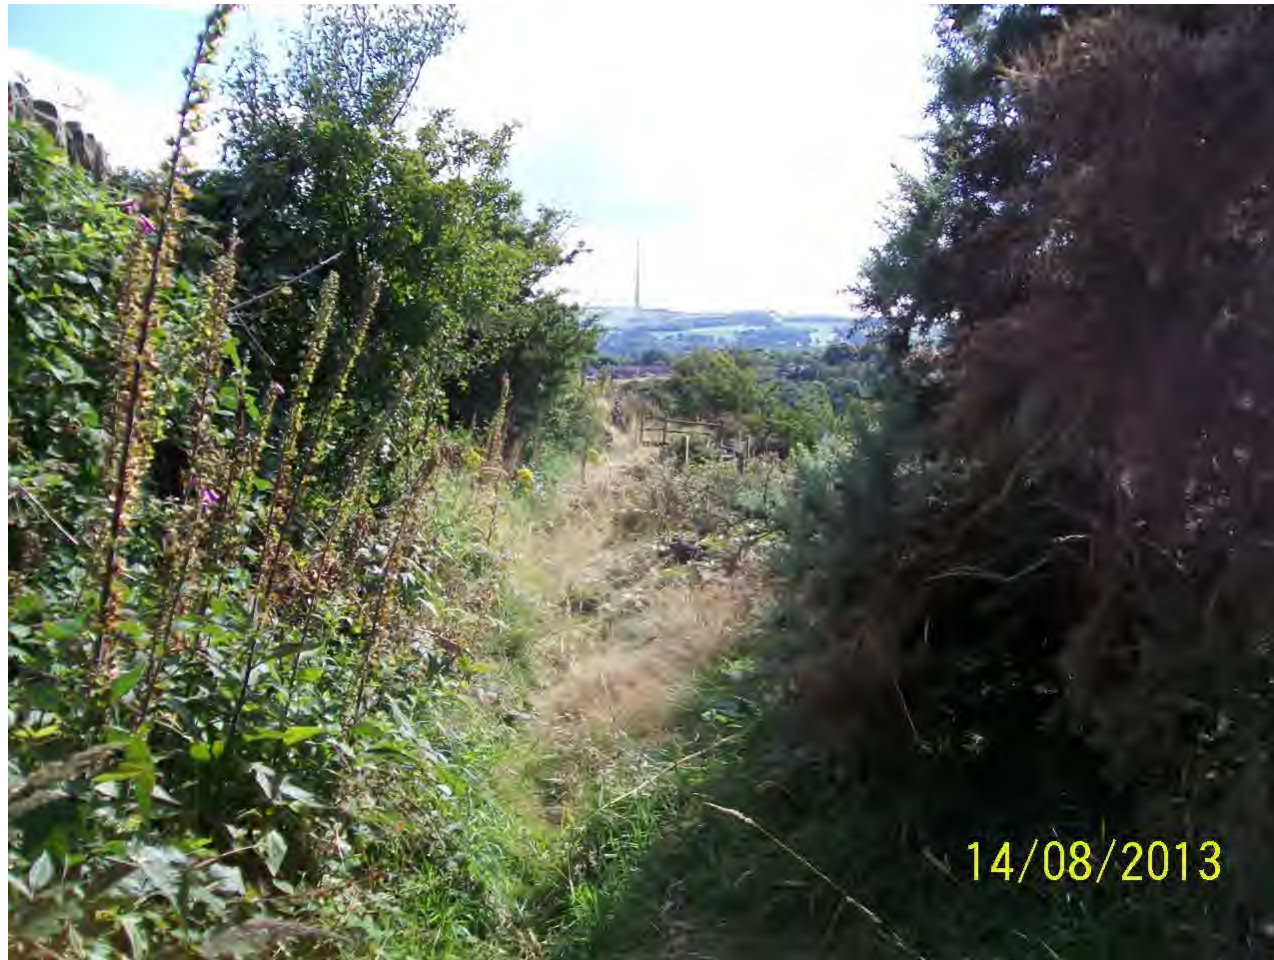
*Photo 37: Photo taken looking easterly showing overgrown vegetation and second wooden stile structure (Grid Reference SE 1697 1258).*

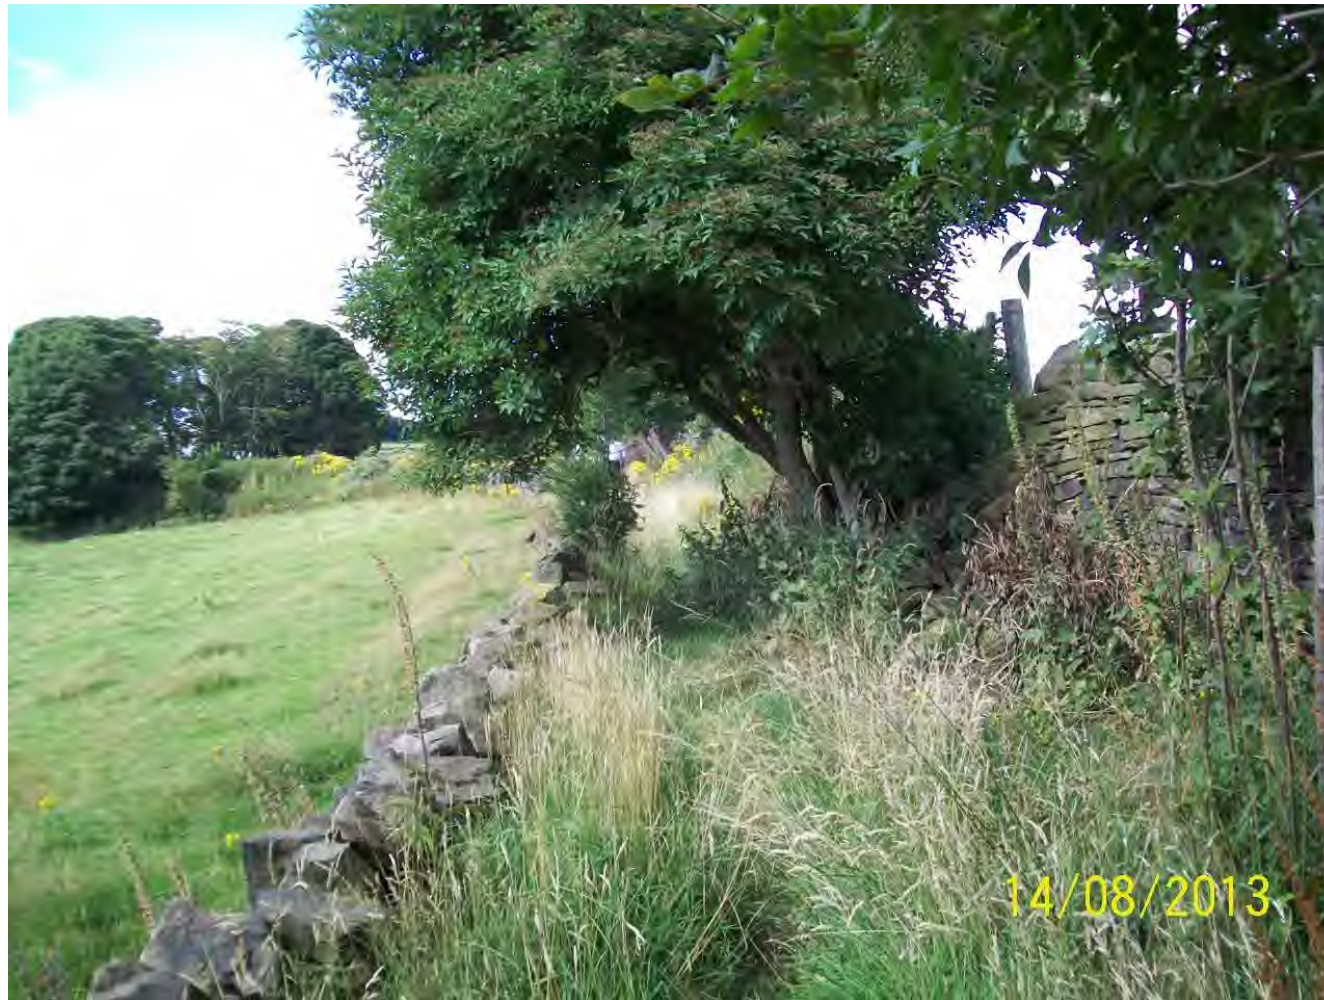
*Photo 38: Order route continues westerly between drystone walls. Trees growing within the way.*

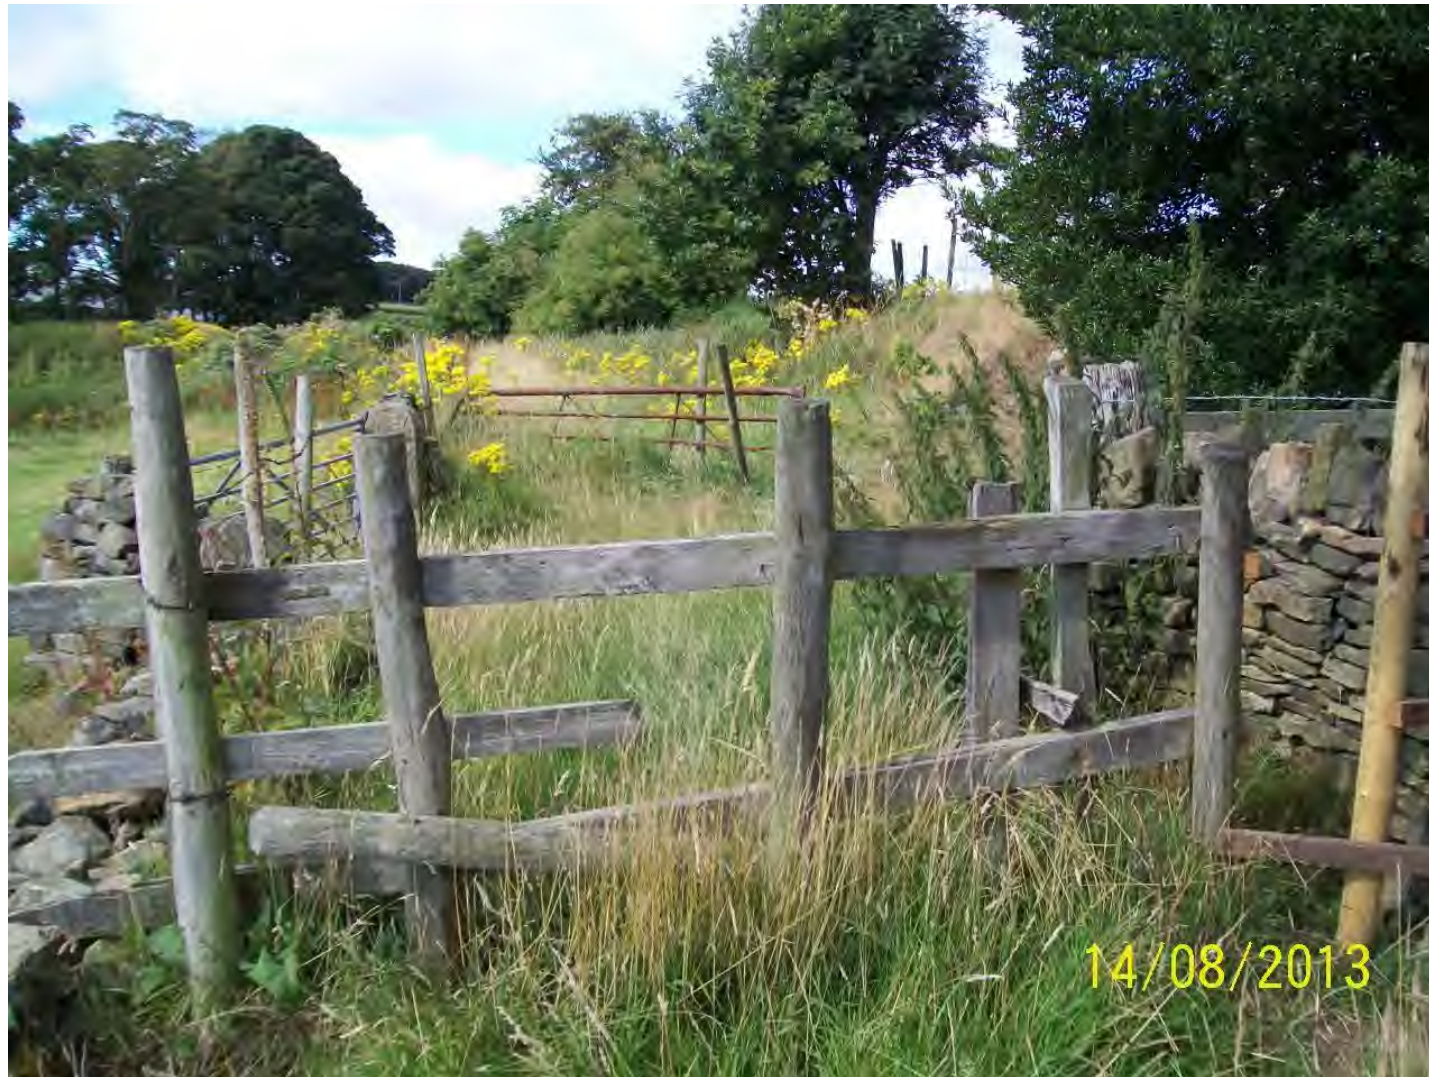
*Photo 39: Close-up of 'first wooden stile' structure and also a metal field gate is shown across the Order route (Grid Reference SE 1697 1258).*

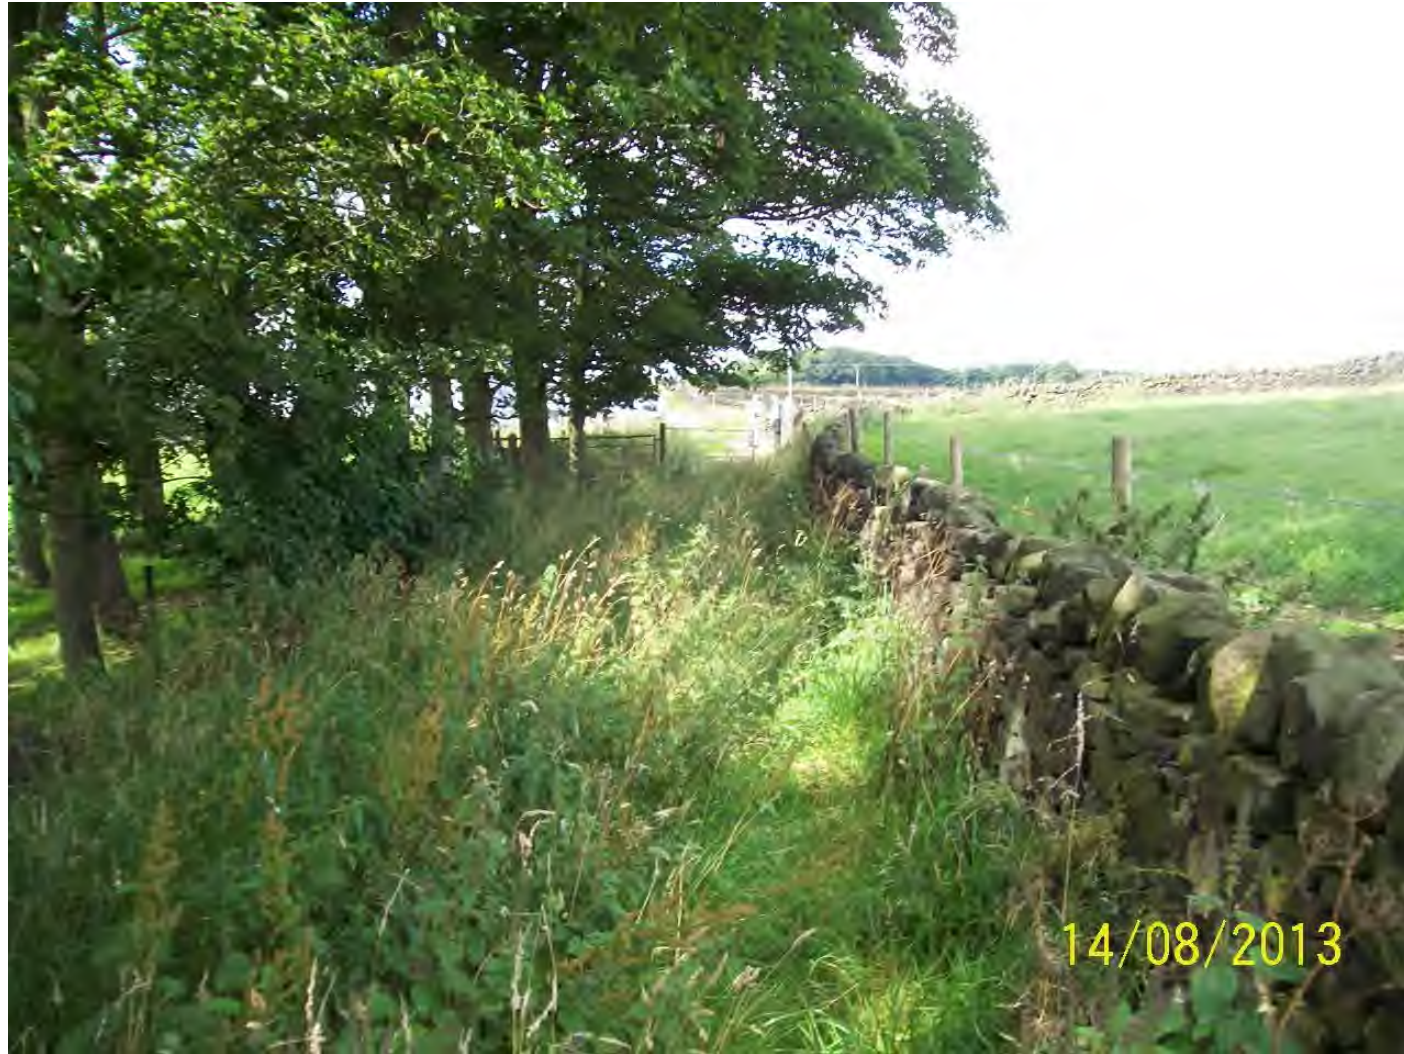
*Photo 40: Order route leads westerly towards its junction with Farnley Road and a metal field gate across the way.*

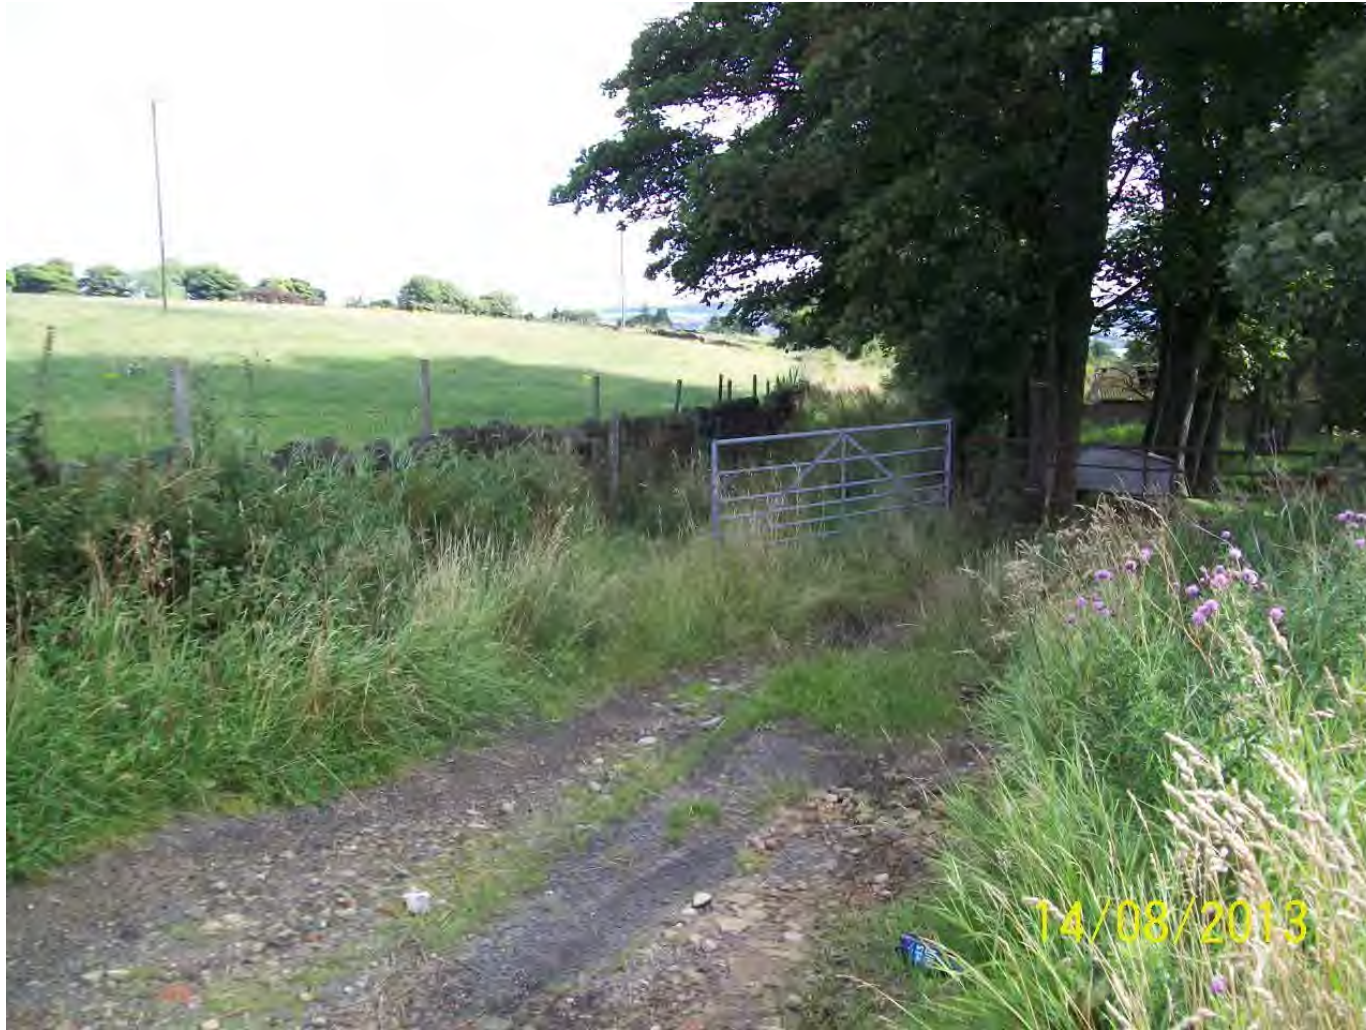
*Photo 41: Point B on the Order Map at its junction with Farnley Road. Metal field gate is shown at Grid Reference SE 1667 1245.*

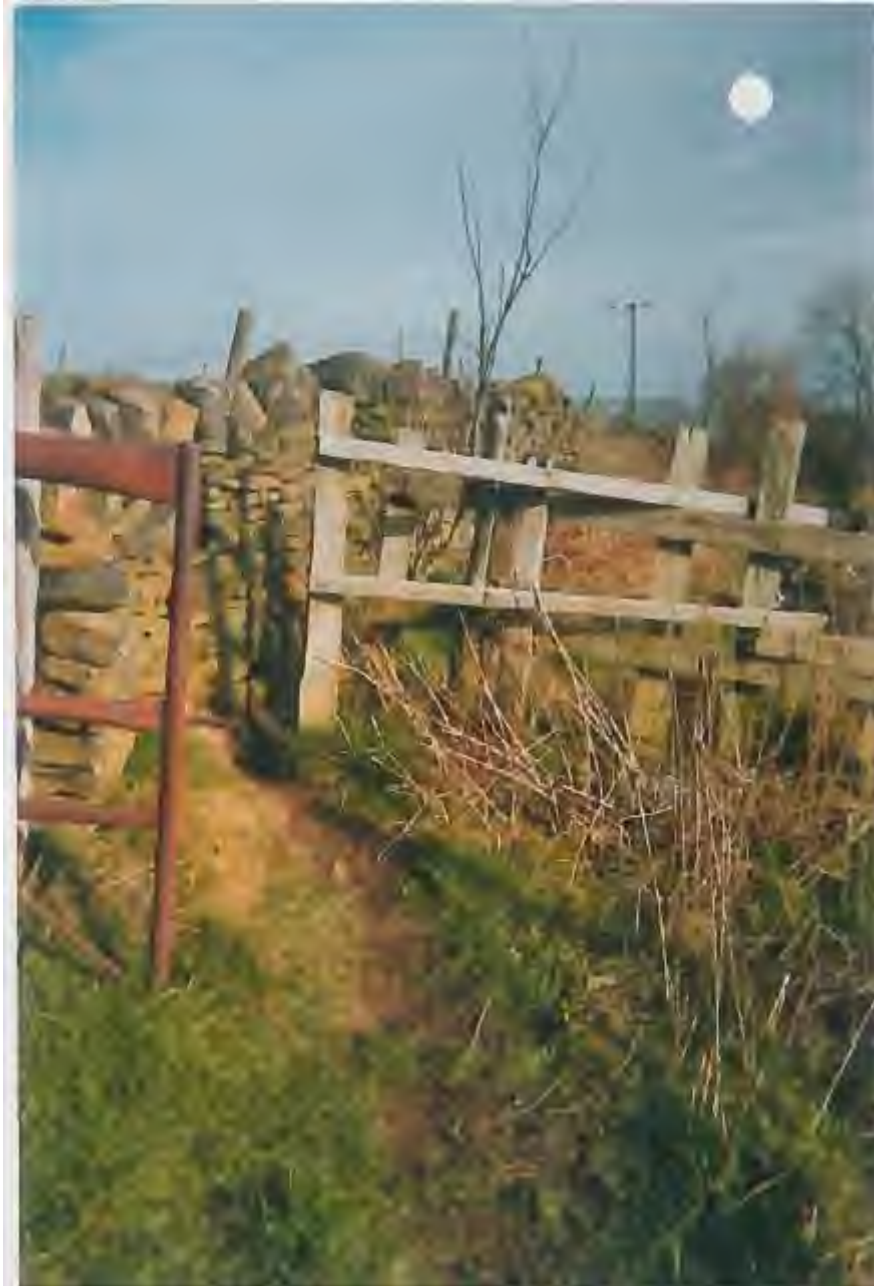
*Photo 42: 'First wooden stile' structure at Grid Reference SE 1680 1255. Note in comparison to photo 9, the tree is a sapling.*

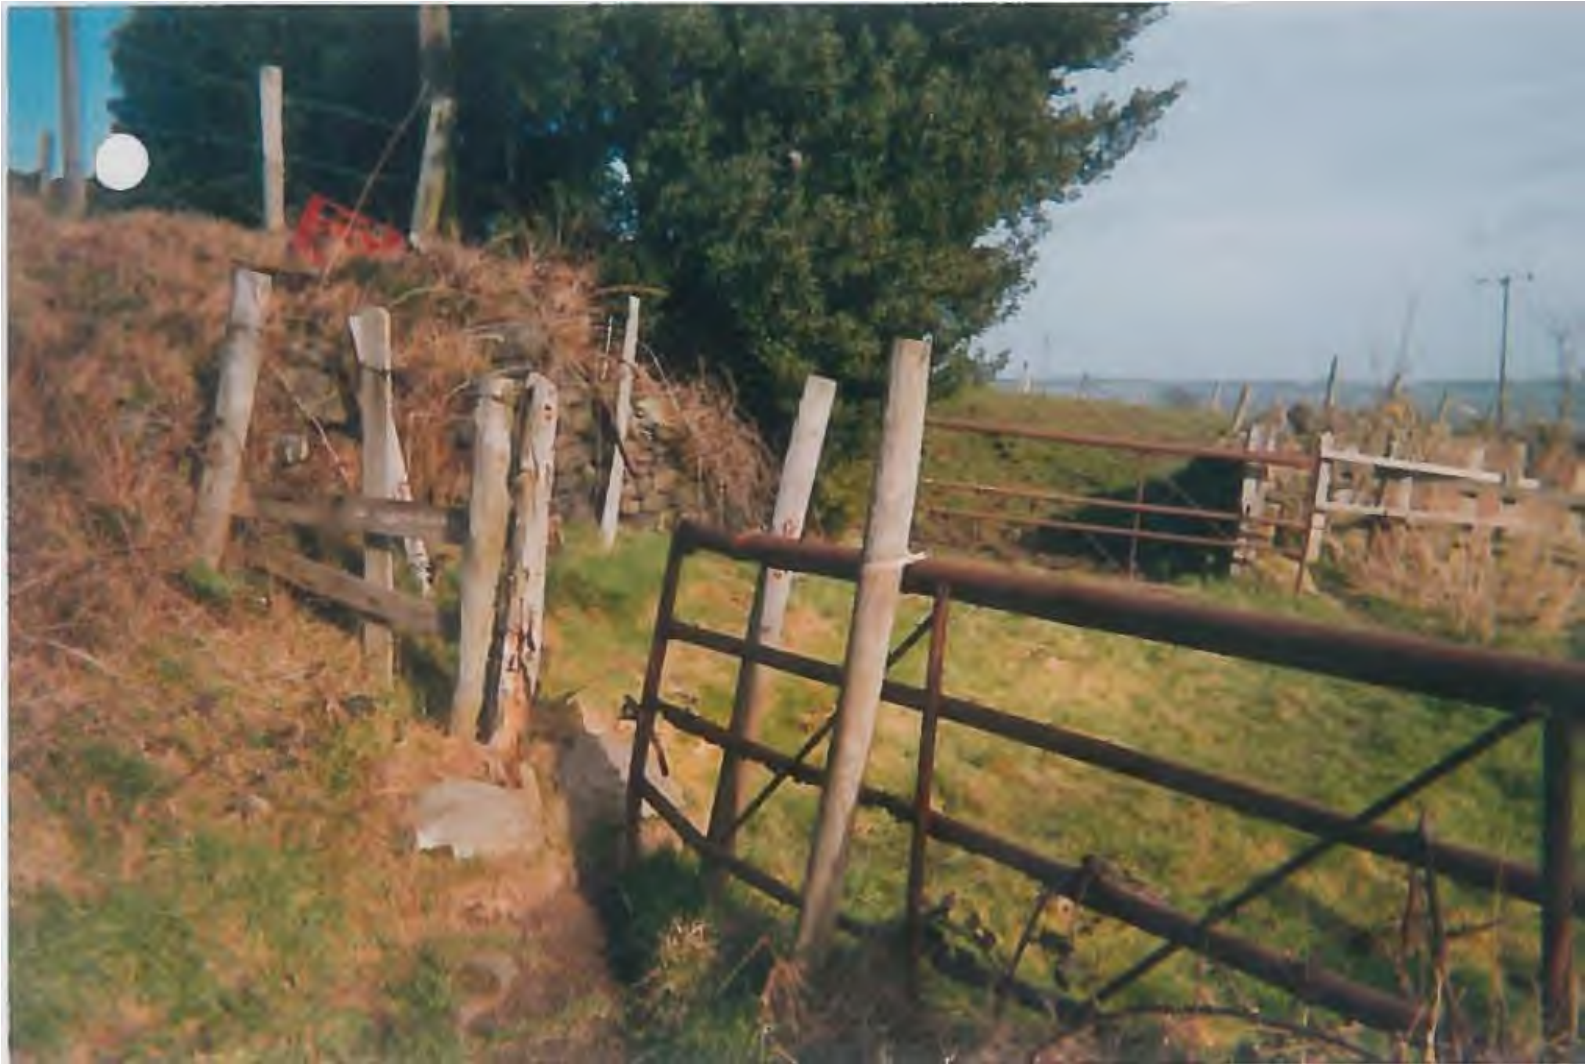
*Photo 43: Structures present across the Order route at location of overgrown tree. Structures no longer present in 2013 or 2023 (see photos 15, 32 & 33) (Grid Reference SE 1706 1261).*

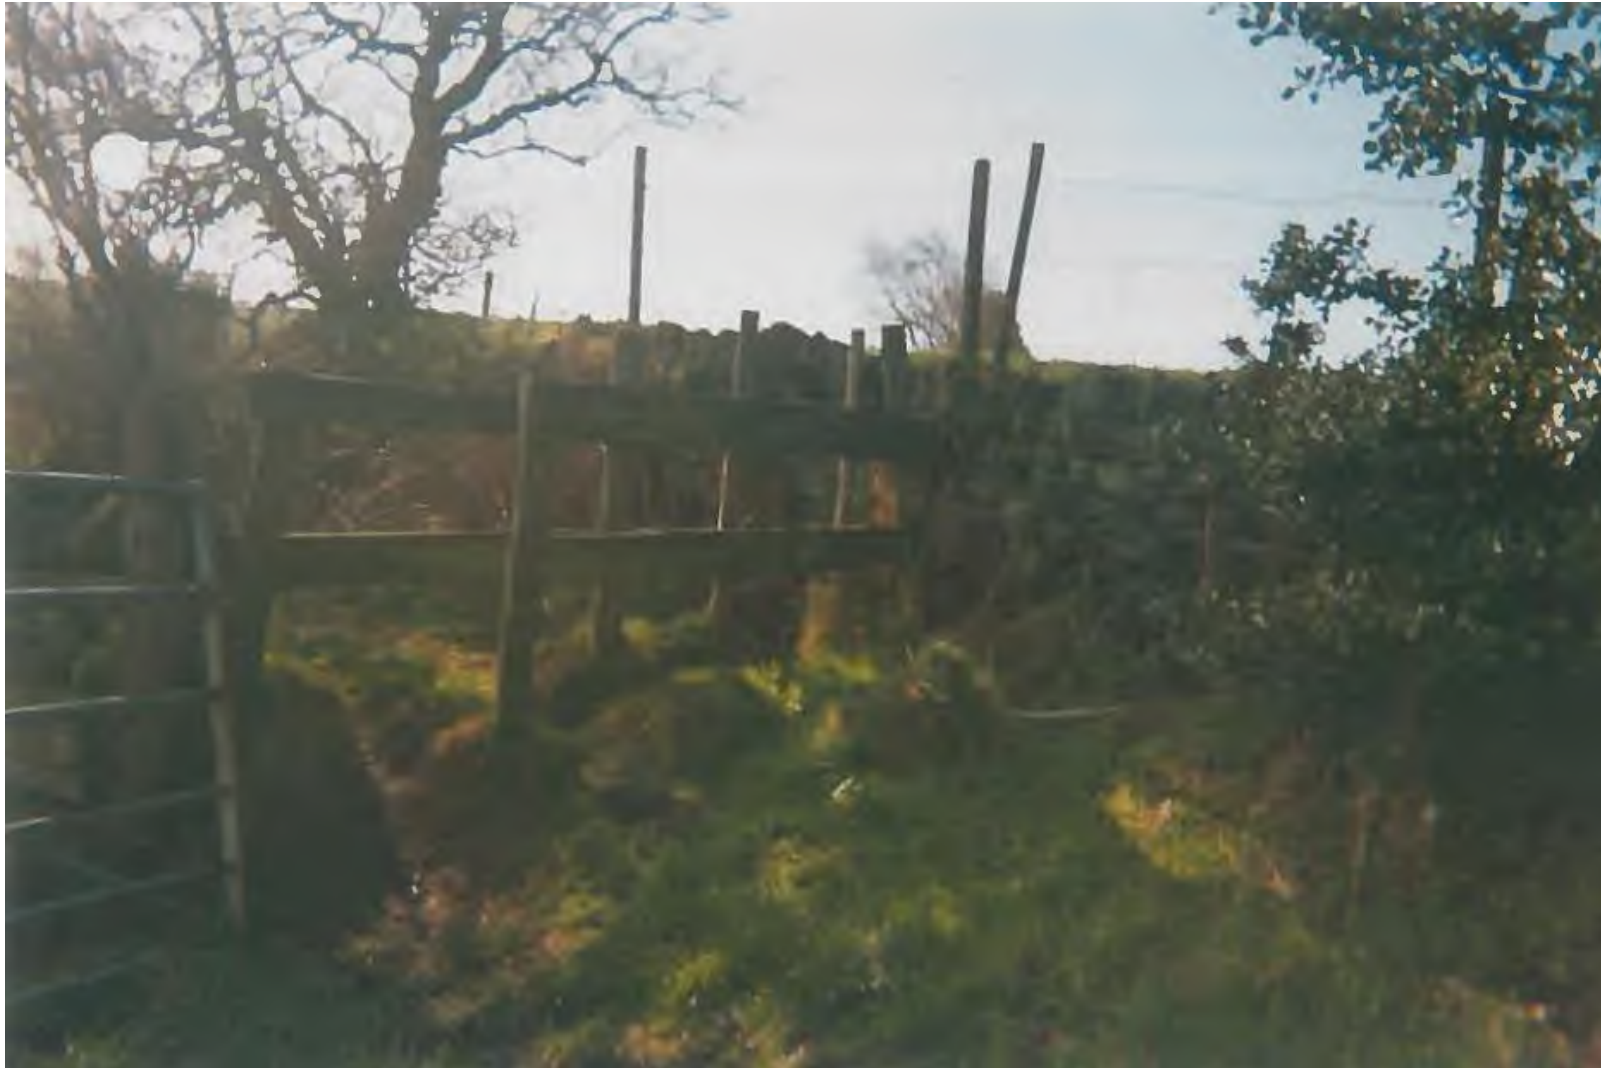
*Photo 44: 'Fourth wooden stile' structure at Order routes junction with Crab Lane (Grid Reference SE 1718 1273))*
