Trial Study

Flood Resilience

Slaithwaite

Protecting a village: delivering a local early flood warning and monitoring system to keep people, homes and businesses safe

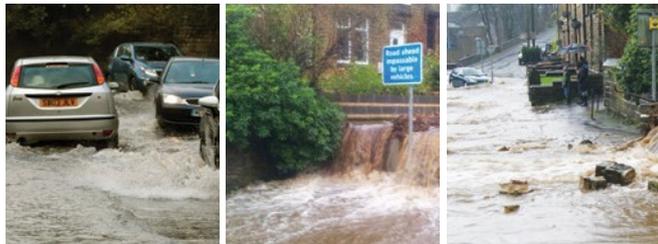
The devastating flood of 2015 in Slaithwaite

Slaithwaite suffered extensive flood damage in 2015 when Crimble Clough, ordinary watercourse, breached its banks, demolishing the wall at the end of Clough Road, flooding the area, and causing damage and disruption.

Extensive damage: In 2015, due to the stream backing up and demolishing the wall, causing flooding downstream from Clough Road.

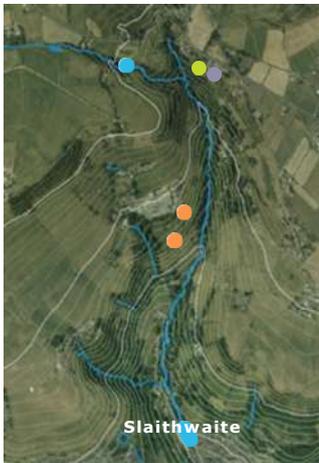
Crimble Clough at Slaithwaite showing catchment network monitoring

- LoRaWAN® gateway connects to all devices and communicates all data to a central network server
- Soil moisture
- Water level sensors
- Rain gauge sensor

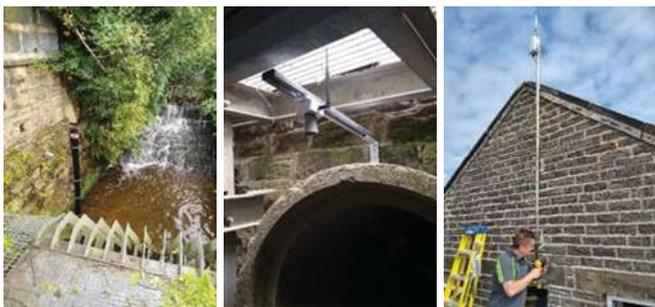
Sensors and LoRaWAN® network gateway installation at Crimble Clough, Slaithwaite

The project is designed to monitor high water levels at Crimble Clough caused by debris washed down from the upper wooded catchment and blocking the debris screen. The sensor-based system monitors the difference between water levels, via two water level sensors immediately before and after the debris screen, automatically sending alerts at pre-set trigger points, if a significant difference in water levels is detected.

- A real-time local watercourse monitoring and alert system.
- A battery powered water level monitoring system at the debris screen that sends out SMS and email alerts when water levels reach critical depths.

By monitoring water levels immediately before and after the screen, sending out SMS and email alerts when the difference is significant.
