Phase 2.

Extracts from RIBA 3 Design Report.  
September 2024.

This RIBA Stage 3 Report for Our Cultural Heart Phase 2 Museum and Art Gallery has been compiled by FCBStudios for the conclusion of RIBA Stage 3, with Design Team contributions for their relevant discipline.

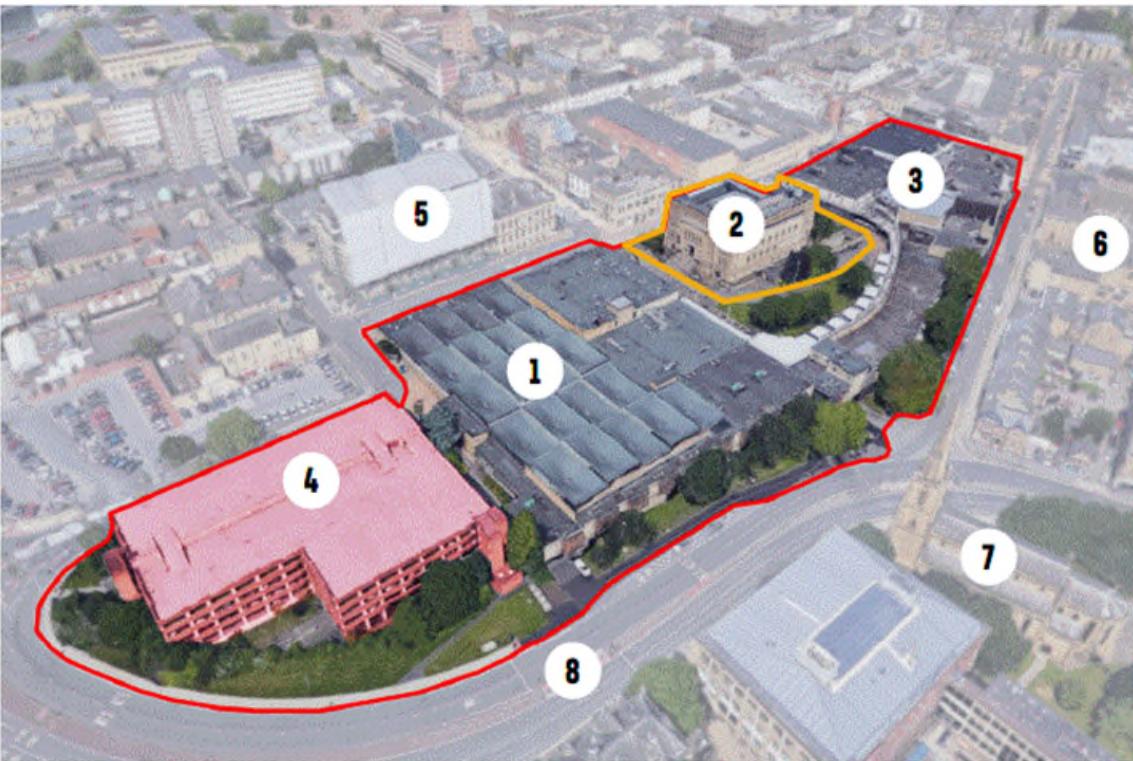
Fig. 1.1.1 Existing Site Location Diagram

The location of the plot can be seen within the overall Our Cultural Heart masterplan boundary in the diagram to the right, building 2. The setting is largely formed by the surrounding Huddersfield Town Centre Conservation Area- which lies to the north, east and west- and works to develop Phase 1 of the wider Our Cultural Heart masterplan to the south. To the north and east the existing building faces onto the Piazza shopping centre, where meanwhile uses are currently housed within former retail units.

Service tunnels beneath the public realm surround the existing building and extend along its north, east and western sides. The tunnel to the east ramps up to the lower ground floor level into an open-air service yard.

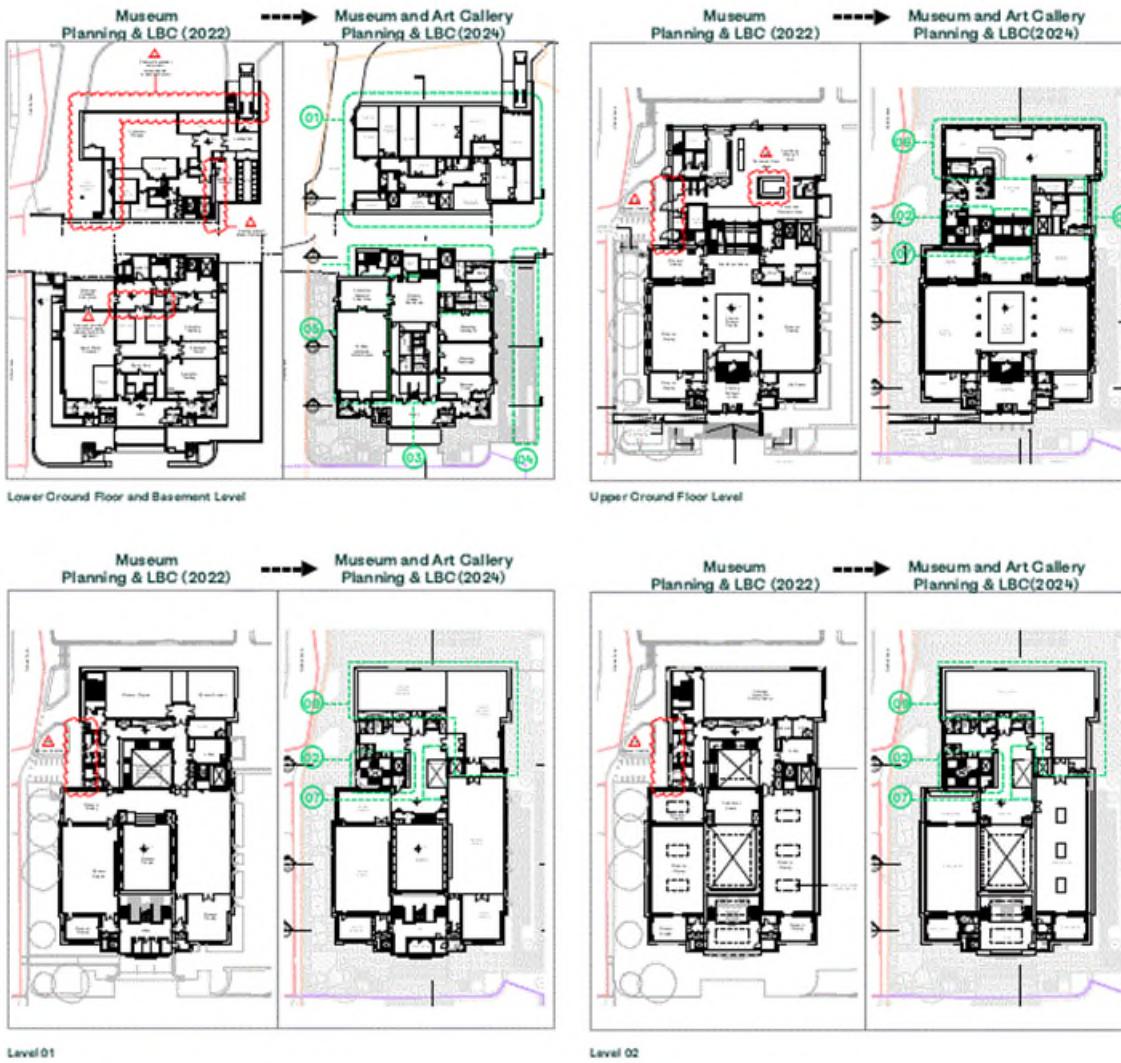
Fig. 2.3.1 Summary of Development in Stage 3

- Basement reconfigured / relocated - to accommodate MEP and structural arrangement. Collections Store relocated off site (1)
- New Extension stair, passenger lift and goods lift locations reconfigured (2)

- Central lower ground floor layout and display stores amended (to be included in fit-out works) (3)
- East terrace landscape revised to enable external step free accessible entry / exit to LCF out-of-hours (4)

- Heritage Innovation Activity Space (HIAS) relocated to LCF (5)
- Reconfigured visitor arrival to north - layout re-planned (foyer, cafe, shop, WCs), east entrance omitted, stone piers updated to suit new entrance (6)

- New atrium feature stair amended between UCF and LCF and omitted on upper floors. (7)
- Previous new entrance through east elevation omitted providing greater retention of existing fabric (8)

- Layout and windows to new extension Art Galleries amended (9)
- Reinstatement of top floor as Art Gallery (as 1940 design)
- Increase in GIS provision - layout and service strategy impact

- Reconfigured Art Gallery entrances at Level 01 and 02
- Amended rooflight design
- Admin spaces redistributed

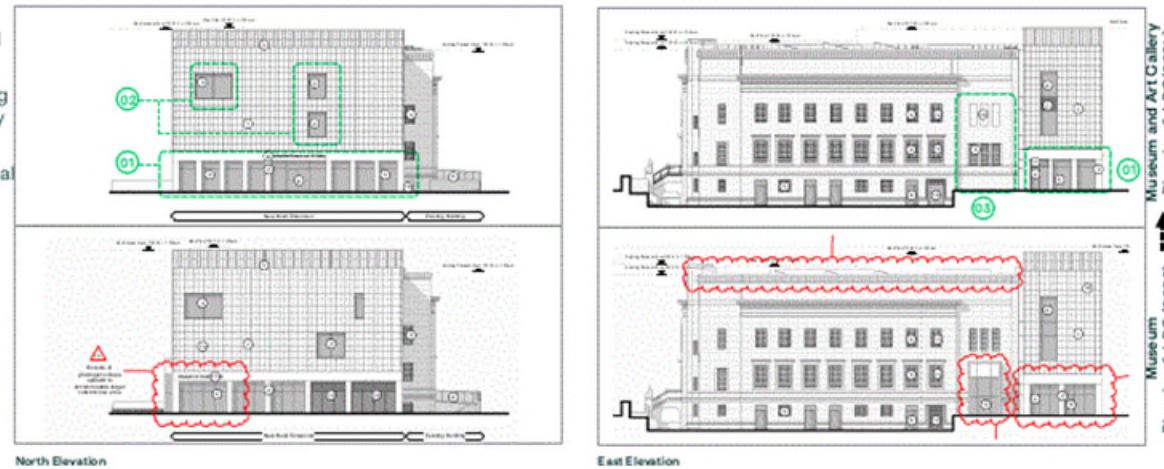
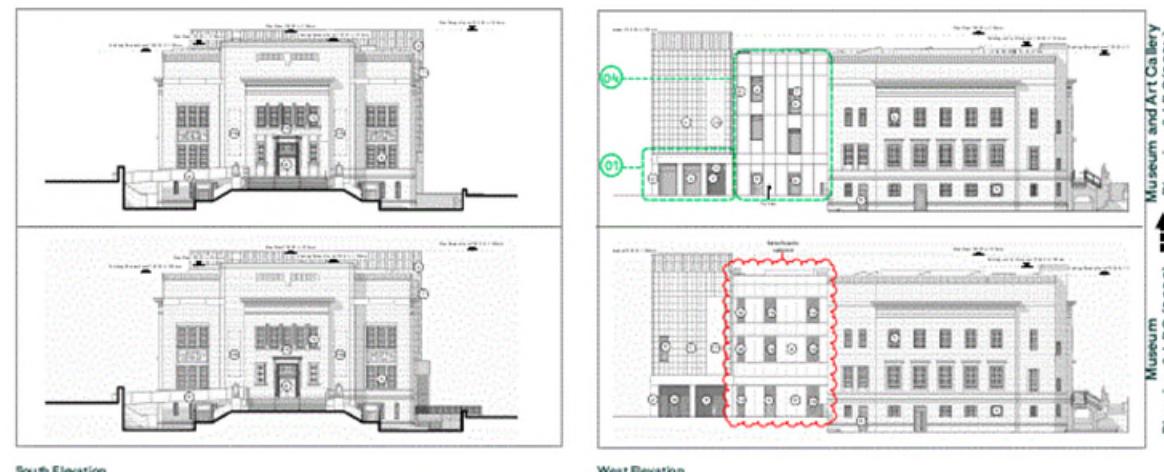
Fig. 2.3.2 Summary of Development in Stage 3

- Facade piers updated to emphasise the new entrance. (1)
- Window locations in extension updated to align with internal layout changes and key views to surrounding context (2)
- New main entrance relocated to the North elevation. Existing windows on level 01 infilled to provide flexibility to Temporary Exhibition space (3)
- Window locations to west new facade updated to suit internal updates and relocation of stair (4)

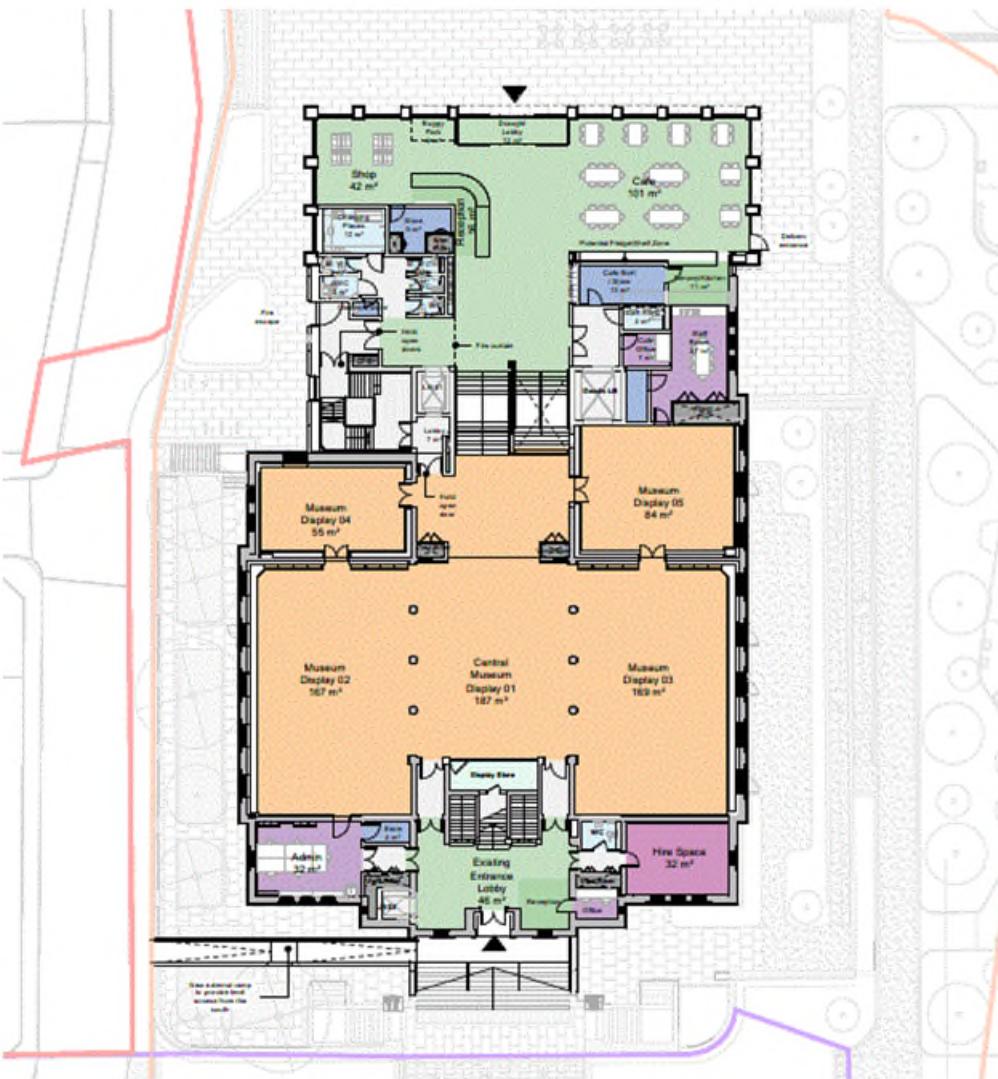
Fig. 2.4.3 Upper Ground Floor plan

To bring new life to the building and facilitate its new use as a museum and art gallery, a new extension will sit to the north, and where historic drawings by the original architect show a future extension had been considered.

From this level, internal access can be provided to both the existing lower ground and upper ground levels via a new public lift, service lift and central stair, in a generous entrance foyer. To the west a new stair enables a public route to all floors of the building, sitting adjacent to the existing facade, with new windows providing daylight throughout. The stair has been carefully coordinated to also act as the primary fire fighting stair and a means of escape, exiting out to the west.

The new entrance foyer will be flanked by a cafe to the east, serving light refreshments, and a museum and art gallery shop to the west, both providing active frontage to key corners. Public facilities including WCs, Changing Places, lockers and buggy parks are also located within this area. Staff spaces are dispersed across each floor to support the different functions.

A feature stair connects the UC and LC levels, with an atrium above providing natural light and visibility between all floors. The wall that spans the full height of the atrium enables possibility of digital projection or physical artworks to act as a connection between different uses and levels.

Half a level up, on the existing UCF, visitors will arrive in the central museum display area, in what was the main lending library, beneath the retained laylight. The space is organised by the existing marble columns, with the historic volume of the reading room space still legible, albeit with some alterations to its layout and fittings to suit its new use, and to demarcate this space as an important threshold between the existing building and its new extension. This floor will be the principal museum display and orientation space.

The existing main entrance to the south will continue to function as a primary visitor entrance at the top of the external stairs, with a new ramp from Victoria Lane providing step-free access from the south for the first time. The existing lobby will be carefully restored, providing space for a small lectern reception area. An updated public lift and existing feature stair will provide access to all existing levels.

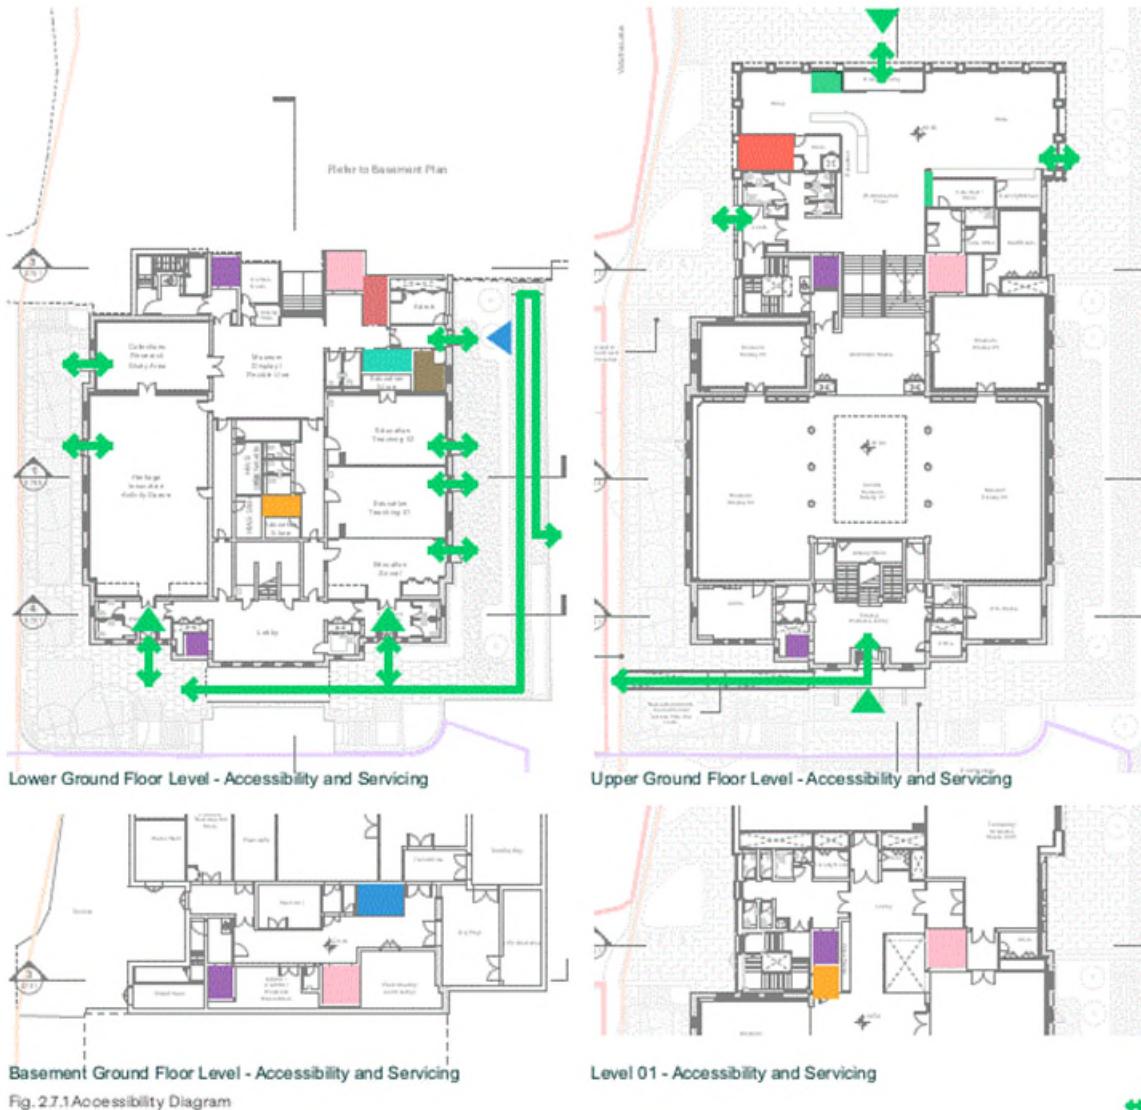
The proposals new adaptions and extension improves accessibility and inclusivity to the existing Library and Art Gallery building alongside its connections to the wider context and masterplan. Level access is provided to all parts of the building and the amendments to the east landscape area enables external level access to the lower ground areas.

All floors have WC's that have a variety of gender-specific superloos, alongside accessible and ambulant disabled WC's. The below highlights the key facilities across the proposed Museum and Art Gallery.

The diagrams to the right indicates some of the key access and inclusivity features.

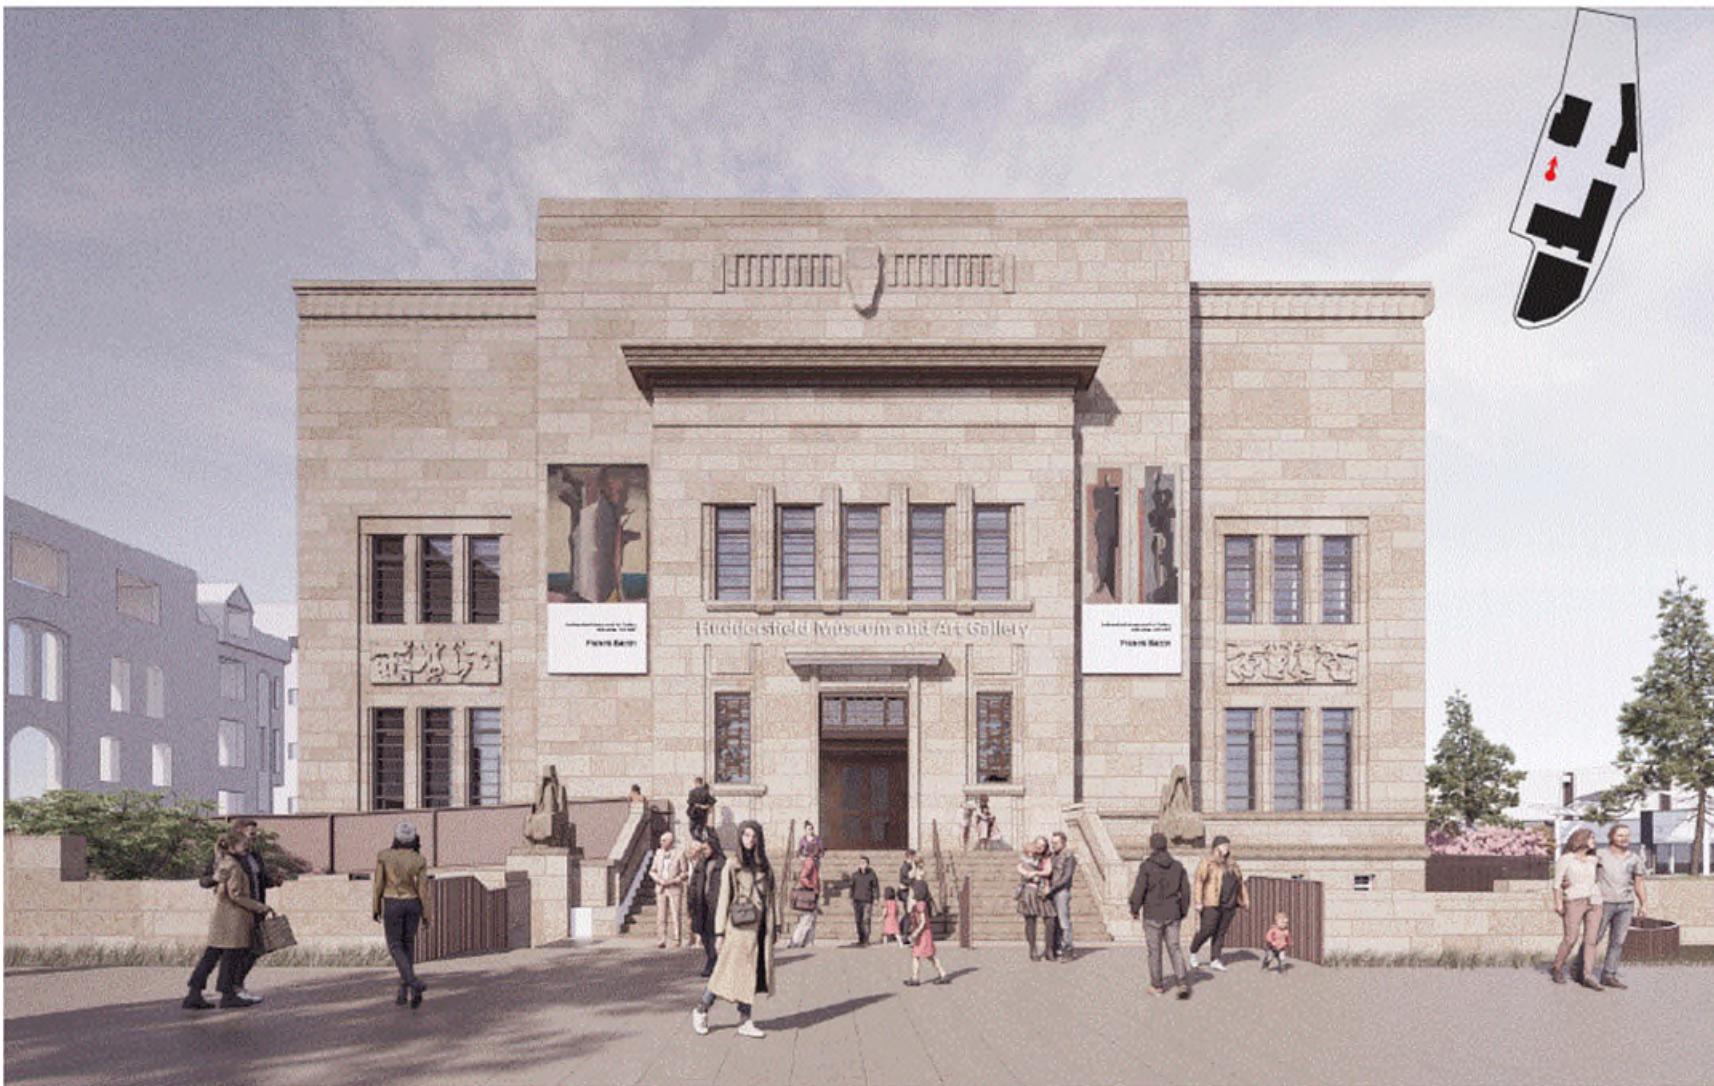
Fig. 2.10.1 Museum and Art Gallery south elevation showing existing fabric with new ramp and landscaping - Landscape shown as per final phase of masterplan indicatively

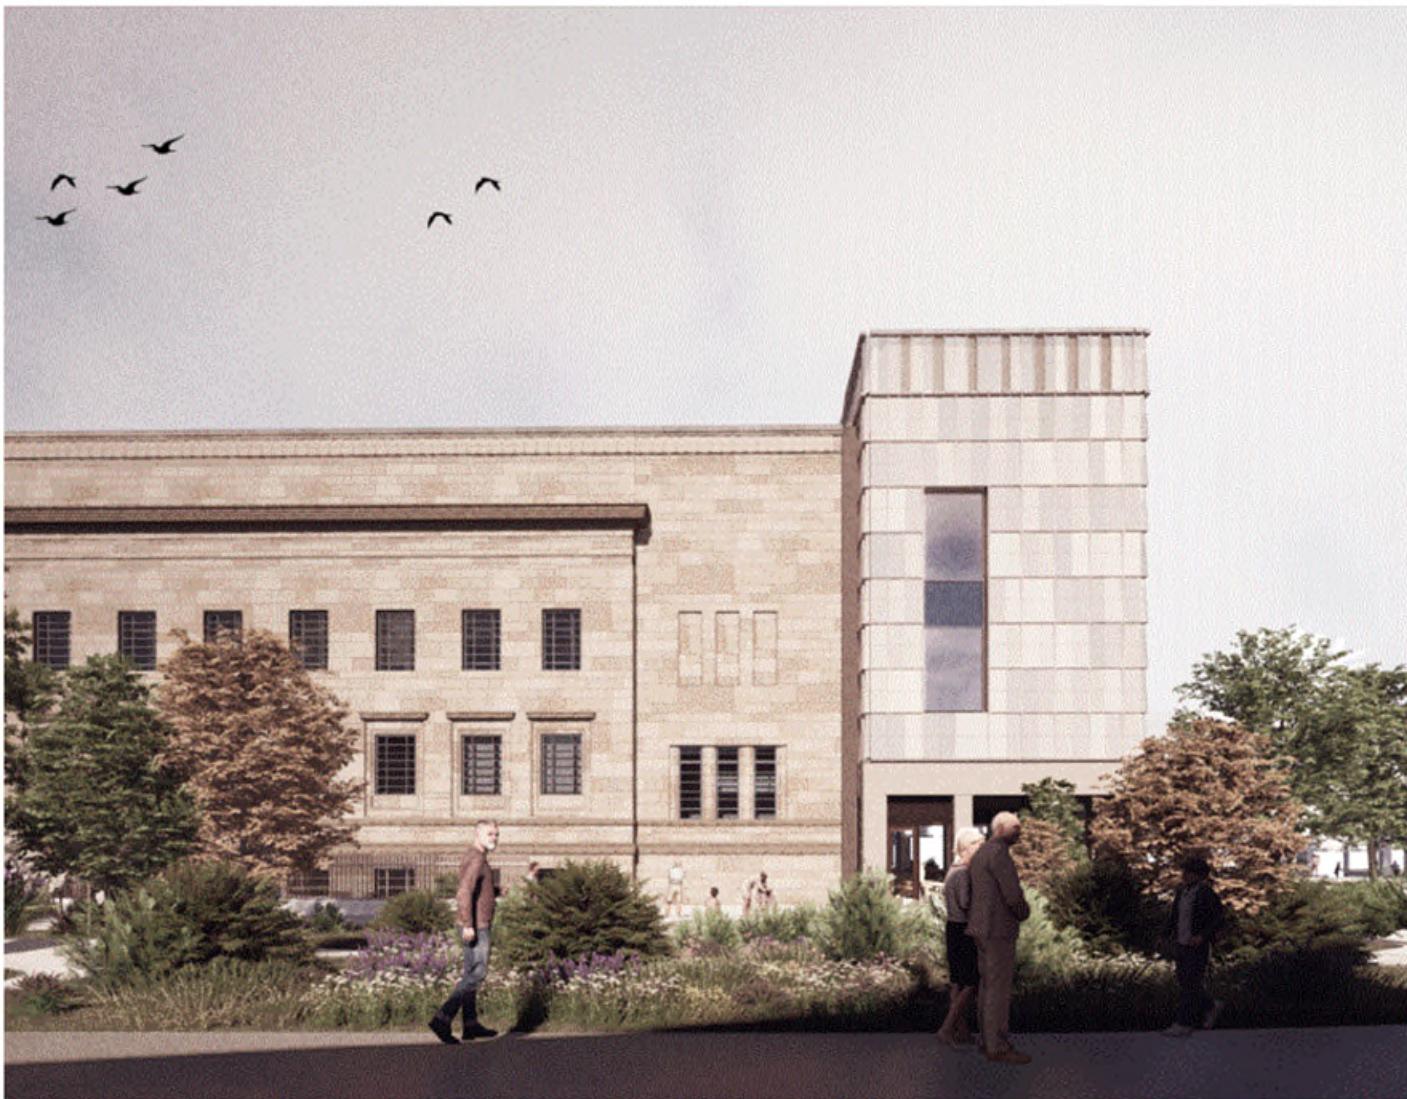
Fig. 2.10.2 Museum and Art Gallery east elevation showing both new and existing fabric, looking west - Landscape shown as per final phase of masterplan indicatively

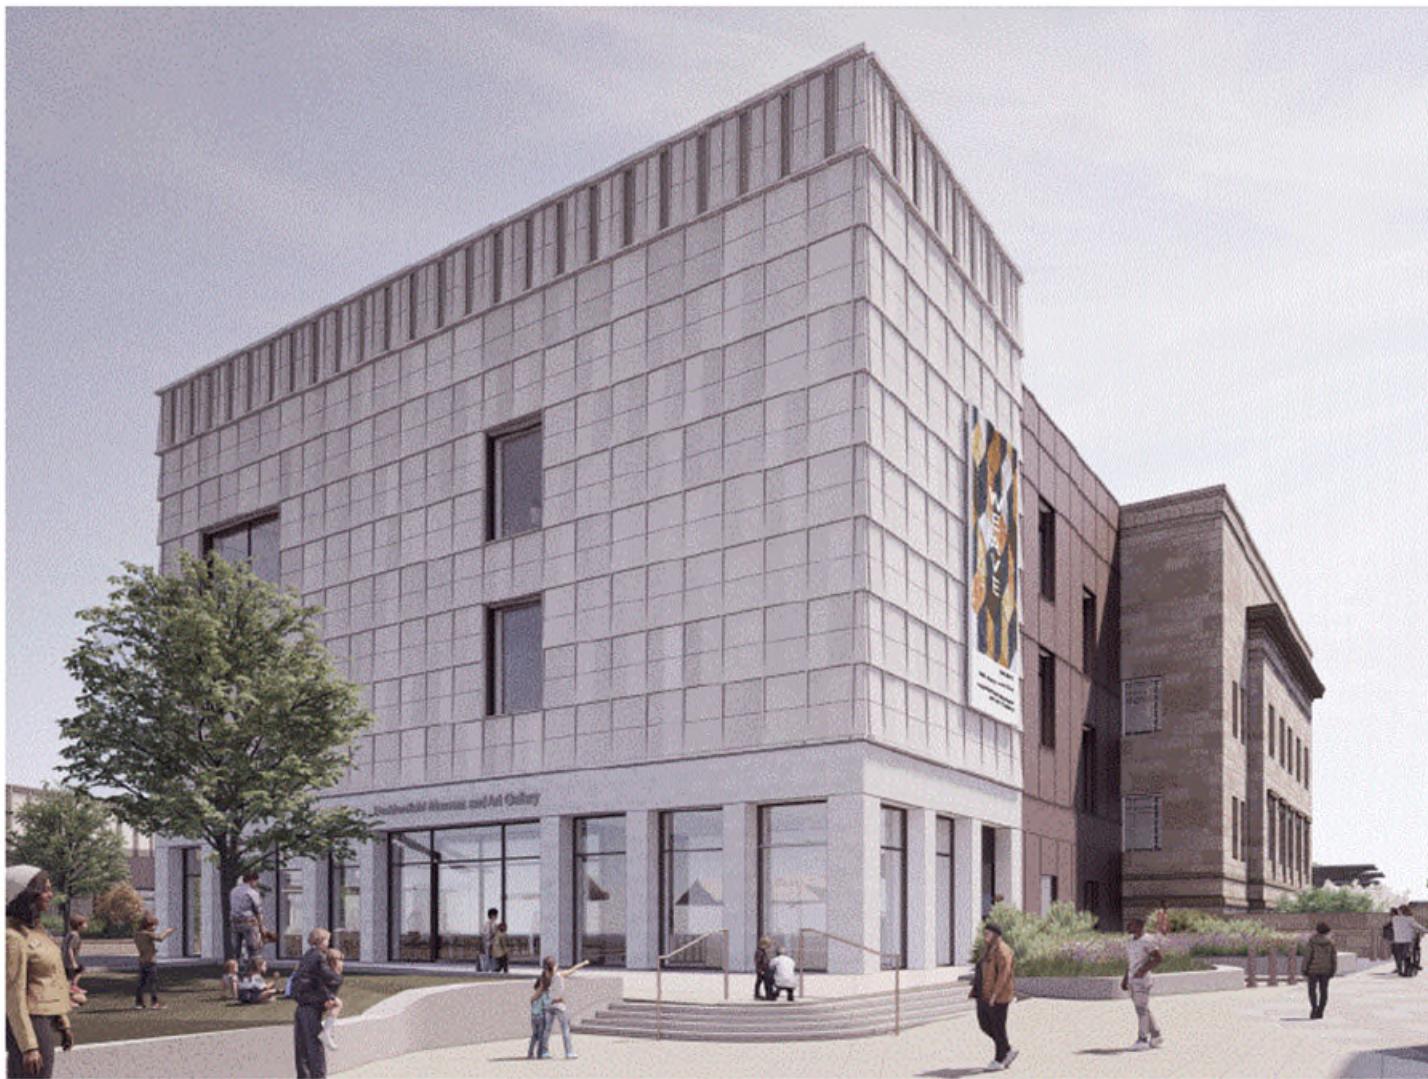
Fig. 2.10.3 Museum and Art Gallery west elevation showing new and existing fabric with new north entrance - Landscape shown as per final phase of masterplan indicatively

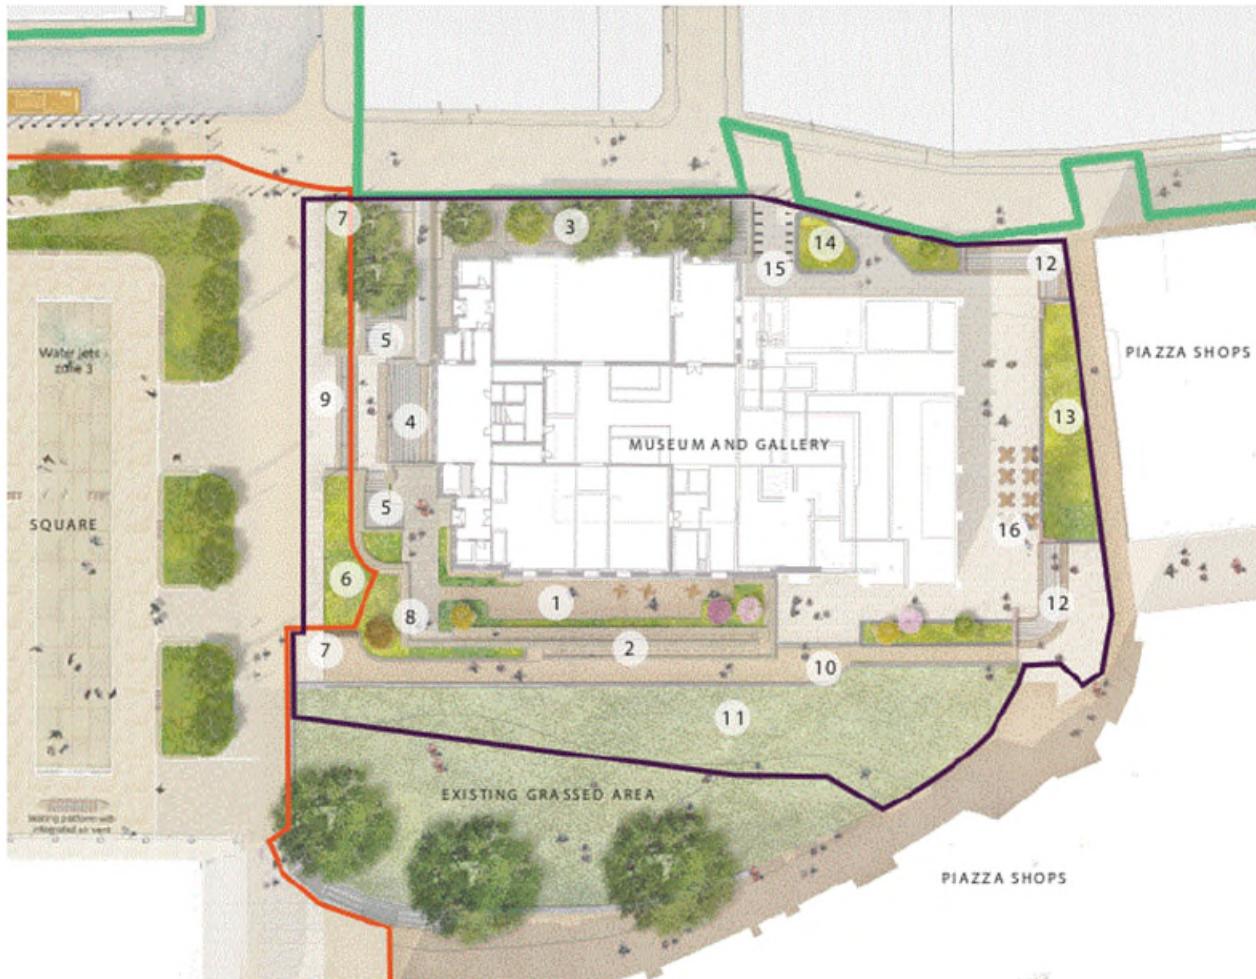
The plan opposite illustrates the phase two design within the context of the existing site condition; i.e. phase one completed, but the remainder of the Our Cultural Heart site as existing with the Piazza shops still in situ.

1. Eastern sunken terrace to provide outdoor education space. Resin bound gravel surfacing, with planting to edges of space to soften walls
2. 1:21 sloped access route from street level to lower ground floor level. To be gated

3. Western sunken terrace to be re-graded and re-surfaced to provide level access in and out of building as per consented scheme
4. Southern entrance stair as existing; new handrails and ramp landing

5. Flank stairs as existing
6. Proposed planting with gravel margin to listed wall
7. Seating
8. Existing walls
9. Section of Ramsden Street to be delivered under this phase

10. North-south accessible pedestrian route as per consented scheme
11. Proposed planting
12. Proposed curved stairs to north east and north west building corners

13. Temporary planted embankment
14. Proposed raised planters as per consented scheme
15. Proposed visitor cycle parking (22no. spaces) as per consented scheme
