B2. Photographs of footpath Holmfirth 60 and other relevant features Holmfirth 60

NB photographs have been organised to illustrate various features along the route from west to east. Where available, photographs taken at similar locations, but on different dates, have been grouped together. Photos generally progress from west to east.

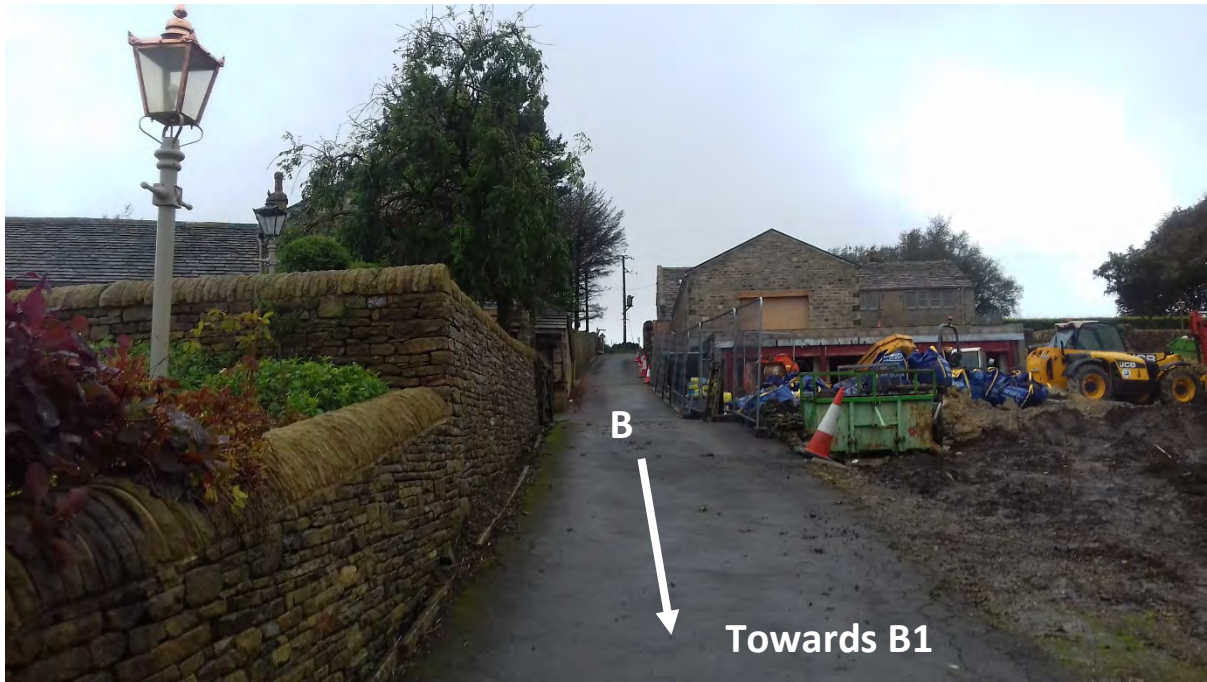
23. View west from west of point B, looking towards B1 and C. At B1 the surface changes from asphalt to grass. The photo shows building materials being stored on the north side of the route, but no deposits, obstructions or structures of any kind obstructions of any k no obstructions on the south side. 02 Jun 2014.

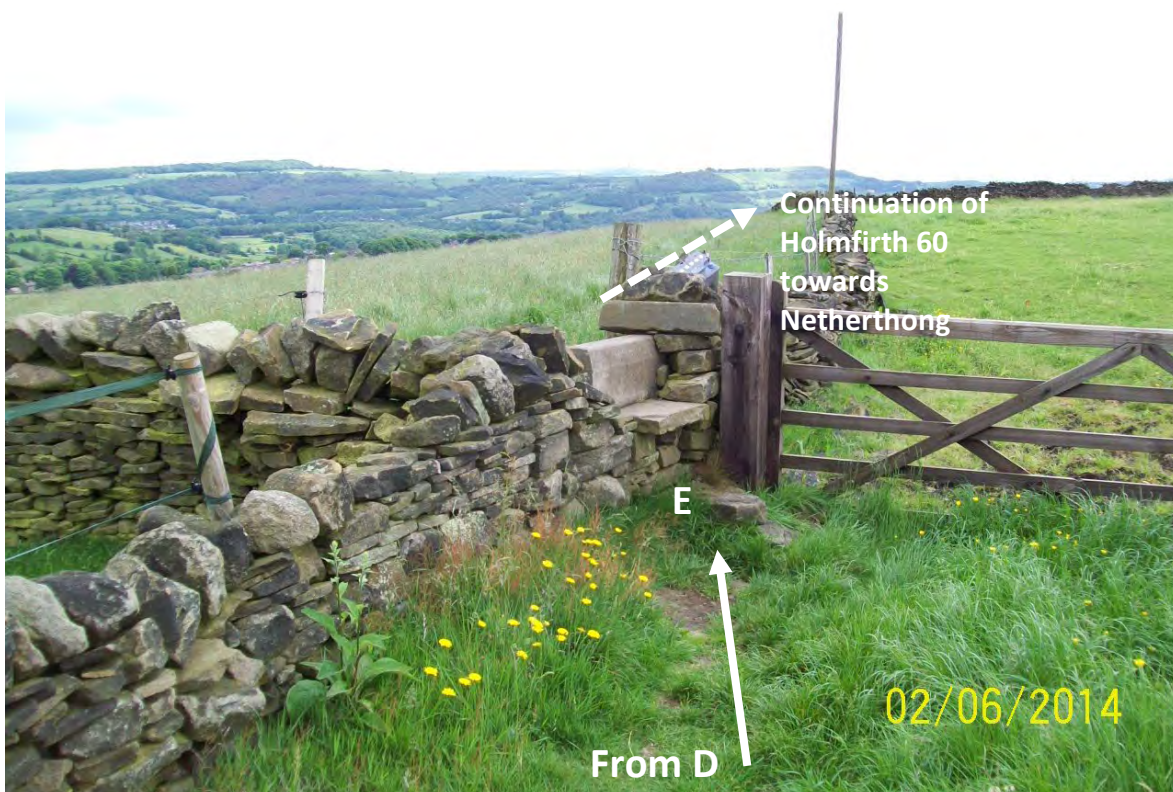
28. View west from point E towards point D. 02 Jun 2014.

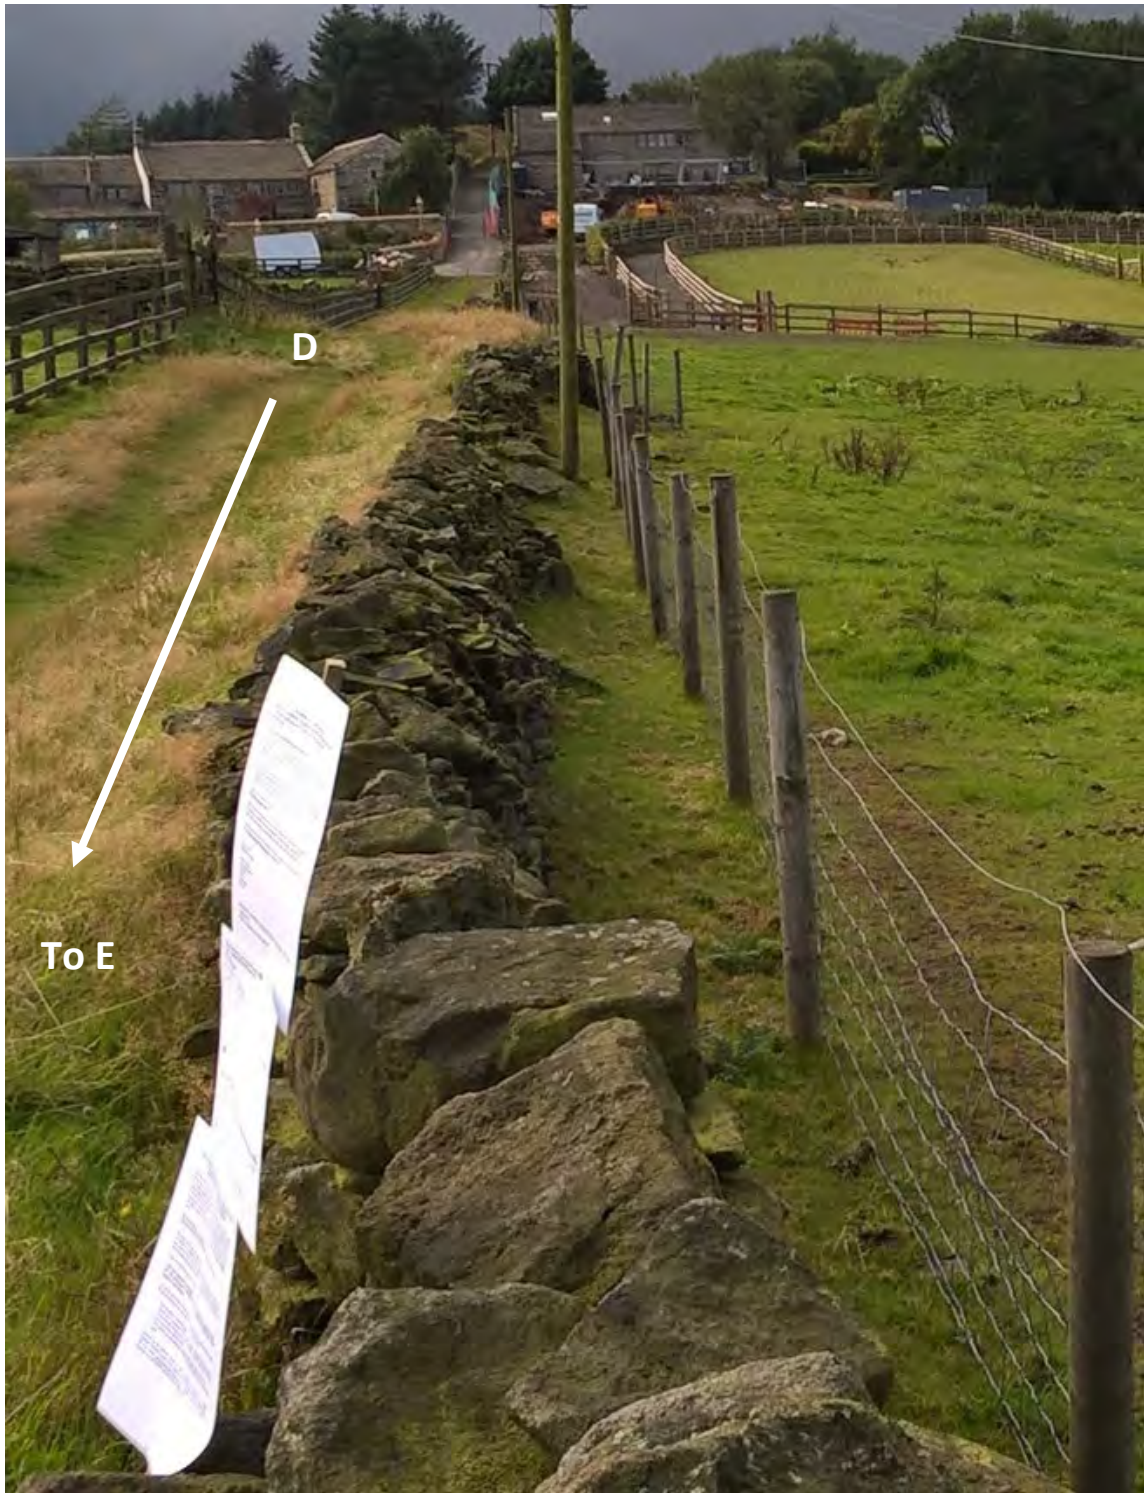
30. View west from near Point E. The position of the path as marked on the Definitive Map is quite generalised at this point to due to deficiencies in the OS base mapping used. However, evidence shows that the footpath continues via a stile and on the north side of the wall, not via the gate. Photograph taken by ESDM surveyor under contract to Kirklees Council. 13 Feb 2007.
