Cleckheaton Town Hall Building Assessment

Kirklees Council Technical Services

CLA420228

29/07/2024

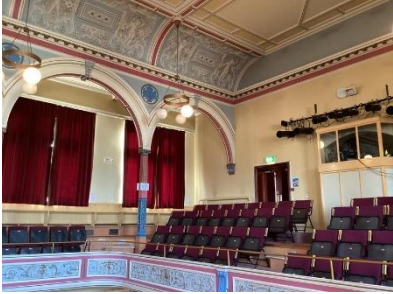
<p>ceilings have stained, missing and broken tiles in places these should be renewed.</p>	
<p>Walls</p> <p>Main hall walls are formed in plaster with ornate detailing in places. The plaster is finished with wallpaper to some flat sections of wall. Both plaster and paper are painted. Walls are marked and damaged in various places throughout the town hall.</p> <p>Offices and circulation areas are plastered with a decorative paint finish and wallpaper. Office walls are marked and damaged in various places throughout the building. Damage is caused by occupational use.</p> <p>Wholesale decoration of the town hall appears not to have been carried out for several years. As part of the wider property refurbishment further fabric damage is expected.</p> <p>We recommend the Town Hall fabric is repaired and fully decorated as part of the final works phases of a wider refurbishment programme.</p>

<p>Figure 25 Main Hall general finishes</p>

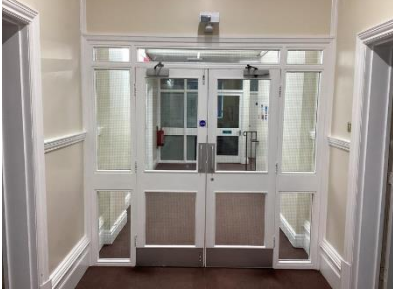
<p>Figure 26 General fit out to circulation spaces</p>

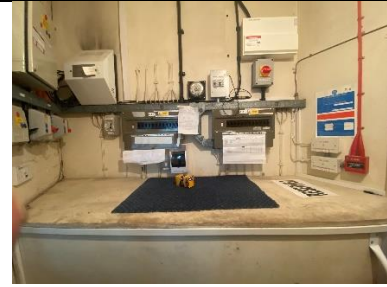
The electrical installation has seen numerous alterations over its lifetime. The MICC cable is difficult to alter due to its rigid nature which can become brittle over time. It also uses imperial type fittings which are hard to source, and modern alternatives can offer poor fitment. Alterations have generally been undertaken using alternative cabling types such as PVC insulated and sheathed cables which do not meet the toxic smoke and fume control requirements required in public buildings today. Alteration and repairs have generally been carried out in an ad hoc manner, introducing cable joints in ceiling voids and service ducts, installed without adequate segregation, containment, or support.

Figure 36 Example of switchgear

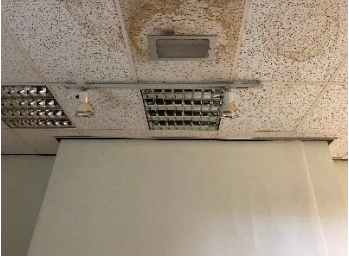
<p>banned in August 2023, so as lamps fail light fittings will need to be replaced or heavily modified to accept LED alternatives.</p> <p>Replacement of the lighting installation would offer, significant energy saving opportunities through the introduction high efficiency LED lighting technology and lighting controls to optimise energy performance.</p>

<p>Figure 40 Example of fluorescent lighting</p>
<p>Emergency Lighting System</p> <p>Age of Installation: 17 years Economic Design Life: 25 years</p> <p>The building is served by an 110V Emergi-lite central battery emergency lighting system employing VRLA batteries. The battery pack and control unit are located in the basement of the annex at the rear of the building.</p> <p>Maintenance records indicate the battery pack is in good working order without a history of significant fault. The batteries have exceeded their design life of 12 years but remain within operable parameters.</p> <p>The central battery system serves emergency lights and illuminated exit signage throughout the building. The wiring network employs MICC cabling with a protective PVC over sheath which is good serviceable condition.</p> <p>The emergency lighting fittings have a life expectancy of 20 years and maintenance records are showing increased failure rates as they reach the end of their expected service life.</p> <p>A programme of upgrade and replacement should be planned alongside the replacement of the other outdated electrical services.</p>

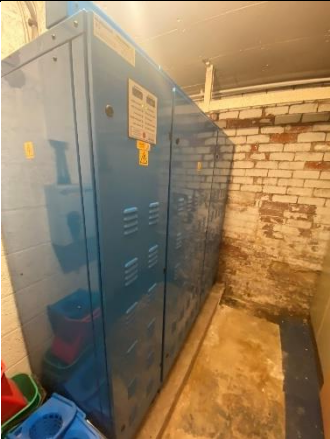
<p>Figure 41 Emergency lighting central battery pack</p>

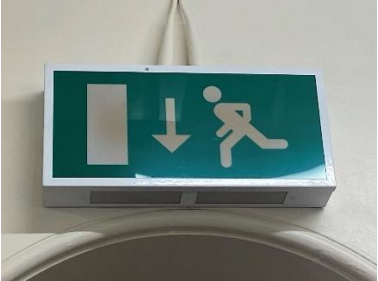
<p>Figure 42 Emergency illuminated signage</p>

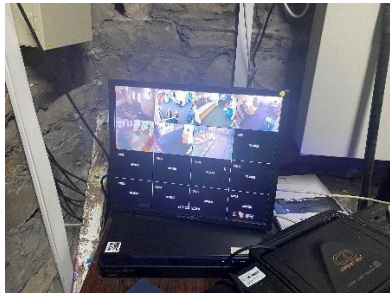
<p>CCTV System</p>	
<p>Age of Installation:19 years (upgrade five years Approx) Economic Service Life: 15 years</p> <p>Although the underlying infrastructure of the CCTV system has exceeded it service life, it has benefitted from a recent significant upgrade within the last five years following a break in. The upgraded system meets the Corporate Landlord standard for CCTV systems.</p>

<p>Figure 45 CCTV monitoring equipment in electrical switch room</p>

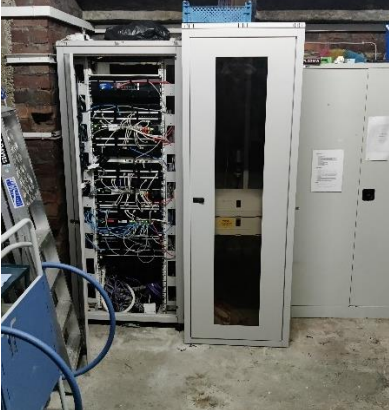
<p>Figure 46 Main building IT cabinet in electrical switch room</p>

<p>potential relocation of the equipment to elsewhere in the building. This should all form part of any wider building refurbishment plan.</p>	
<p>Stage Light & Audio Equipment</p> <p>At the time of the survey, the production lighting and audio equipment had been dismantled and largely removed from site.</p> <p>The Town Hall technical staff advised that the lighting rig had been replaced in 2016 and was generally in a good operational condition.</p> <p>Prior to the closure of the Town Hall, proposals had been made to replace the audio and PA system which was considered to be in poor condition and no longer fit for purpose. The proposal also included an extension to the stage lighting with an additional front of house lighting bar and associated stage lights.</p>

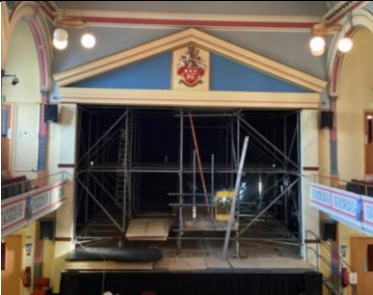
<p>Figure 47 Concert Hall stage</p>
<p>Lightning Protection System.</p> <p>Age of Installation: Not Known Economic Service Life: 30 years</p> <p>The building is protected by a basic lightning protection system comprising of an air termination network connected by a metallic tape mesh with down conductors / earth electrodes to safely direct a lightning strike to ground and protect the building from fire and structural damage.</p> <p>The system was last subject to a test and inspection in April 2024 and was considered to be in a ‘satisfactory’ condition. However, recommendations were made to lower resistance to elements of the network by the introduction of additional interconnections and also to improve access to the ground termination positions.</p> <p>There is no evidence of electrical surge protection devices which exposes the electronic equipment within the building to damage in the event of a lightning strike.</p> <p>Provision of a coordinated system of surge protection should be installed as part of a planned replacement of the electrical services within the building.</p>

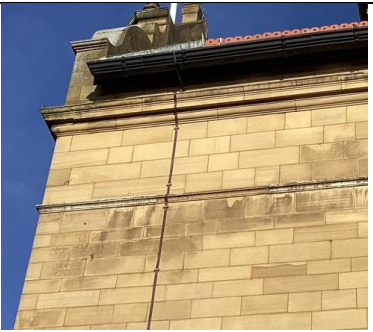
<p>Figure 48 Lightning protection system down conductor</p>

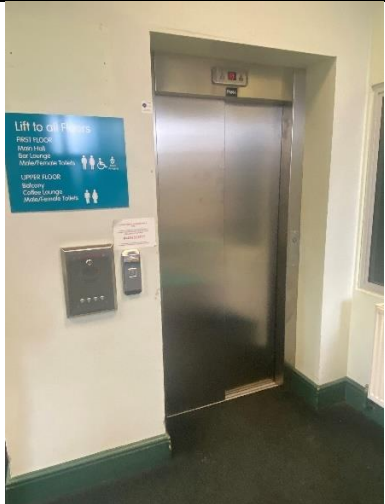
<p>Figure 49 Passenger Lift Ref PM44</p>

Passenger Lift	
<p>Age of Installation: 17 years Economic Service Life: 20 years</p> <p>The building benefits from a 630KG 8-person passenger lift manufactured by KONE (Monospace), which serves three floors of the building. The lift is DDA compliant and is equipped to provide an evacuation function for the building.</p> <p>Maintenance records show that the lift has been running satisfactorily, with breakdowns within an acceptable performance envelope. Despite this, consideration should be given as to whether the lift should be replaced as part of a wider refurbishment scheme as it is approaching the end of its design life.</p> <p>A second goods lift exists with the south staircase which is decommissioned and is beyond economic repair. The lift serves the same floor as the main passenger lift and could be deemed surplus to requirement. This would need to be investigated further as part of any refurbishment scheme.</p>

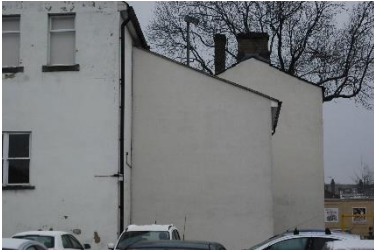
<p>The pellet storage silo is located in a separate, purposely constructed area adjacent the existing plant room. If the silo is to be removed, it would either need to be dismantled and cut up in situ to allow removal via the single access door, or alternatively, the roof be temporarily removed to allow the silo to be craned out.</p>

<p>Figure 52 Biomass silo housing</p>
<p>The silo storage room could potentially be repurposed for general storage or similar.</p>	
<p>Gas Fired Boiler Plant</p>	
<p>The gas fired boiler plant was also installed in 2009 and consists of two large, floor mounted Hoval Ultra Gas condensing boilers providing an overall capable output of around 180kW. One of these boilers is no longer operable and needs to be repaired or replaced.</p>

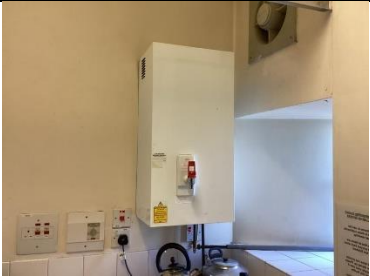
<p>Domestic Hot and Cold-Water Distribution</p> <p>The existing domestic hot water is generally fed from one of two hot water cylinders. There is a cylinder located with the boiler room and another in a storeroom adjacent the reception area. Both cylinders appear to be in a fair condition, with the distribution pipework from them also appearing to be reasonable. There is also a local hot water heater serving one of the w.c. areas. It is estimated that the distribution pipework would have a serviceable life expectancy of 10-15 years.</p> <p>There are several instantaneous hot water boilers for drinking purposes in the two kitchens and the bar area which appear to be in moderate to good condition. Subject to layout or room alterations, it is envisaged that these units can remain as existing.</p> <p>In some areas the sanitaryware appears old and in a poorer condition. Although not a mechanical element for condition appraisal, if any of the sanitaryware and sinks were to be upgraded or re-configured, there will be an element of domestic hot and cold-water pipework modifications required. As such, a cost for undertaking some re-piping will be included.</p>

<p>Figure 59 Water boiler</p>

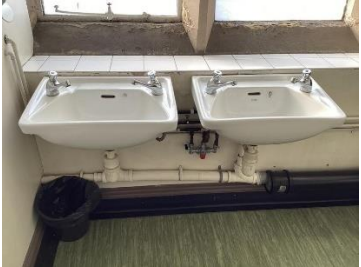
<p>Figure 60 Sanitaryware</p>

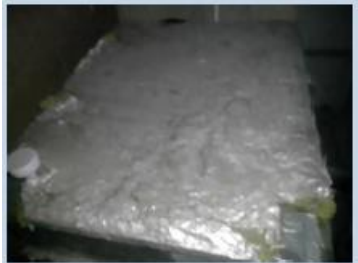
<p>Tank Cold Water Supply</p> <p>There are three domestic water tank located in various areas of the building supplying sinks and toilet flushes and also supply two domestic hot water cylinders. To remove the risk of any legionella forming and reduce the need to access these areas for maintenance and water quality testing purposes, it is suggested that these tanks are made redundant and removed, if possible. The toilets and hot water cylinders will then be switched to a mains cold water supply.</p> <p>One tank has been indicated as a high risk and should be replaced as part of any refurbishment scheme.</p> <p>It would also be recommended that any major refurbishment scheme or reconfiguration the systems are reviewed and upgrade to a main supply to ensure adequate supplies for the proposed changes.</p>

<p>Figure 62 Cold tank storage</p>

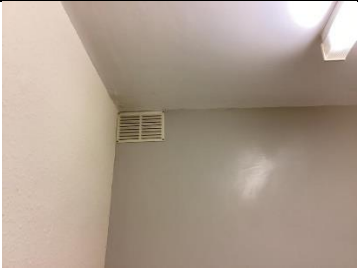
<p>Ventilation Systems</p>	
<p>In general, the building is primarily ventilated by natural means. There are a number of localised mechanical extract fans installed within internal office spaces, w.c. areas and the kitchens. Although most appear to be individual fans, there are some areas that seem to be linked and it is assumed they utilise a ceiling void located ventilation system.</p> <p>The ventilation generally appears very old, with perhaps 3-5 years serviceable life expectancy remaining. It is therefore suggested that depending on the final layout and if ceilings are to be removed or modified for any electrical rewiring works, the ventilation fans should also be replaced.</p>

<p>Figure 63 Ventilation</p>

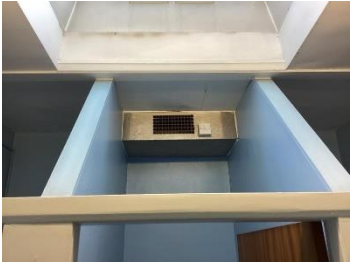
<p>Figure 64 Ventilation</p>
<p>Other Mechanical Items</p>	
<p>The existing bar area currently has a split cooling system installed. It is assumed this is for maintaining drinks temperatures within the storeroom. The unit is towards the end of its serviceable life expectancy with perhaps a further 3-5 remaining years. Should a bar area be retained within the building, it is suggested that the cooling unit is replaced.</p>

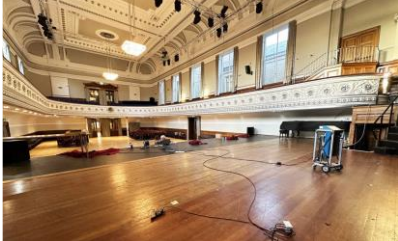
<p>Figure 68 DTH vibration testing</p>

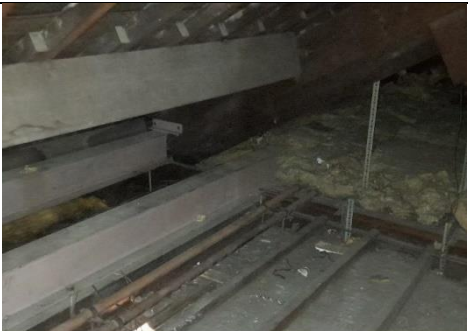
The investigations have confirmed that the existing structure is adequate for the proposed loadings but due to maintenance requirements, this causes excessive bending of the joists exceeding the maximum by over three times the allowable bend, which causes cracking and bending of the ceiling below and leads to issues such as the collapse of the ceiling, which has been seen over the stage area.

Figure 70 Concert Hall roof structure

- to repair all current condition items on the existing structure.
- add additional support structure to eradicate the joists bending.

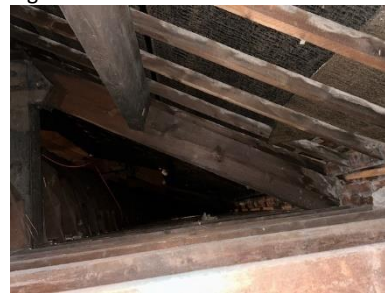
Similar to the main concert hall the circle gallery has also deteriorated and can no longer be considered as adequate in areas. This is due to general deterioration over the life of the materials used and age of the premises.

Figure 71 Circle gallery

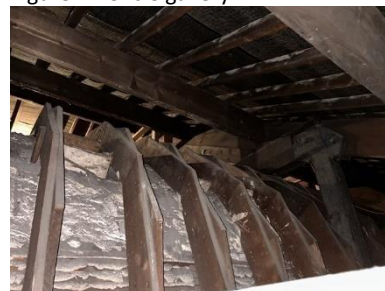
Figure 70 Circle gallery support structure

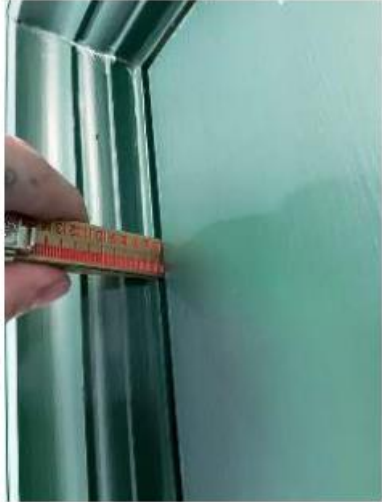
Fire Doors	
<p>The general overview regarding the doors is that they will require replacement as they do not meet current BS8214.</p> <p>The doors that have been replaced in recent years do not have the required certification to be considered a fire door. They will require adjustment and replacement hinges to meet current standards.</p>
